Exhibit 8.2

Sherwood Park Matrix of Required Retrofits to Public and Common Use Areas

SHERWOOD PARK APARTMENTS: PUBLIC AND COMMON USE AREAS

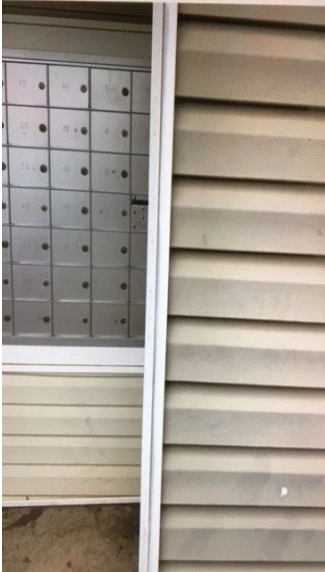
Numbers		Deficiency	Required Retrofit
7

<p>The mailboxes are inaccessible--the two top rows are 58.75 and 64 inches above the slab.</p>	<p>Lower mailboxes so that the topmost lock is no more than 54 inches about the adjacent concrete to comply with ANSI 4.2.6. Alternatively, provide written confirmation that all ground-floor units are assigned mailboxes with locks no more than 54" above the ground level.</p>
8		<p>The leasing office/clubhouse entry and all the interior clubhouse doors have inaccessible knob type hardware that requires tight grasping, pinching, and/or turning.</p>	<p>Install accessible lever door hardware where the existing hardware is knob style to comply with ANSI 4.13.9.</p>
