APPENDIX G
RETROFIT PLAN FOR MANOR RIDGE APARTMENTS

Manor Ridge Apartments Retrofit Plan – 1

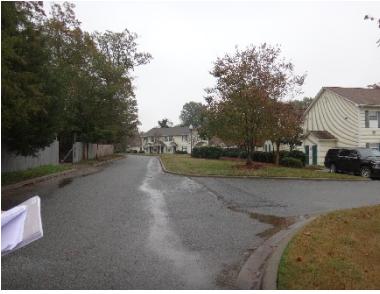
Lack of Accessible Route			
1

<p><i>View looking west from north of Building 8.</i></p>	<p>There is no accessible route between pedestrian site arrival points and leasing office; existing route ends at vehicular way (accessible route required).</p>	<p>Provide new sidewalk and curb ramps from Earns Rd. to the existing walk in front of the leasing office building (see Accessible Route Diagram).</p>

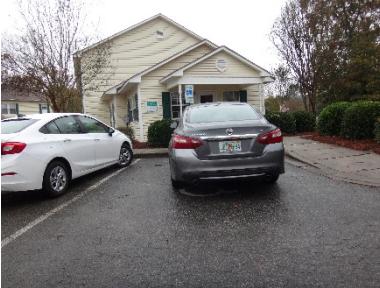
<i>Parking space at leasing office entry.</i>	The designated accessible parking space at the leasing office has no access aisle (aisle required).	Verify all slopes at space and proposed access aisle are less than 2%. Designated access aisle must be a minimum of 8-feet across. Stripe access aisle, relocate sign, and connect accessible aisle to accessible route.				
4

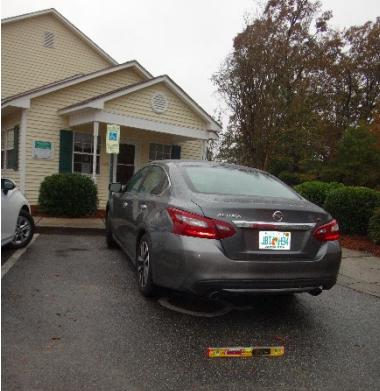
<i>Leasing office parking</i>	<p>The designated accessible parking space has a running slope of 6.6% (maximum 5% allowed per ANSI 1986; maximum 2% allowed per ADAAG).</p> <table> <thead> <tr> <th><u>Location</u></th> <th><u>Slope</u></th> </tr> </thead> <tbody> <tr> <td>Leasing Office Parking</td> <td>6.6%</td> </tr> </tbody> </table>	<u>Location</u>	<u>Slope</u>	Leasing Office Parking	6.6%	Repave/overlay asphalt at parking space and create access aisle. Restripe parking space and access aisle.
<u>Location</u>	<u>Slope</u>						
Leasing Office Parking	6.6%

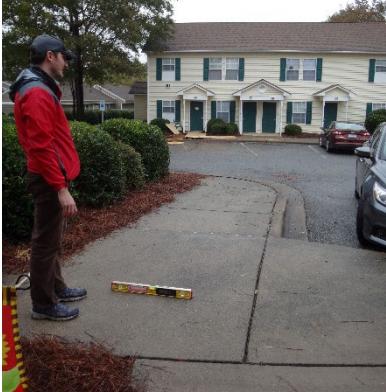
<p><i>Intersection of sidewalks in front of leasing office.</i></p>

<p><i>Measurement of cross slope.</i></p>	<p>Cross slope at the route northeast of Building 4 is 3.2% (maximum 2% allowed).</p>	<p>Replace sidewalks at accessible route(s) as required to retrofit sections with excessive cross slope.</p> <p>Note: continuous accessible routes shown on the diagram incorporate access aisles at parking. Retrofit includes relocation of accessible parking space and access aisle at Building 1 in order to allow for the striped crossing indicated between the leasing office parking access aisle and the access aisle and walk serving Buildings 1, 2 and 3.</p>

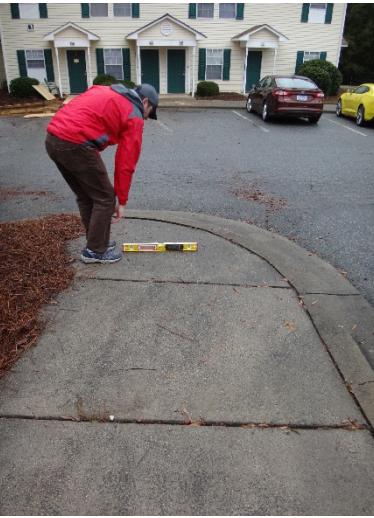
<p><i>Curb ramp at leasing office parking.</i></p>

<p><i>Measurement of slope perpendicular to sidewalk.</i></p>	<p>Cross slopes at the curb ramp northeast of Building 4 (Leasing) are as high as 3.3% to 4.8% (maximum 2.0% allowed).</p> <p>Note: if the ramp is considered a straight run, then the 3.3% slope is a cross slope exceeding 2% (as shown in the photo). If the ramp is considered to turn and the user exits to the access aisle to the right, then the 4.8% slope is a cross slope exceeding 2%.</p>	<p>Replace curb ramps at accessible route(s) as required to retrofit sections with excessive cross slope.</p>

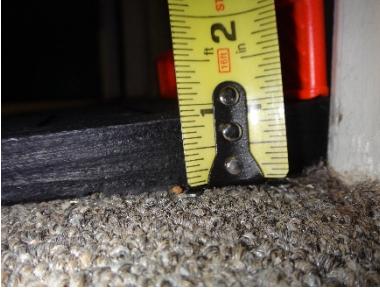
<p><i>Interior threshold.</i></p>

<p><i>Exterior threshold</i></p>	<p>The leasing office door interior and exterior threshold heights are greater than 1/2 inch with no bevel (maximum 1/4 inch vertical allowed, 1/2 inch threshold height with bevel is allowed).</p>

<u>Location</u>	<u>Height (inches)</u>	Interior threshold	7/8	Exterior threshold assembly	1-3/8	Replace threshold.
<u>Location</u>	<u>Height (inches)</u>								
Interior threshold	7/8								
Exterior threshold assembly	1-3/8

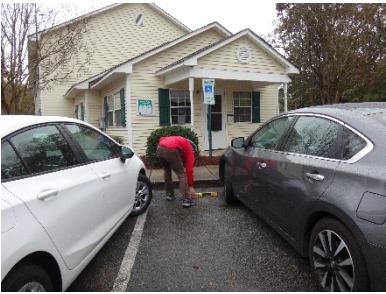
<p><i>Parking space at leasing office entry.</i></p>	<p>The leasing office does not have a van accessible parking space (minimum 1 required by ADA).</p>	<p>See Item 3 above.</p>

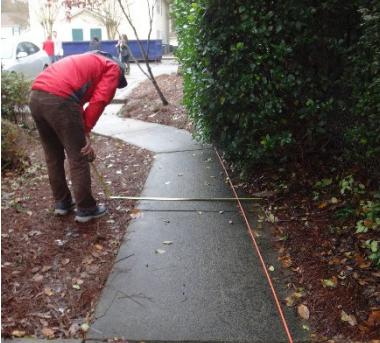
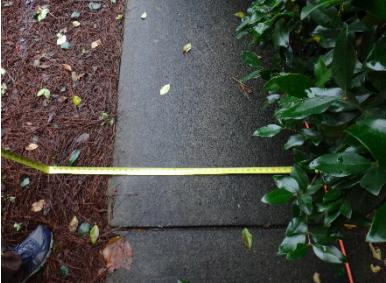
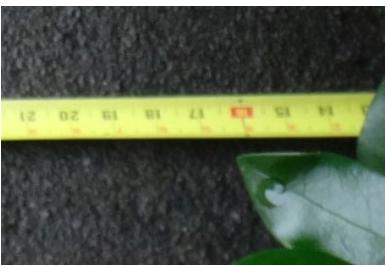
<p><i>Sidewalk south of Building 6.</i></p>	<p>The route south of Building 6 has vegetation overhanging the sidewalk and the clear width is 24 inches (minimum 36 inches required).</p>	<p>Trim vegetation.</p>

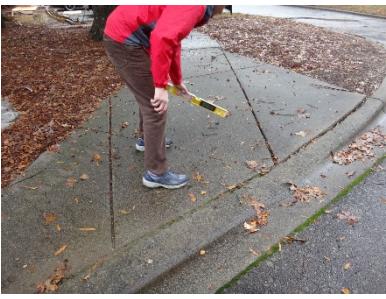
<p><i>Curb ramp west of Building 1 at Earns.</i></p>

<p>The route has changes in level greater than 1/2 inch (maximum 1/2 inch with bevel allowed).</p> <table> <thead> <tr> <th><u>Location</u></th> <th><u>Height (inches)</u></th> </tr> </thead> <tbody> <tr> <td>West of Building 1 at curb of Earns</td> <td>1-1/4</td> </tr> </tbody> </table>	<u>Location</u>	<u>Height (inches)</u>	West of Building 1 at curb of Earns	1-1/4	<p>Replace, bevel, or grind the edge of concrete as required to retrofit sections with excessive cross slope.</p>
<u>Location</u>	<u>Height (inches)</u>					
West of Building 1 at curb of Earns	1-1/4

<p><i>Measurement of change in level.</i></p>	<p>West of Building 1, east of curb ramp at Earns 1/2 no bevel</p> <p>End of walk at playground 1-3/4</p> <p>Northwest of Building 3 at parking 3/4</p> <p>Dumpster apron at mail center 1</p> <p>Dumpster apron at walk to Building 4 1</p> <p>North of Building 8 at top of curb ramp at Earns 1/2 no bevel</p>																	
	Inaccessible Gaps in Route																		
12

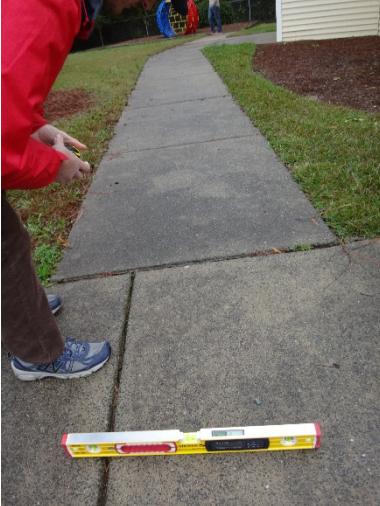
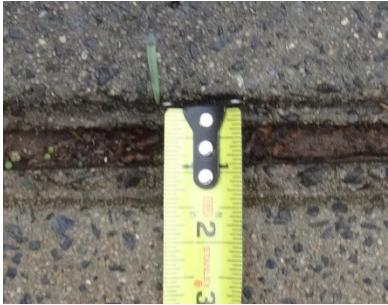
<p><i>Location west of Building 2</i></p>	<p>Gaps in the pavement are wider than 1/2 inch (maximum 1/2 inch allowed).</p>

<u>Location</u>	<u>Gap (inches)</u>	South of Building 1 at walk to Unit 104 storage	3/4	Off southwest corner of Building 3	1	Off northeast corner of Building 5	1-1/8	East of Building 4 (route to unit 401 storage)	3/4	West of Building 4 (route to unit 401)	1-1/8	Northeast of Building 8	1	East of Building 6	trench	<p>Fill gaps flush with walk surfaces.</p>
<u>Location</u>	<u>Gap (inches)</u>																		
South of Building 1 at walk to Unit 104 storage	3/4																		
Off southwest corner of Building 3	1																		
Off northeast corner of Building 5	1-1/8																		
East of Building 4 (route to unit 401 storage)	3/4																		
West of Building 4 (route to unit 401)	1-1/8																		
Northeast of Building 8	1																		
East of Building 6	trench

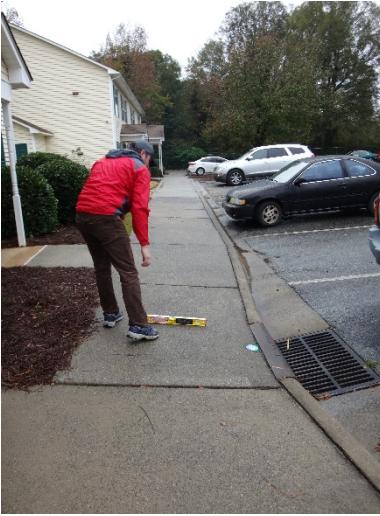
<p><i>Measuring slopes between Units 201 and 202.</i></p>

<p><i>Measurement of cross slope.</i></p> <p>Inaccessible Slopes at Sidewalks</p> <p>The cross slopes of the route are more than 2% (maximum 2% allowed).</p>

<u>Location</u>	<u>Slope</u>	West of Building 1 at bend in sidewalk	3.3%	In front of Unit 103	3.4%	In front of Unit 104	3.8%	At walk to Unit 201 storage	4.1%	At walk to Unit 201	4.8%	At walk to Units 202 and 203	10.4%	Between Units 203 and 204	13.8%	At walk to Unit 204	9.2%	South of walk to Unit 204	5.8%	In front of Unit 302	6.6%	Between Units 303 and 304	12.0%	At walk to Unit 304	6.7%	Off southwest corner of Building 3	3.8%	Midway down walk to Unit 304 storage	3.6%	Northeast of Building 5 at turn to unit entries	6.8%	East of Building 4 at south end of parking row	3.3%	South of walk to leasing office	3.9%	At walk to leasing office	3.9%	Replace concrete as required to retrofit sections with excessive cross slopes.	
<u>Location</u>	<u>Slope</u>																																								
West of Building 1 at bend in sidewalk	3.3%																																								
In front of Unit 103	3.4%																																								
In front of Unit 104	3.8%																																								
At walk to Unit 201 storage	4.1%																																								
At walk to Unit 201	4.8%																																								
At walk to Units 202 and 203	10.4%																																								
Between Units 203 and 204	13.8%																																								
At walk to Unit 204	9.2%																																								
South of walk to Unit 204	5.8%																																								
In front of Unit 302	6.6%																																								
Between Units 303 and 304	12.0%																																								
At walk to Unit 304	6.7%																																								
Off southwest corner of Building 3	3.8%																																								
Midway down walk to Unit 304 storage	3.6%																																								
Northeast of Building 5 at turn to unit entries	6.8%																																								
East of Building 4 at south end of parking row	3.3%																																								
South of walk to leasing office	3.9%																																								
At walk to leasing office	3.9%

At sidewalk intersection west of Building 4	6.4%	
	At first parking space west of Building 4	8.4%	
	West of Building 4 at north end of parking row	7.4%	
	At walk to Unit 404 storage	5.2%	
	At bend in walk to Unit 404 storage	3.2%	
	Southwest of Unit 404 storage	3.2%	
	South of walk to Unit 404 storage	5.3%	
	North of walk to Building 5	3.5%	
	At walk to Unit 504	3.5%	
	At walk to Unit 701	3.1%	
	South of Unit 801 storage	3.1%	
	At walk to Unit 801 storage	3.6%	
	Off southeast corner of Building 8	3.3%	
	South of walk to Unit 801	3.7%	
	At walk to Unit 801	4.4%	
	South of Unit 802 porch	7.3%	
	At walk to Unit 803	5.6%	
	At walk to Unit 804	3.8%	
	At walk to Unit 804 storage	3.2%

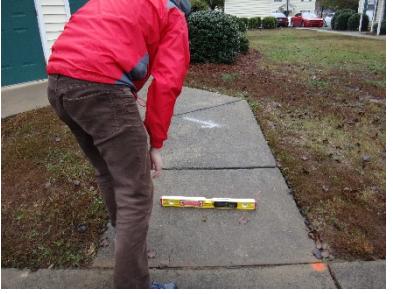
<p><i>Walk to Unit 404 storage.</i></p>

<p><i>Measurement of running slope.</i></p>	<p>The running slopes of routes are greater than 8.3% (maximum 8.3% allowed).</p>

<u>Location</u>	<u>Slope</u>	South end of walk to Unit 404 storage	12.5%	Bend in walk to Unit 404 storage	12.1%	<p>Replace concrete as required to retrofit sections with excessive running slopes.</p>
<u>Location</u>	<u>Slope</u>								
South end of walk to Unit 404 storage	12.5%								
Bend in walk to Unit 404 storage	12.1%

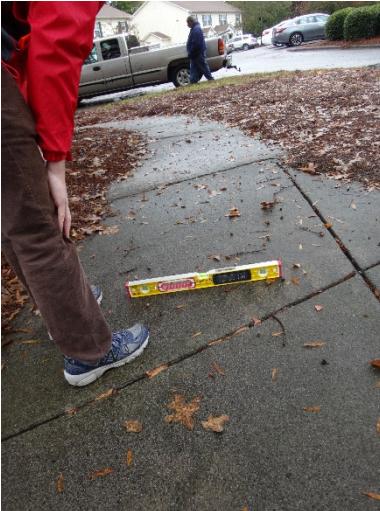
<p><i>Curb ramp.</i></p>

<p><i>Cross slope.</i></p>	<p>Cross slope at curb ramps is more than 2.0% (maximum 2.0% allowed).</p>

<p>A maximum 2.0% cross slope is allowed. (Guidelines Requirement 2 Chart; ANSI 1986 4.8.6).</p>	<u>Location</u>	<u>Slope</u>	Curb ramp west of Building 1	6.0% bottom of ramp	Curb ramp west of Building 1	5.5% parallel with curb	Curb ramp west of Building 1	5.2% perpendicular to route	<p>Replace concrete as required to retrofit sections with excessive cross slopes.</p>
<u>Location</u>	<u>Slope</u>										
Curb ramp west of Building 1	6.0% bottom of ramp										
Curb ramp west of Building 1	5.5% parallel with curb										
Curb ramp west of Building 1	5.2% perpendicular to route

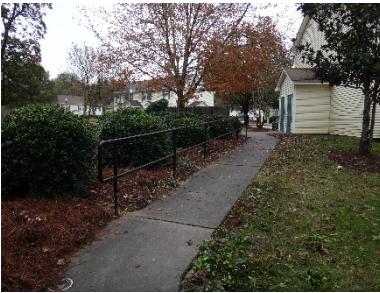
<p><i>Ramp north of Building 7.</i></p>	The ramp north of Building 7 has only one handrail (handrails required on both sides).	Install handrail. See item 16.
17	<i>See above.</i>	The ramp north of Building 7 has no edge protection (required on both sides).	Install edge protection at both sides of ramp.
18

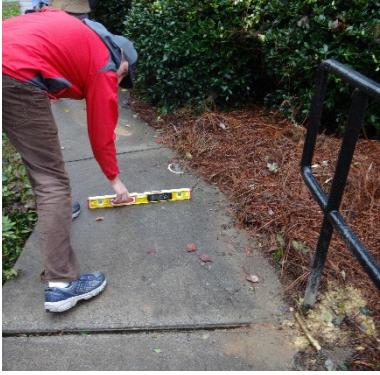
<p><i>Ramp north of Building 7.</i></p>	The landings at the ramp north of Building 7 slope as much as 6.1% (level landings required).	Replace ramp and landings as required to provide running and cross slopes as required at landings and at ramp runs.

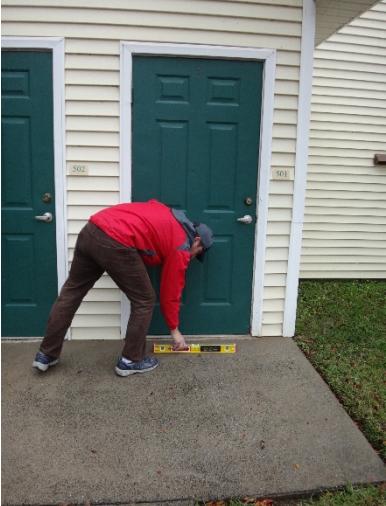
<p><i>Door at Unit 501 storage.</i></p>	<p>Common area door maneuvering clearances are sloped greater than 2.0% (maximum 2% allowed).</p>

<u>Location</u>	<u>Slope</u>	Unit 301	3.1%	Unit 301 storage	3.2%	Unit 501 storage	5.2%	Unit 504 storage	4.4%	Unit 601 storage	4.6%	<p>Replace concrete at door maneuvering clear spaces.</p>
<u>Location</u>	<u>Slope</u>														
Unit 301	3.1%														
Unit 301 storage	3.2%														
Unit 501 storage	5.2%														
Unit 504 storage	4.4%														
Unit 601 storage	4.6%

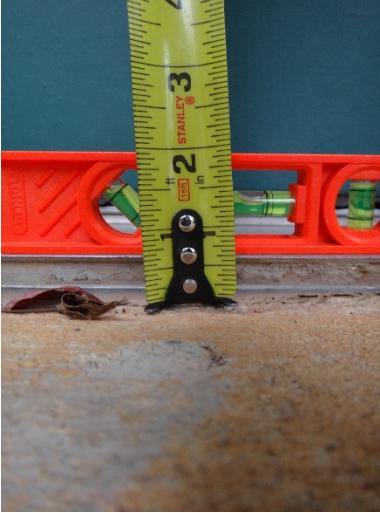
<p><i>Unit 204 entrance door threshold.</i></p>	<p>Entrance door thresholds are more than 3/4 inches high (maximum 3/4 inch height allowed).</p>

<u>Location</u>	<u>Height (inches)</u>	Unit 101 storage	5/8 no bevel	Unit 204	5/8 no bevel	Unit 401	7/8 no bevel	Unit 401 storage	7/8	Unit 404	3/4	Unit 504 storage	1-1/8	Unit 601 storage	1-1/4	Unit 604	1-1/4	Unit 701	1-1/4	Unit 704	1/2 no bevel	Unit 704 storage	1-1/4	Unit 801	7/8	Unit 804	1-1/2	<p>At unit entry doors: Install beveled transitions.</p> <p>At storage room doors:</p> <p>Provide beveled transition strip or offer remediation upon request of tenants. If offered on tenant request, a durable-material placard, contrasting black text on white background, in minimum 14-point font, must be placed on the side of the patio door stating: "A BEVEL TO ASSIST PERSONS WITH DISABILITIES FOR THIS THRESHOLD IS AVAILABLE UPON REQUEST. CONTACT MANAGEMENT."</p>
<u>Location</u>	<u>Height (inches)</u>																														
Unit 101 storage	5/8 no bevel																														
Unit 204	5/8 no bevel																														
Unit 401	7/8 no bevel																														
Unit 401 storage	7/8																														
Unit 404	3/4																														
Unit 504 storage	1-1/8																														
Unit 601 storage	1-1/4																														
Unit 604	1-1/4																														
Unit 701	1-1/4																														
Unit 704	1/2 no bevel																														
Unit 704 storage	1-1/4																														
Unit 801	7/8																														
Unit 804	1-1/2

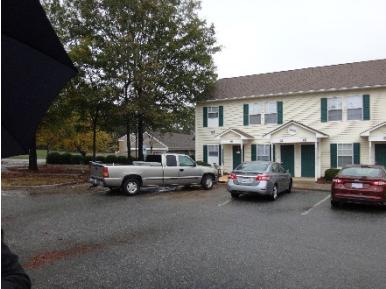
<p><i>Designated accessible parking space at Building 1.</i></p>	<p>Designated accessible parking spaces have no access aisle (aisle required).</p> <p><u>Location</u></p> <p>Building 1, no access aisle Building 3, no access aisle Building 5, no access aisle Building 5, no access aisle Building 6, no access aisle Building 7, no access aisle</p>	<p>Stripe parking spaces and install access aisles. See Accessible Route Diagram. Stripe routes crossing parking.</p>

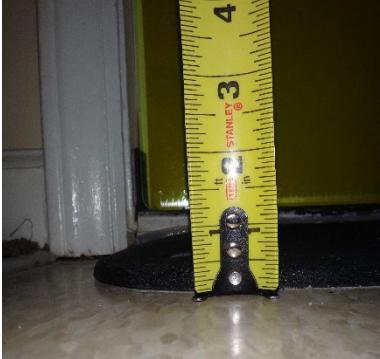
<p><i>Entrance door threshold interior side at Unit 101.</i></p>	<p>Door thresholds are more than 3/4 inches high at the interior face and are not beveled (maximum 3/4 inch with bevel allowed).</p>

<p>Provide beveled transition strips.</p>	<u>Location</u>	Height (inches)	Unit 101 entrance	1-1/4	Unit 601 entrance	1-3/8
<u>Location</u>	Height (inches)							
Unit 101 entrance	1-1/4							
Unit 601 entrance	1-3/8

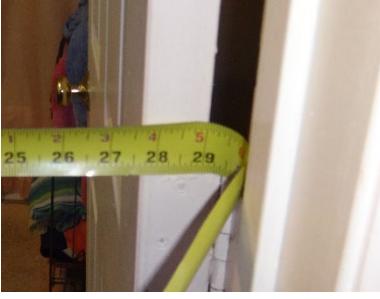
<p><i>Clear width of door opening.</i></p>	<p>Bathroom door clear opening widths are 27-5/8 inches (minimum 31-5/8 inch required).</p>	<p>Widen door opening and replace door.</p>
24

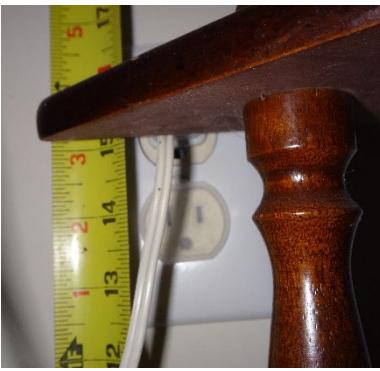
<p><i>Height of outlet in Unit 101</i></p>	<p>Typical outlets are less than 13-3/4 inches to 14 inches above the floor (minimum 15-inches required).</p>	<p>Raise at least one outlet for each room area.</p>

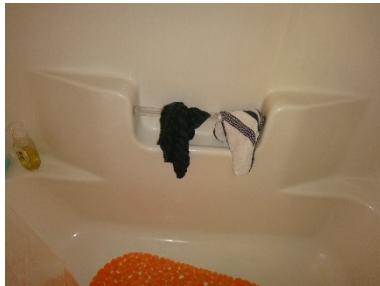
<p><i>Bathtub/shower surround in Unit 101.</i></p>	<p>The shape of the bathtub surrounds precludes the installation of future grab bars with firm attachment to blocking (ability to install grab bars required).</p>	<p>Replace tub surround or install custom grab bars that can be mounted in the required locations at the existing surrounds. If not replacing the tub surround, fabricate at least two custom grab bars for the tub back walls. Maintain a stock of two such grab bars on site at all times. Install on request at no charge.</p>						
26

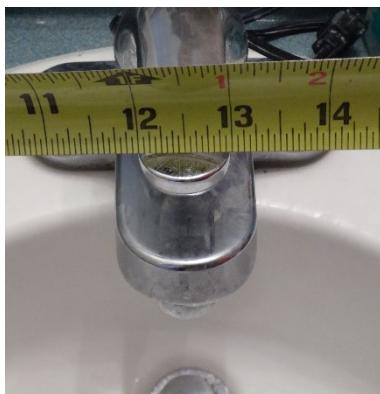
<p><i>Dimension from side wall to centerline of lavatory in Unit 101.</i></p>	<p>Lavatory centerlines are less than 24 inches to the side wall (minimum 24 inches required) and the cabinets are not removable. Flooring, base, and finishes do not extend below vanity.</p>

Location	Distance (inches)	Unit 101 bathroom	12-1/2	Unit 601 bathroom	18	<p>Install removable base cabinet with 30 inch wide knee space in compliance with safe harbor (ANSI) knee and toe clearance requirements.</p> <p>Attach a durable-material placard measuring at least 1" by 3" and stating: "THIS CABINET IS REMOVABLE FOR PERSONS WITH DISABILITIES. CONTACT MANAGEMENT."</p>
Location	Distance (inches)								
Unit 101 bathroom	12-1/2								
Unit 601 bathroom	18

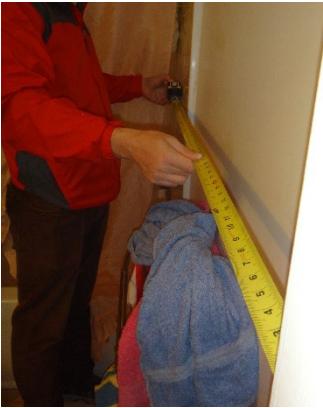
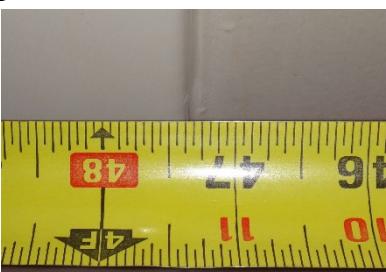
<p><i>Bathroom door leaf in open position at Unit 601</i></p>

<p><i>Dimension from door leaf in open position to bathtub</i></p>	<p>The clear floor space in the bathrooms is 41-3/4 to 42 inches long (minimum 48-inches required).</p>	<p>Reverse the door so that it does not swing into the bathroom.</p>
----	--	---	--

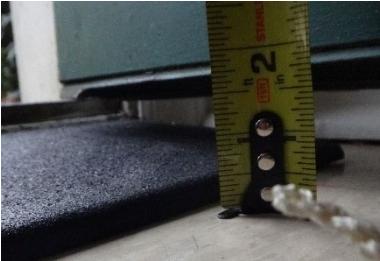
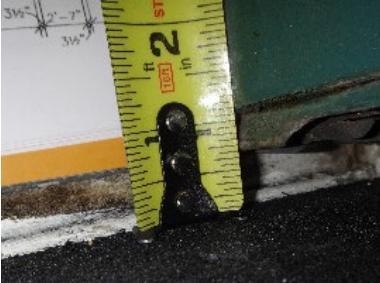
<p><i>Entrance door threshold interior side at Unit 501.</i></p>	<p>Door thresholds are more than 3/4 inches high at the exterior face and are not beveled (maximum 3/4 inch with bevel allowed).</p>

<u>Location</u>	Height (inches)	Unit 501 entrance	1-1/4	Unit 501 storage (storage closet is more than 24 inches deep)	1-1/4	<p>At unit entry doors: Provide beveled transition strips.</p> <p>At unit storage closet doors: Provide beveled transition strip or offer remediation upon request of tenants. If offered on tenant request, a durable-material placard, contrasting black text on white background, in minimum 14-point font, must be placed on the side of the patio door stating:</p>
<u>Location</u>	Height (inches)								
Unit 501 entrance	1-1/4								
Unit 501 storage (storage closet is more than 24 inches deep)	1-1/4

<p><i>Entrance door threshold interior side at Unit 501.</i></p>	<p>“A BEVEL TO ASSIST PERSONS WITH DISABILITIES FOR THIS THRESHOLD IS AVAILABLE UPON REQUEST. CONTACT MANAGEMENT.”</p>
29

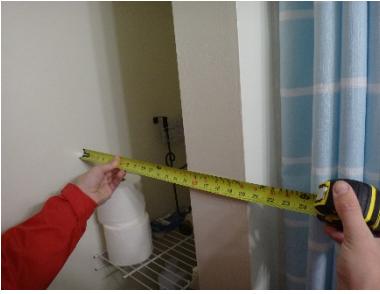
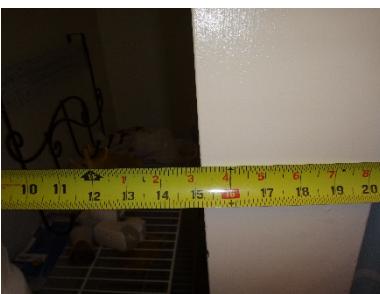
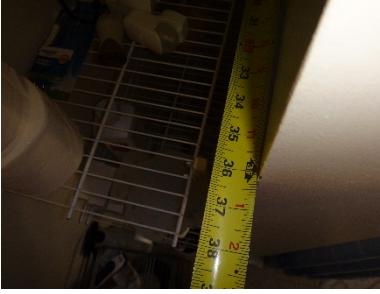
<p><i>Linen storage in unit 501.</i></p>

<p><i>Measurement of clear opening.</i></p>	<p>The width of the clear opening at the linen closet doorway is 15-1/8 inches and the closet depth is 36 inches (minimum 31-5/8 inch clear opening width required).</p> <p>(Note: shelf is mounted on the long sidewall of the closet space.)</p> <p>Widen door or install new back wall at closet such that closet depth is reduced to 24 inches.</p>

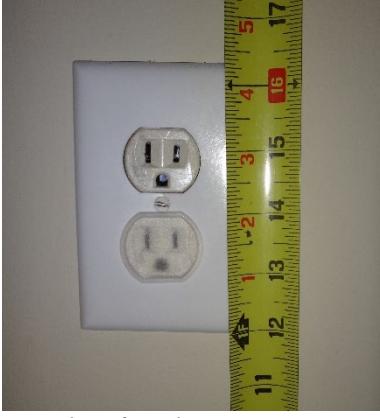
<p><i>Height of outlet in Unit 501</i></p>	<p>Typical outlets are 13-5/8 inches above the floor (minimum 15 inches required).</p>	<p>Raise at least one outlet for each room area.</p>

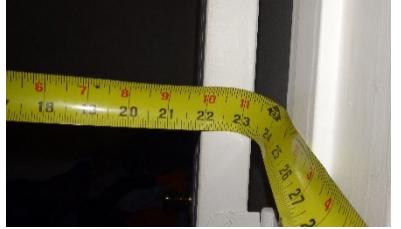
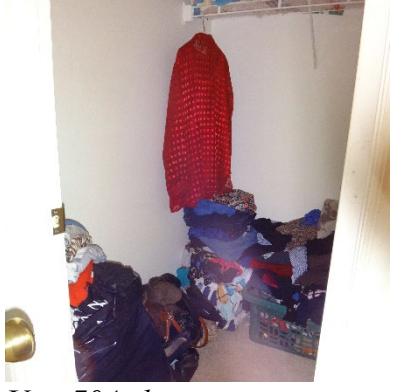
<i>Measurement of door width at Unit 704 walk-in closet.</i>

<i>Unit 704 closet.</i>	<p>Door clear opening widths are less than 31-5/8 inches (minimum 31-5/8 inch required).</p>

<u>Location</u>	<u>Clear Width (inches)</u>	Unit 304, walk-in closet	21-3/4	Unit 304, powder room	22	Unit 704, walk-in closet	22	Unit 704, powder room	22	<p>Widen door to provide a compliant clear opening width or install new back wall to closet that reduces the closet depth to 24" interior depth.</p>
<u>Location</u>	<u>Clear Width (inches)</u>												
Unit 304, walk-in closet	21-3/4												
Unit 304, powder room	22												
Unit 704, walk-in closet	22												
Unit 704, powder room	22												
33

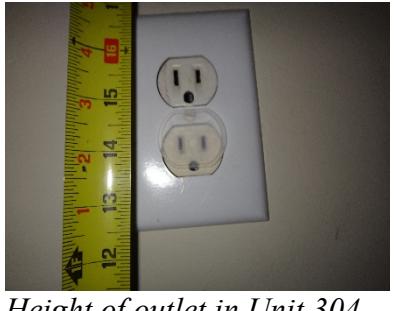
<i>Height of outlet in Unit 304.</i>	<p>Typical outlets are 14 inches above the floor (minimum 15 inches required).</p>	<p>Raise at least one outlet for each room area.</p>

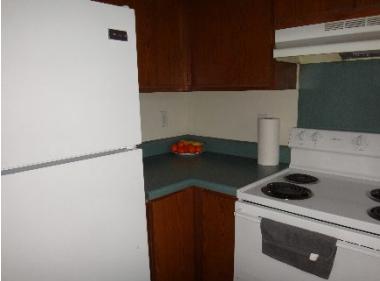
<p><i>Clear floor space obstructed by adjacent refrigerator and counters in Unit 304.</i></p>

<p><i>Range and countertop depth in Unit 304.</i></p>	<p>The outlets above kitchen countertops lack the required clear floor space for approach to an outlet serving the area between the range and refrigerator (at least 1 outlet in each counter area must have clear floor space for approach).</p>	<p>Replace range or add outlet(s) at accessible location serving the counter area.</p>
----	---	---	--

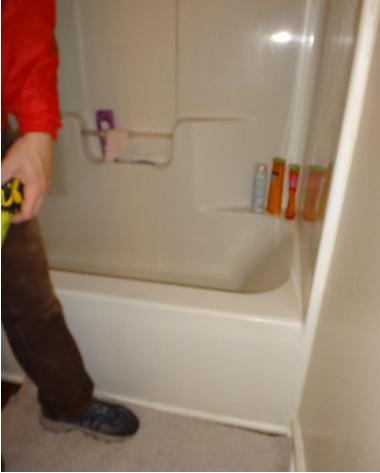
<p><i>Bathtub/shower surround in Unit 304</i></p>	<p>The shape of the bathtub surrounds precludes the installation of future grab bars with firm attachment to blocking (ability to install grab bars required).</p>	<p>Replace tub surround or install custom grab bars that can be mounted in the required locations at the existing surrounds. If not replacing the tub surround, fabricate at least two custom grab bars for the tub back walls. Maintain a stock of two such grab bars on site at all times. Install on request at no charge.</p>						
36

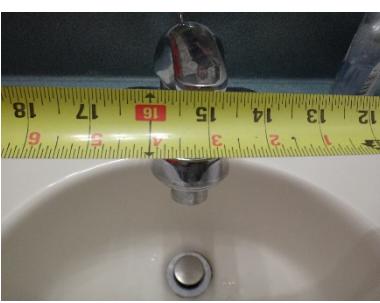
<p><i>Dimension from side wall to centerline of lavatory in Unit 304.</i></p>	<p>Lavatory centerlines are less than 24 inches to the side wall (minimum 24 inches required) and the cabinets are not removable. Flooring, base, and finishes do not extend below vanity.</p>

<u>Location</u>	Distance (inches)	Unit 304, bathroom	15-3/8	Unit 704, bathroom	15-1/8	<p>Install removable base cabinet with 30 inch wide knee space in compliance with safe harbor knee and toe clearance requirements.</p> <p>Attach a durable-material placard measuring at least 1" by 3" and stating: "THIS CABINET IS REMOVABLE FOR PERSONS WITH DISABILITIES. CONTACT MANAGEMENT."</p>
<u>Location</u>	Distance (inches)								
Unit 304, bathroom	15-3/8								
Unit 704, bathroom	15-1/8
