APPENDIX H

RETROFIT PLAN FOR MILLERS RIDGE APARTMENTS

Millers Ridge Apartments Retrofit Plan – 1

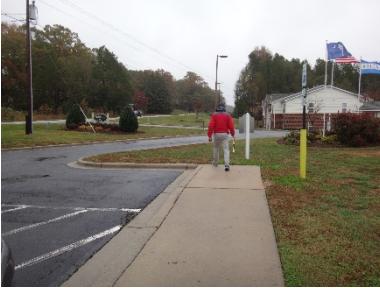
Lack of Accessible Route										
1

<i>Route along drive lane.</i>	There is no accessible route between pedestrian site arrival points and leasing office (accessible route required).	Provide new sidewalk and curb ramps from Monroe Highway to existing walk west of the leasing office/clubhouse (see Accessible Route Diagram).								
	Crosswalks										
2	<i>See Accessible Route Diagram.</i>	Crosswalks at vehicular drives are incorporated into the accessible route(s).	Stripe crosswalks.								
	Inaccessible Slopes at Sidewalks										
3

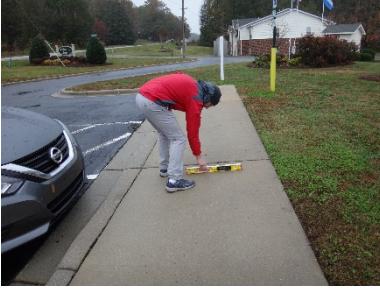
<i>South of Leasing Office, sidewalk at curb ramp.</i>	<p>Cross slopes at the route are more than 2% (maximum 2% allowed).</p>

<table><tr> <th><u>Location</u></th> <th><u>Slope</u></th> </tr><tr> <td>West of Leasing Office at south curb ramp</td> <td>8.2%</td> </tr><tr> <td>West of Leasing Office at curb ramp</td> <td>10.2%</td> </tr><tr> <td>West of Leasing Office north of access aisle</td> <td>4.1%</td> </tr></table>

<u>Location</u>	<u>Slope</u>	West of Leasing Office at south curb ramp	8.2%	West of Leasing Office at curb ramp	10.2%	West of Leasing Office north of access aisle	4.1%	Replace existing curb ramp and sidewalk sections (at least one slab north and south of the curb ramp) by the parking space and access aisle west of leasing office.
<u>Location</u>	<u>Slope</u>										
West of Leasing Office at south curb ramp	8.2%										
West of Leasing Office at curb ramp	10.2%										
West of Leasing Office north of access aisle	4.1%

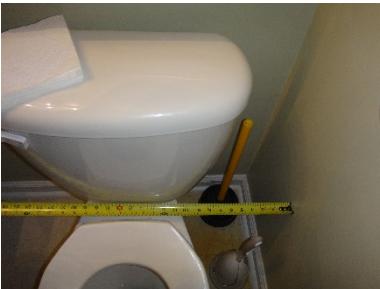
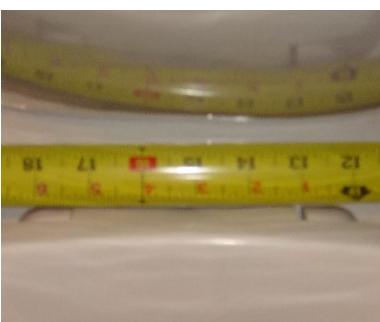
<p><i>Toilet in unisex restroom.</i></p>

<p><i>Dimension from wall to toilet centerline.</i></p>	<p>The toilet centerline is 15 inches from the side wall (minimum 16 inches required and maximum 18 inches allowed by 2010 ADA, 18 inches required by the Guidelines/ANSI 1986).</p>	<p>Install offset flange. Shift existing toilet at least 1 inch further from the sidewall.</p>

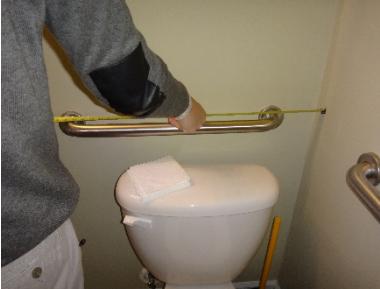
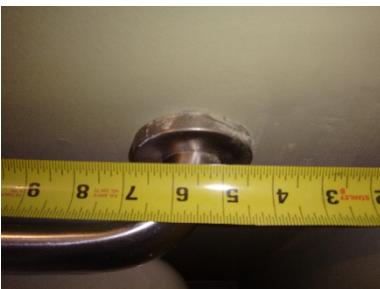
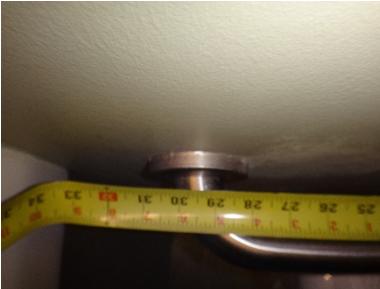
<p><i>Toilet and grab bar.</i></p>

<p><i>Measurement to wall end of grab bar.</i></p>

<p><i>Measurement to far end of grab bar.</i></p>	<p>Accessories:</p> <p>The rear wall grab bar is 24 inches long (minimum 36 inches required).</p> <p>The toilet paper holder is 32-3/4 inches from the back wall and approximately 2-3/4 inches in front of the nose of the toilet (minimum 7 inches to maximum 9 inches in front of toilet required).</p>	<p>Remove and replace rear grab bar. New bar minimum 36 inches long. Note: new grab bar location may conflict with the existing lavatory. Omit this work if distance from sidewall to side of lavatory is less than 38 inches.</p> <p>Relocate toilet paper dispenser.</p>
---	--	--	--

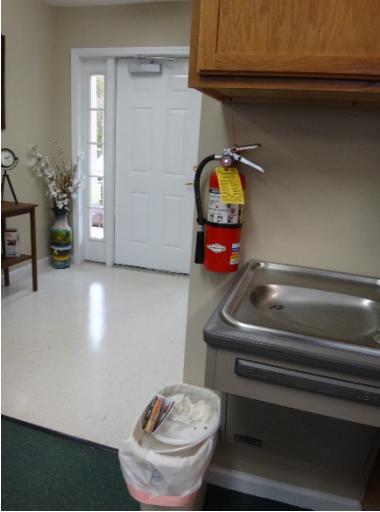
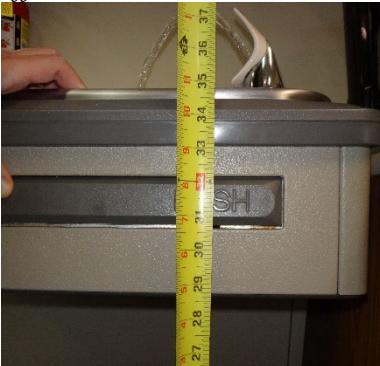
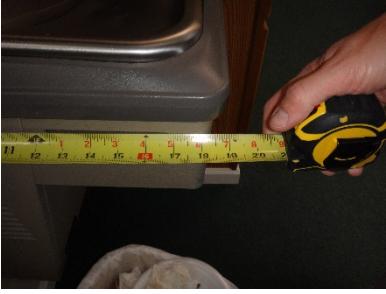
<p><i>Protruding objects in leasing office.</i></p>

<p><i>Drinking fountain protruding height.</i></p>	<p>Objects protrude more than 4 inches into the circulation path at heights greater than 27 inches and less than 80 inches (maximum 4 inch protruding objects allowed at heights greater than 27 inches and less than 80 inches).</p>	<p>Retrofit at fire extinguisher:</p> <ol style="list-style-type: none"> 1) Lower so that bottom of unit is less than 27 inches above the floor; or 2) Install permanent cane detectable barrier under the fire extinguisher. <p>Retrofit at drinking fountain:</p> <ol style="list-style-type: none"> 1) Lower so that bottom of unit is less than 27 inches above the floor; or 2) Install permanent cane detectable barrier under edge of the drinking fountain such that the bottom is exactly 27 inches above the floor. Unit must be both cane detectable and have required clear knee space.

<p><i>Drinking fountain protruding depth.</i></p>								
7

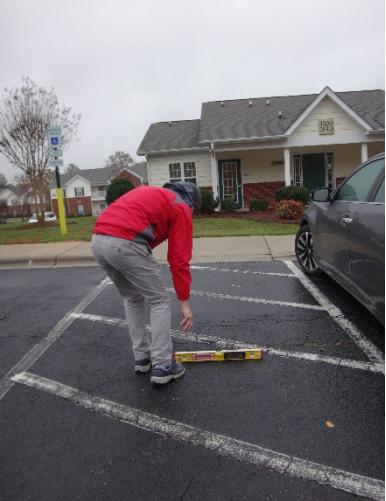
<p><i>Access aisle.</i></p>	<p>Leasing office designated accessible parking access aisle has running slopes greater than 2.0% (maximum 2% allowed).</p>

<table><tr> <th><u>Location</u></th> <th><u>Slope</u></th> </tr><tr> <td>Leasing Office</td> <td>3.7%</td> </tr><tr> <td>Leasing Office</td> <td>3.9%</td> </tr></table>

<u>Location</u>	<u>Slope</u>	Leasing Office	3.7%	Leasing Office	3.9%	<p>Repave access aisle. Restripe aisle and apply ISA marking at space after paving.</p>
<u>Location</u>	<u>Slope</u>								
Leasing Office	3.7%								
Leasing Office	3.9%

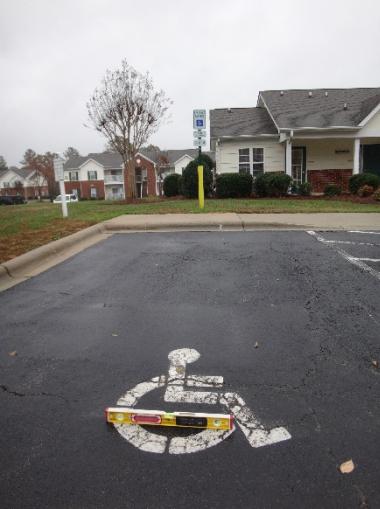
<p><i>Leasing Office designated accessible parking space.</i></p>

<p><i>Running slope at foot of parking space.</i></p>	<p>The designated accessible parking space has running slopes greater than 2% (maximum 2% allowed).</p>

<table><tr> <th><u>Location</u></th> <th><u>Slope</u></th> </tr><tr> <td>Leasing Office Parking</td> <td>3.4%</td> </tr><tr> <td>Leasing Office Parking</td> <td>4.0%</td> </tr></table>

<u>Location</u>	<u>Slope</u>	Leasing Office Parking	3.4%	Leasing Office Parking	4.0%	<p>Repave parking space. Restripe aisle and apply ISA marking at space after paving.</p>
<u>Location</u>	<u>Slope</u>								
Leasing Office Parking	3.4%								
Leasing Office Parking	4.0%

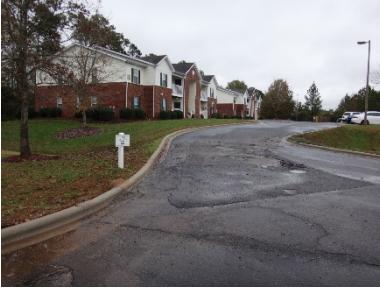
Lack of Accessible Route		
9

<p><i>No route to east building group</i></p>	<p>There is no accessible route from covered dwelling units to site arrival points, leasing office, and common areas.</p>	<p>Provide new sidewalks and curb ramps from Monroe Highway to existing walks (see Accessible Route Diagram).</p>
10

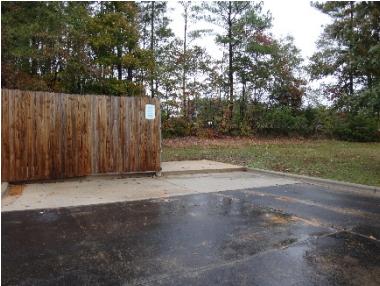
<p><i>Dumpster east of 3001-3029.</i></p>	<p>The route has changes in level greater than 1/4 inch (maximum 1/4 inch allowed without a bevel and 1/2 inch with a bevel) at trash areas.</p> <table> <thead> <tr> <th><u>Location</u></th> <th>Height (inches)</th> </tr> </thead> <tbody> <tr> <td>Trash east of 3001-3029</td> <td>5-3/4</td> </tr> <tr> <td>Trash south of 5001-5029</td> <td>3/4</td> </tr> <tr> <td>Trash south of 4000-4028</td> <td>6-1/4</td> </tr> </tbody> </table>	<u>Location</u>	Height (inches)	Trash east of 3001-3029	5-3/4	Trash south of 5001-5029	3/4	Trash south of 4000-4028	6-1/4	<p>Provide new curb ramp and route to trash dumpsters south of 5001-5029 and south of 4000-4028.</p> <p>Relocate the trash dumpster east of 3001-3029 to the parking area between 2001-2029 and 3001-3029. Provide accessible route to the new location.</p> <p>Note: alternate locations for the trash north of Millers Ridge Lane may be considered. Submit any revisions for approval prior to beginning design or construction.</p>

<u>Location</u>	Height (inches)										
Trash east of 3001-3029	5-3/4										
Trash south of 5001-5029	3/4										
Trash south of 4000-4028	6-1/4

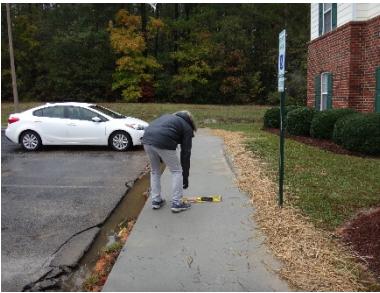
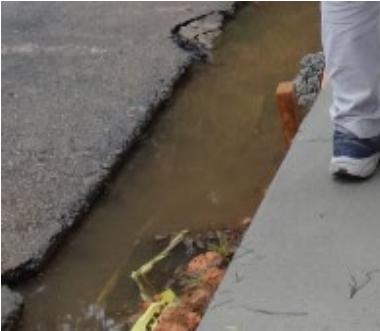
Inaccessible Gaps in Route		
12	<p><i>Location of trench at designated accessible parking space.</i></p>

<p><i>Trench.</i></p>

<p>Continuous gap in the pavement at the base of a curb ramp is wider than 1/2 inch (maximum 1/2 inch allowed). Trench is approximately 12 inches wide and 4 inches deep.</p>	<p>Pave edge of parking lot and fill trench.</p>

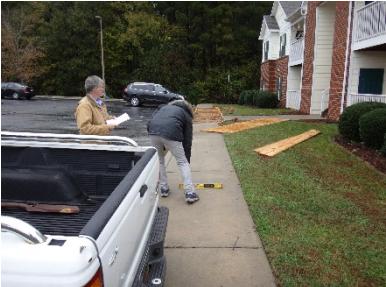
<p><i>Sidewalk west of 3001-3029.</i></p>

<p><i>Measurement of cross slope.</i></p>	<p>Cross slopes at the route are more than 2% (maximum 2% allowed).</p>

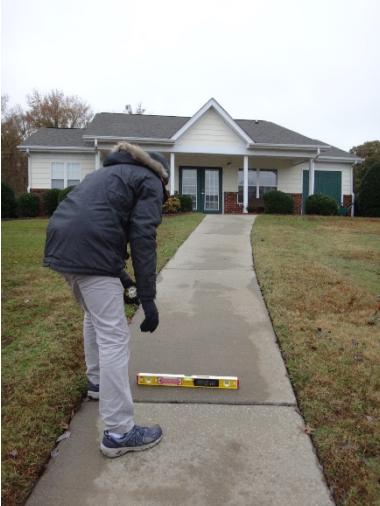
<p><i>Sidewalk east of the Leasing Office building.</i></p>	<p>Running slopes at ramp to leasing are greater than 8.3% (maximum 8.3% allowed at a ramp).</p>	<p>Proposed accessible routes on the Accessible Route Diagram do not include this walk. No work at this walk is required unless an alternate route is proposed.</p>

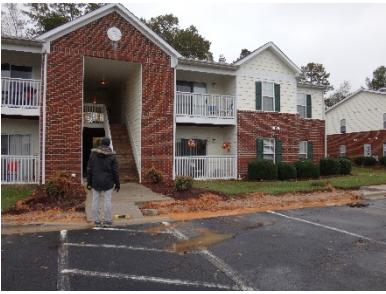
<p><i>Curb ramp measurement location.</i></p>

<p><i>Running slope.</i></p>	<p>Running slopes of curb ramps are more than 8.3% (maximum 8.3% allowed).</p>

<table><tr> <th><u>Location</u></th> <th><u>Slope</u></th> </tr><tr> <td>Bottom of ramp at 4001-29</td> <td>12.0%</td> </tr><tr> <td>Top of ramp at 4001-29</td> <td>10.7%</td> </tr><tr> <td>Top of ramp at 5001-29</td> <td>12.6%</td> </tr><tr> <td>Bottom of ramp at 5001-29</td> <td>11.8%</td> </tr></table>

<u>Location</u>	<u>Slope</u>	Bottom of ramp at 4001-29	12.0%	Top of ramp at 4001-29	10.7%	Top of ramp at 5001-29	12.6%	Bottom of ramp at 5001-29	11.8%	<p>Remove and replace curb ramp and adjacent paving as required to maintain a continuous accessible route at the sidewalk.</p>
<u>Location</u>	<u>Slope</u>												
Bottom of ramp at 4001-29	12.0%												
Top of ramp at 4001-29	10.7%												
Top of ramp at 5001-29	12.6%												
Bottom of ramp at 5001-29	11.8%

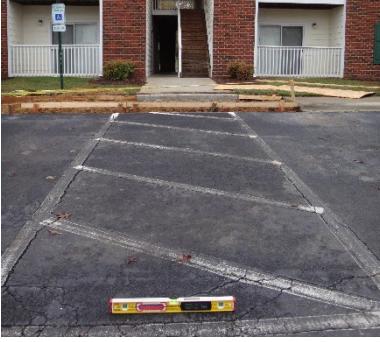
<p><i>Access aisle east of 3000-3028 (level in cross slope position).</i></p>

<p><i>Running slope.</i></p>	<p>Access aisles have running slopes greater than 5% (maximum 5% allowed).</p>

<table><tr> <th><u>Location</u></th> <th><u>Slope</u></th> </tr><tr> <td>Foot of aisle east of 3000-28</td> <td>8.7%</td> </tr><tr> <td>Head of aisle west of 4000-28</td> <td>5.7%</td> </tr></table>

<u>Location</u>	<u>Slope</u>	Foot of aisle east of 3000-28	8.7%	Head of aisle west of 4000-28	5.7%	<p>Repave parking space and aisle. Include new pavement markings and International Symbol of Accessibility.</p>
<u>Location</u>	<u>Slope</u>								
Foot of aisle east of 3000-28	8.7%								
Head of aisle west of 4000-28	5.7%

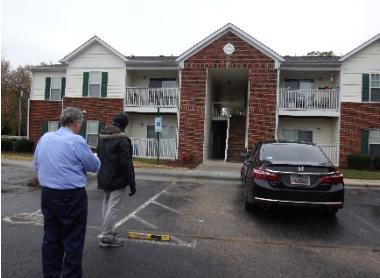
<p><i>Access aisle at 1001-1029.</i></p>	<p>Access aisles are not on an accessible route (accessible route required). There is a vertical curb at the sidewalk.</p> <p><u>Locations</u></p> <p>East of 1001-1029 West of 2001-2029 East of 2001-2029 West of 3001-3029 West of 2000-2028 East of 2000-2028 West of 3000-3028 East of 3000-3028 West of 4000-4028 West of 5000-5028</p>	<p>Install curb ramp at each listed access aisle. Curb ramp design must not create cross slope conditions at sidewalk.</p>				
	<p>Inaccessible Slopes at Clear Floor Space Serving Mail Center</p>						
19

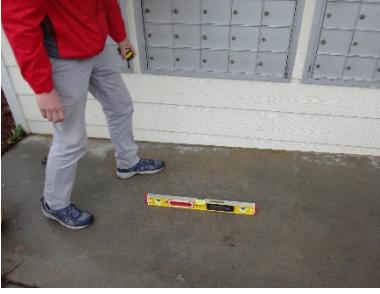
<p><i>Clear floor space at mail center.</i></p>	<p>Clear floor space(s) at the mail center have slopes greater than 2% (maximum 2% allowed).</p> <table border="1"> <thead> <tr> <th><u>Location</u></th> <th><u>Slope</u></th> </tr> </thead> <tbody> <tr> <td>Midpoint of mail center</td> <td>3.2%</td> </tr> </tbody> </table>	<u>Location</u>	<u>Slope</u>	Midpoint of mail center	3.2%	<p>Grind, replace, or top existing concrete to provide level clear floor spaces at mail boxes.</p>
<u>Location</u>	<u>Slope</u>						
Midpoint of mail center	3.2%

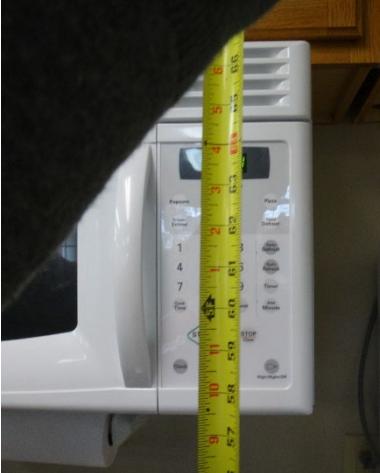
<p><i>Height of microwave controls.</i></p>	<p>The microwave controls located 62-3/4 inches above the finished floor (maximum 46 inches allowed for side reach range over obstruction).</p>	<p>Relocate microwave or provide a portable microwave on the countertop in a compliant location.</p>

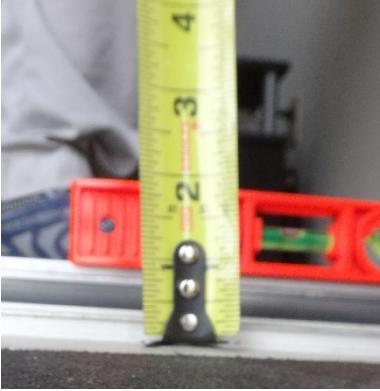
<p>Patio door threshold at Unit 1005.</p>	<p>Door thresholds are more than 3/4 inches high and are not beveled (maximum 3/4 inch with bevel allowed).</p>

<table><tr><th>Location</th><th>Height (inches)</th></tr><tr><td>Unit 1005, patio</td><td>7/8</td></tr><tr><td>Unit 1005, storage</td><td>1-1/2</td></tr><tr><td>Unit 3004, patio</td><td>1</td></tr><tr><td>Unit 3004, storage</td><td>1-3/4</td></tr></table>

Location	Height (inches)	Unit 1005, patio	7/8	Unit 1005, storage	1-1/2	Unit 3004, patio	1	Unit 3004, storage	1-3/4	<p>Patio and storage closet doors:</p> <p>Provide beveled transition strip or offer remediation upon request of tenants. If offered on tenant request, a durable-material placard, contrasting black text on white background, in minimum 14-point font, must be placed on the side of the patio door stating: "A BEVEL TO ASSIST PERSONS WITH DISABILITIES FOR THIS THRESHOLD IS AVAILABLE UPON REQUEST. CONTACT MANAGEMENT."</p>
Location	Height (inches)												
Unit 1005, patio	7/8												
Unit 1005, storage	1-1/2												
Unit 3004, patio	1												
Unit 3004, storage	1-3/4

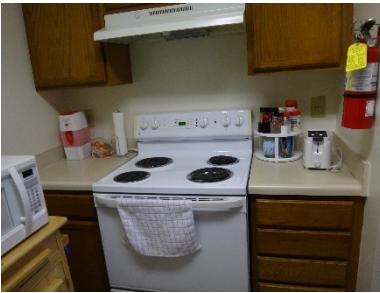
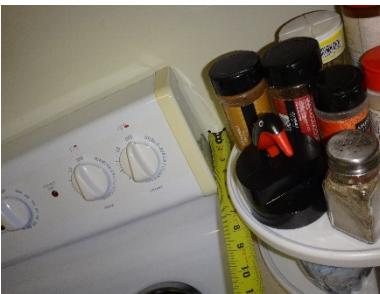
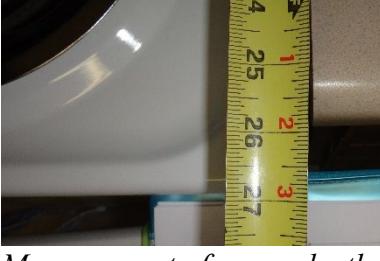
<p><i>Kitchen in Unit 1005.</i></p>

<p><i>Measurement of range depth.</i></p>	<p>Outlets above kitchen countertops lack the required clear floor space for approach (at least 1 outlet in each counter area must have a clear floor space). The depth of the range obstructs approach.</p>

<table><tr> <th><u>Location</u></th> <th><u>Depth (inches)</u></th> </tr><tr> <td>Unit 1005</td> <td>26-7/8</td> </tr><tr> <td>Unit 3004</td> <td>27 +/-</td> </tr></table>

<p>Replace range or add outlets on side walls at each side of the counters. New outlets on side walls to be maximum 10 inches back from the front face of the range.</p>	<u>Location</u>	<u>Depth (inches)</u>	Unit 1005	26-7/8	Unit 3004	27 +/-
<u>Location</u>	<u>Depth (inches)</u>							
Unit 1005	26-7/8							
Unit 3004	27 +/-

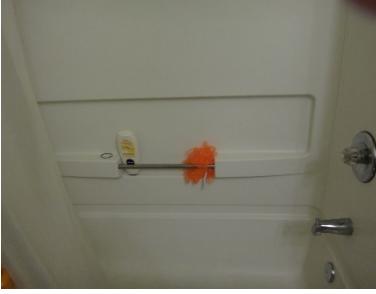
<p><i>Bathtub/shower surround in Unit 1005.</i></p>	<p>The shape of the bathtub surrounds precludes the installation of future grab bars with firm attachment to blocking (ability to install grab bars required).</p>	<p>Replace tub surround or install custom grab bars on request that can be mounted in the required locations at the existing surrounds.</p>
24

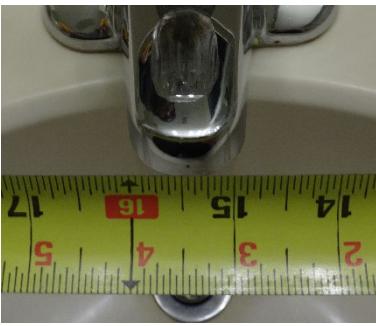
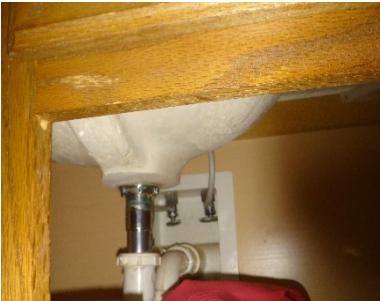
<p><i>Measurement to centerline of lavatory in Unit 1005.</i></p>	<p>Lavatory centerlines are 15-1/2 inches to the side wall (minimum 24 inches required) and the cabinets are not removable.</p>	<p>Install removable base cabinet with 30 inch wide knee space in compliance with safe harbor knee and toe clearance requirements.</p> <p>Attach a durable-material placard stating: “THIS CABINET IS REMOVABLE FOR PERSONS WITH DISABILITIES. CONTACT MANAGEMENT.”</p>

<p><i>Vanity base interior in Unit 1005.</i></p>								
25

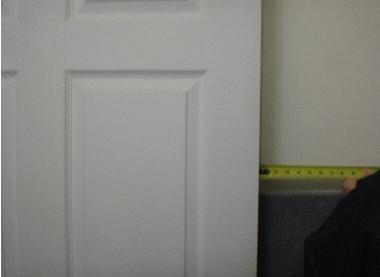
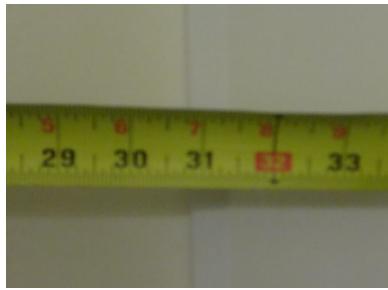
<p><i>Bathroom door leaf in open position at Unit 1005.</i></p>	<p>The clear floor space in the bathroom is less than 48-inches long (minimum 48-inches required).</p>

<table><tr> <th><u>Location</u></th> <th><u>Distance (inches)</u></th> </tr><tr> <td>Unit 1005</td> <td>30-7/8</td> </tr><tr> <td>Unit 3004</td> <td>31-3/8</td> </tr></table>

*Measurement from door leaf
in open position to bathtub*

<u>Location</u>	<u>Distance (inches)</u>	Unit 1005	30-7/8	Unit 3004	31-3/8	<p>Reverse the door so that it does not swing into the bathroom.</p>
<u>Location</u>	<u>Distance (inches)</u>								
Unit 1005	30-7/8								
Unit 3004	31-3/8

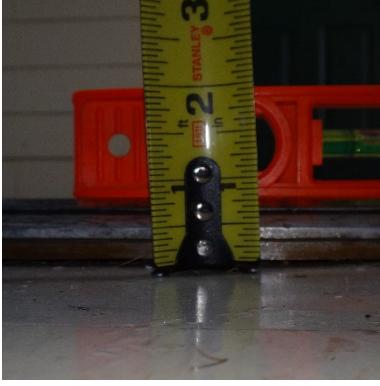
<p><i>Entry door threshold interior side at Unit 1009.</i></p>	<p>Door thresholds are more than 3/4 inches high at the interior face and are not beveled (maximum 3/4 inch with bevel allowed).</p>

<table><tr> <th><u>Location</u></th><th><u>Height (inches)</u></th></tr><tr> <td>Unit 1009 entry</td><td>7/8</td></tr><tr> <td>Unit 1009 patio</td><td>1-1/8</td></tr></table>

<u>Location</u>	<u>Height (inches)</u>	Unit 1009 entry	7/8	Unit 1009 patio	1-1/8	<p>Unit entry door: Install threshold transition strips at each side of each location or replace threshold.</p> <p>Patio doors: Provide beveled transition strip or offer remediation upon request of tenants. If offered on tenant request, a durable-material placard, contrasting black text on white background, in minimum 14-point font, must be placed on the side of the patio door stating: "A BEVEL TO ASSIST PERSONS</p>
<u>Location</u>	<u>Height (inches)</u>								
Unit 1009 entry	7/8								
Unit 1009 patio	1-1/8

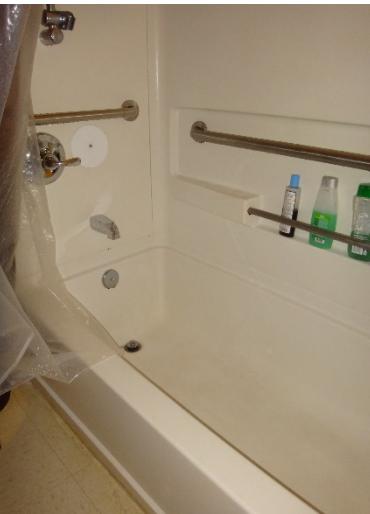
<p><i>Bathtub/shower surround in Unit 1009.</i></p>	<p>The shape of the bathtub surrounds precludes the installation of future grab bars with firm attachment to blocking (ability to install grab bars required).</p>	<p>Replace tub surround or install custom grab bars on request that can be mounted in the required locations at the existing surrounds.</p>

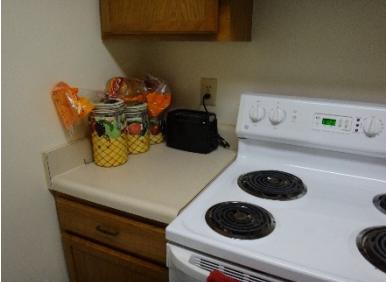
<p>Countertop adjacent to range in Unit 2004.</p>	<p>Outlets above kitchen countertops lack the required clear floor space for approach (at least 1 outlet in each counter area must have a clear floor space). The depth of the range obstructs approach.</p>

<table><tr><th>Location</th><th>Depth (inches)</th></tr><tr><td>Unit 2004</td><td>27 +/-</td></tr><tr><td>Unit 5004</td><td>27 +/-</td></tr></table>

Location	Depth (inches)	Unit 2004	27 +/-	Unit 5004	27 +/-	<p>Replace range or add outlets on side walls at each side of the counters. New outlets on side walls to be maximum 10 inches back from the front face of the range.</p>
Location	Depth (inches)								
Unit 2004	27 +/-								
Unit 5004	27 +/-

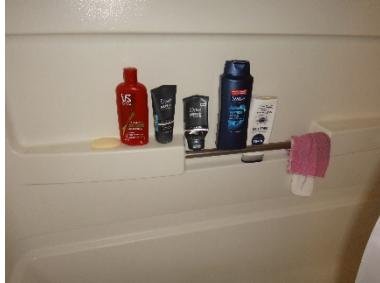
<p><i>Bathtub/shower surround in Unit 2004.</i></p>	<p>The shape of the bathtub surrounds precludes the installation of future grab bars with firm attachment to blocking (ability to install grab bars required).</p>	<p>Replace tub surround or install custom grab bars on request that can be mounted in the required locations at the existing surrounds.</p>										
30

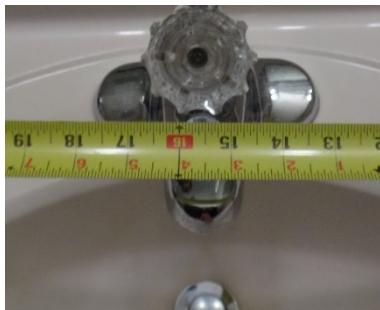
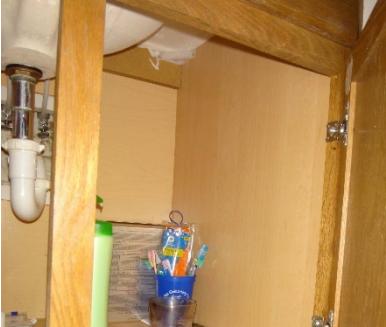
<p><i>Measurement to centerline of master bathroom lavatory in Unit 5004.</i></p>	<p>Lavatory centerlines are less than 24 inches to the side wall (minimum 24 inches required) and the cabinets are not removable.</p>

<table><tr> <th><u>Location</u></th> <th>Distance (inches)</th> </tr><tr> <td>Unit 2004 hall bathroom</td> <td>15-1/2</td> </tr><tr> <td>Unit 2004 master bathroom</td> <td>15-3/4</td> </tr><tr> <td>Unit 5004 hall bathroom</td> <td>15-3/8</td> </tr><tr> <td>Unit 5004 master bathroom</td> <td>15-1/2</td> </tr></table>

<p><i>Interior of vanity cabinet in Unit 5004.</i></p>												
31

<u>Location</u>	Distance (inches)	Unit 2004 hall bathroom	15-1/2	Unit 2004 master bathroom	15-3/4	Unit 5004 hall bathroom	15-3/8	Unit 5004 master bathroom	15-1/2	<p>Install removable base cabinet with 30 inch wide knee space in compliance with safe harbor knee and toe clearance requirements.</p> <p>Attach a durable-material placard stating: "THIS CABINET IS REMOVABLE FOR PERSONS WITH DISABILITIES. CONTACT MANAGEMENT."</p>
<u>Location</u>	Distance (inches)												
Unit 2004 hall bathroom	15-1/2												
Unit 2004 master bathroom	15-3/4												
Unit 5004 hall bathroom	15-3/8												
Unit 5004 master bathroom	15-1/2

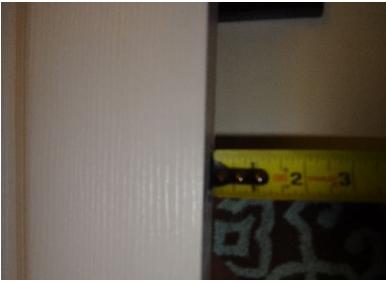
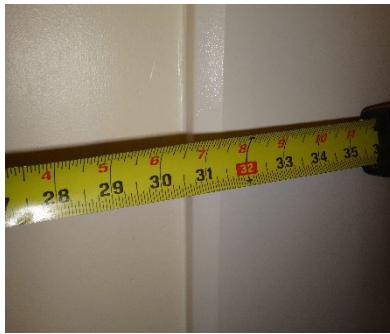
<p><i>Hall bathroom door leaf in open position at Unit 2004.</i></p>	<p>The clear floor space in the bathroom is less than 48 inches long (minimum 48-inches required).</p>

<table><tr> <th><u>Location</u></th> <th>Distance (inches)</th> </tr><tr> <td>Unit 2004 hall bathroom</td> <td>31</td> </tr><tr> <td>Unit 2004 master bathroom</td> <td>30</td> </tr><tr> <td>Unit 5004 hall bathroom</td> <td>31-1/4</td> </tr><tr> <td>Unit 5004 master bathroom</td> <td>27</td> </tr></table>

Measurement to bathtub.

<u>Location</u>	Distance (inches)	Unit 2004 hall bathroom	31	Unit 2004 master bathroom	30	Unit 5004 hall bathroom	31-1/4	Unit 5004 master bathroom	27	<p>Reverse the door so that it does not swing into the bathroom.</p>
<u>Location</u>	Distance (inches)												
Unit 2004 hall bathroom	31												
Unit 2004 master bathroom	30												
Unit 5004 hall bathroom	31-1/4												
Unit 5004 master bathroom	27

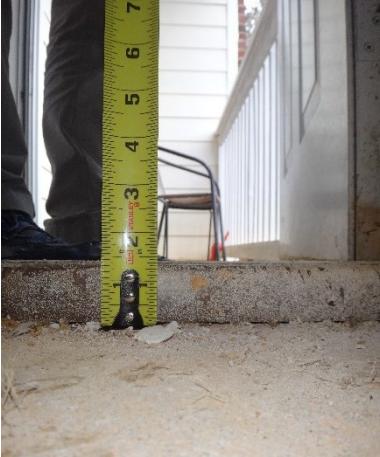
<p>Storage room door threshold at Unit 2005.</p>	<p>Storage door thresholds are 1-3/8 inches high and are not beveled (maximum 3/4 inch with bevel allowed).</p> <p>Provide beveled transition strip or offer remediation upon request of tenants. If offered on tenant request, a durable-material placard, contrasting black text on white background, in minimum 14-point font, must be placed on the side of the patio door stating: "A BEVEL TO ASSIST PERSONS WITH DISABILITIES FOR THIS THRESHOLD IS AVAILABLE UPON REQUEST. CONTACT MANAGEMENT."</p>
----	---	---

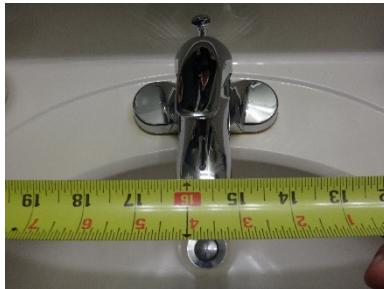
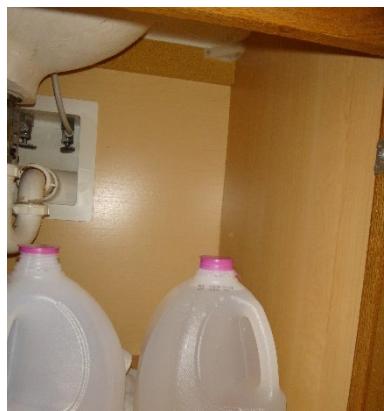
Measurement to centerline of hall bathroom lavatory in Unit 2005.

Interior of vanity cabinet.

Lavatory centerlines are less than 24 inches to the side wall (minimum 24 inches required) and the cabinets are not removable.

<u>Location</u>	Distance (inches)
Unit 2001 hall bathroom	15-5/8
Unit 2001 master bathroom	15-3/4
Unit 2005 hall bathroom	15-3/4
Unit 2005 master bathroom	15-1/2

Install removable base cabinet with 30 inch wide knee space in compliance with safe harbor knee and toe clearance requirements.

Attach a durable-material placard stating: "THIS CABINET IS REMOVABLE FOR PERSONS WITH DISABILITIES. CONTACT MANAGEMENT."

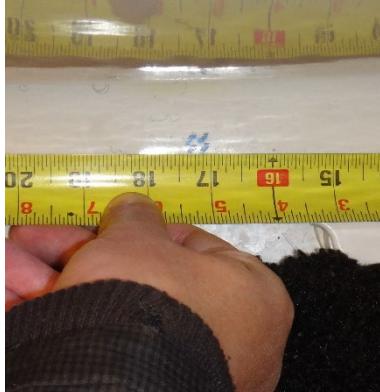
<p><i>Measurement to hall bathroom toilet centerline in Unit 2001</i></p>	<p>Toilet centerlines are less than 18 inches to the bathtub on the side opposite the direction of approach (minimum 18 inches required).</p> <table> <thead> <tr> <th data-bbox="688 393 868 425"><u>Location</u></th><th data-bbox="1100 355 1227 425">Distance (inches)</th></tr> </thead> <tbody> <tr> <td data-bbox="688 425 1079 458">Unit 2001 master bathroom</td><td data-bbox="1100 425 1227 458">12-1/4</td></tr> </tbody> </table>	<u>Location</u>	Distance (inches)	Unit 2001 master bathroom	12-1/4	<p>Install offset flange at master bathroom to shift toilet centerline to a position as close to 18 inches from the tub as is possible without requiring changes to the waste line or flooring.</p>				
<u>Location</u>	Distance (inches)										
Unit 2001 master bathroom	12-1/4										
37

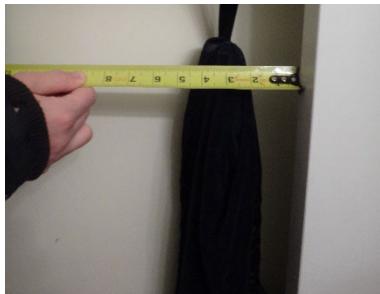
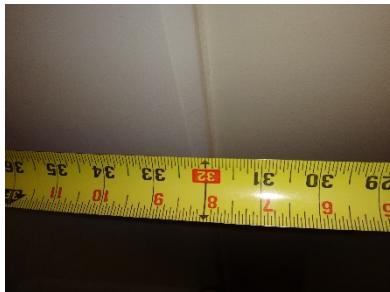
<p><i>Bathroom door leaf in open position at Unit 2001.</i></p>	<p>The clear floor space in the bathroom is less than 48 inches long (minimum 48-inches required).</p> <table> <thead> <tr> <th data-bbox="688 943 868 975"><u>Location</u></th><th data-bbox="1100 905 1227 975">Length (inches)</th></tr> </thead> <tbody> <tr> <td data-bbox="688 975 1079 1008">Unit 2001 hall bathroom</td><td data-bbox="1100 975 1227 1008">32</td></tr> <tr> <td data-bbox="688 1008 1079 1041">Unit 2001 master bathroom</td><td data-bbox="1100 1008 1227 1041">24-3/8</td></tr> <tr> <td data-bbox="688 1041 1079 1073">Unit 2005 hall bathroom</td><td data-bbox="1100 1041 1227 1073">32</td></tr> </tbody> </table>	<u>Location</u>	Length (inches)	Unit 2001 hall bathroom	32	Unit 2001 master bathroom	24-3/8	Unit 2005 hall bathroom	32	<p>Reverse the door so that it does not swing into the bathroom.</p>

<u>Location</u>	Length (inches)										
Unit 2001 hall bathroom	32										
Unit 2001 master bathroom	24-3/8										
Unit 2005 hall bathroom	32

Dimension from door leaf in open position to bathtub.

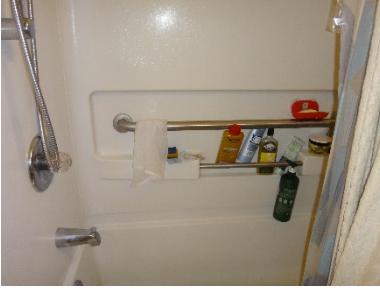
<p><i>Hall bathroom bathtub/shower surround in Unit 3001.</i></p>	<p>The shape of the bathtub surrounds precludes the installation of future grab bars with firm attachment to blocking (ability to install grab bars required).</p>	<p>Replace tub surround or install custom grab bars on request that can be mounted in the required locations at the existing surrounds.</p>
----	--	--	---
