Exhibit 2.2

Marsh Creek Matrix of Required Retrofits to Public and Common Use Areas

MARSH CREEK APARTMENTS: PUBLIC AND COMMON USE AREAS

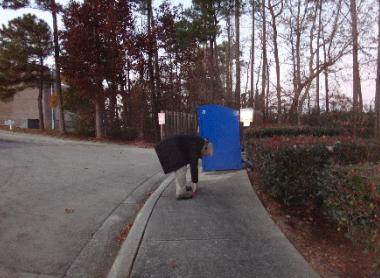
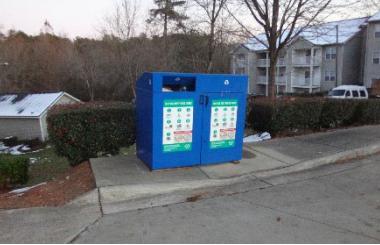
<i>Route to leasing office.</i>	<p>The curb ramp and sidewalk leading to the leasing office is blocked by recycling can and the width is not accessible (minimum 36 inches required).</p>	<p>Add a lease addendum in which property management will deposit recycling in container upon resident request.</p>				
3

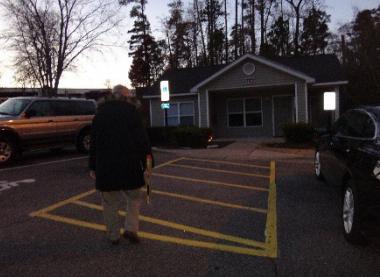
<i>Parking space & cross slope.</i>	<p>The designated parking space access aisle at the leasing office has a cross slope greater than 2% (maximum 2% allowed).</p> <p><u>Location</u></p> <table> <tr> <td>Foot of access aisle</td> <td>5.5%</td> </tr> <tr> <td>Head of access aisle</td> <td>5.3%</td> </tr> </table>	Foot of access aisle	5.5%	Head of access aisle	5.3%	<p>Modify parking space and access aisle so that cross slope is 2% or less.</p>
Foot of access aisle	5.5%						
Head of access aisle	5.3%

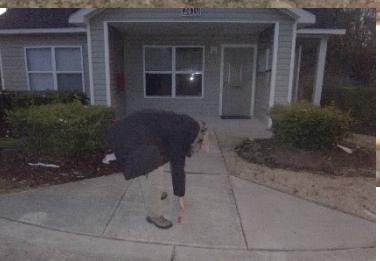
<i>Curb ramp leading towards Building 2.</i>	<p>Curb ramp cross slopes are more than 2.0% (maximum 2.0% allowed).</p> <p><u>Location</u></p> <p>North of entry drive 3.5%</p> <p>At leasing office 5.9%</p> <p>Bottom of curb ramp at south end of entry drive 13.3%</p> <p>Entry drive, west of trash dumpster 7.8%</p>	Modify 3.5%, 5.9%, 13.3%, and 7.8% cross slopes to comply with ANSI 4.3.7.
8

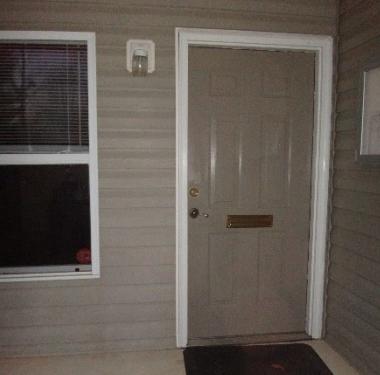
<i>Light fixture at entrance to leasing office.</i>	The light fixture at entrance to leasing office protrudes approximately 5 inches into the circulation path (maximum 4 inches allowed).	Modify protruding objects that project more than 5" into the circulation path to comply with ANSI 4.4.1.

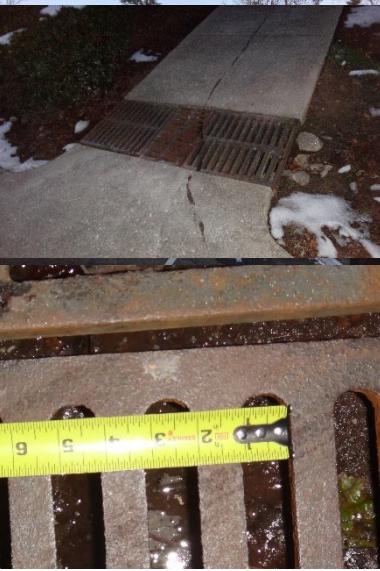
<p><i>Inlet grate at Building 1 west entrance.</i></p>	<p>Gaps at the inlet grate at Building 1 west entrance are 1 inch wide (maximum 1/2 inch allowed).</p> <p><i>Inlet grate at Building 1 west entrance. Measurement of typical gap in grate.</i></p>	<p>Modify gap to comply with ANSI 4.5.</p>
----	--	--	--

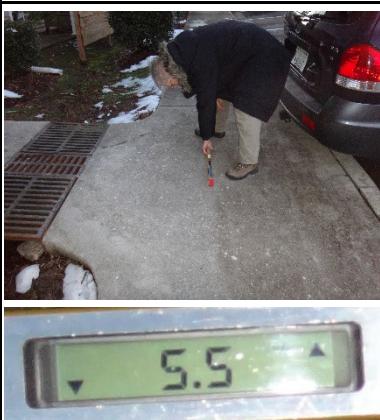
<i>Route at turn towards Building 1 unit entrances.</i>	Cross slopes of the route North of Building 1 at the turn to Units 101, 102, 103, and 104 are more than 2% (maximum 2% allowed).	Modify 5.5% cross slope to 3.0% maximum to comply with ANSI 4.3.7.
12	<i>Sidewalk/ramp north of Building 1.</i>

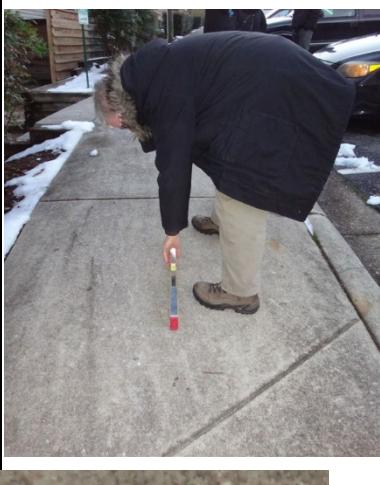
Running slope of ramp at sidewalk north of Building 1 is 10.3% (maximum 8.3% allowed).	Replace sidewalk to comply with ANSI.

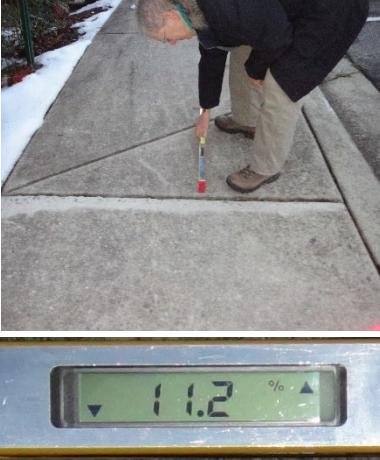
<i>Ramp north of Building 1</i>	<p>The running slope of the curb ramp apron north of Building 1 is 10.3% to 11.2% (maximum 10% allowed, ANSI 1986, maximum 8.3% at ramps).</p>	<p>Install a new sidewalk to bypass this curb ramp to connect to walkway toward accessible parking space on the south side of the building or replace curb ramp with new sidewalk to comply with ANSI.</p>

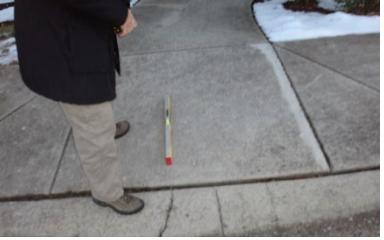
<i>Ramp north of Building 1 (shows level measuring running slope). 5.3% is cross slope reading.</i>	The cross slope of the curb ramp north of Building 1 is 5.3% (maximum 2.0% allowed).	Install a new sidewalk to bypass this curb ramp to connect to walkway toward accessible parking space on the south side of the building or replace curb ramp with new sidewalk to comply with ANSI.	
	Inaccessible Ramp Features

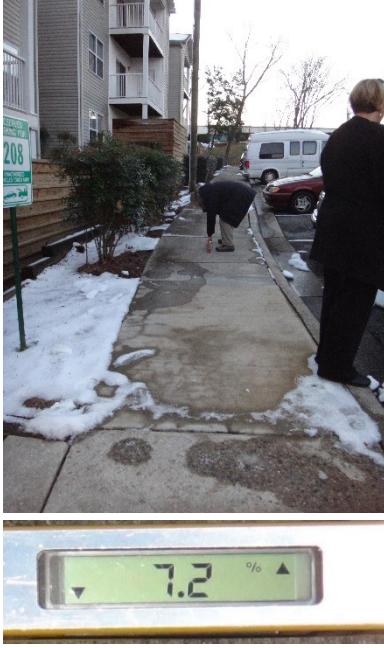
<i>Ramp north of Building 1.</i>	<p>The sidewalk north of Building 1 has slopes of 5.8%, 6.3%, 6.8%, and 7.2%; has a rise greater than 6 inches, is a ramp, and lacks handrails and edge protection (handrails and edge protection required on both sides).</p>	<p>Modify 6.3%, 6.8% and 7.2% by installing handrails on both sides of walkway or replace walkway to provide 6% maximum running slopes to comply with ANSI.</p>	
	Protruding Objects

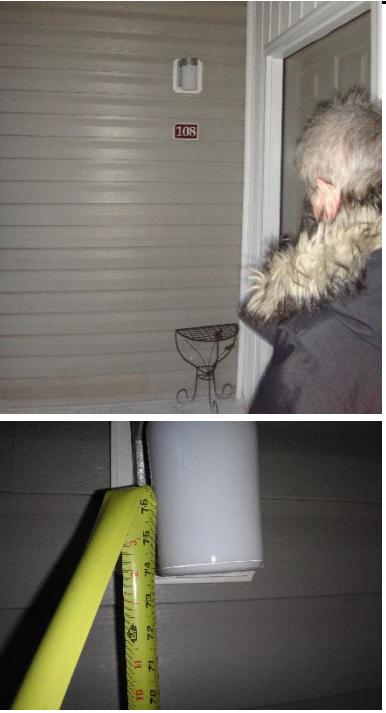
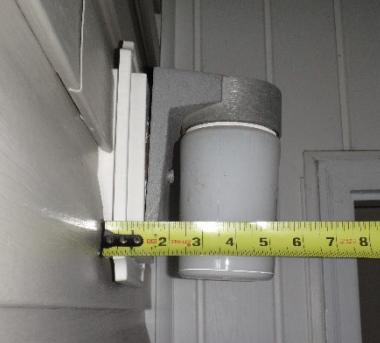
<p>Lights and fire extinguisher cabinets protrude approximately 7 inches into the circulation path (maximum 4 inches allowed where the bottom of the object is more than 27 inches and less than 80 inches above the adjacent walking surface).</p> <p><u>Locations:</u></p> <ul style="list-style-type: none"> West breezeway fire ext. cabinet East breezeway fire ext. cabinet East breezeway passage light fixture West breezeway passage light fixture Light fixture at Unit 101 entry Light fixture at Unit 102 entry Light fixture at Unit 103 entry Light fixture at Unit 104 entry Light fixture at Unit 105 entry Light fixture at Unit 106 entry Light fixture at Unit 107 entry Light fixture at Unit 108 entry 	<p>Modify protruding objects that project more than 5" into the circulation path to comply with ANSI 4.4.1.</p>

<p><i>Light fixture at entry to Unit 108 (typical).</i></p>

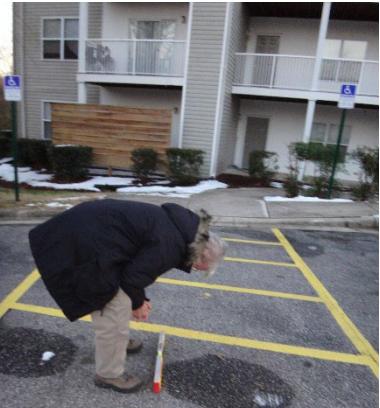
<p>At the parking north of Building 1, the designated parking aisle has cross slopes of 6.5% to 7.1% (maximum 2% allowed).</p>	<p>Modify 6.5% to 7.1% running slopes of access aisle to 5% maximum running slopes to compliant with ANSI.</p>

<i>Parking north of Bldg. 1</i>		
	Inaccessible Common Area Features		
18

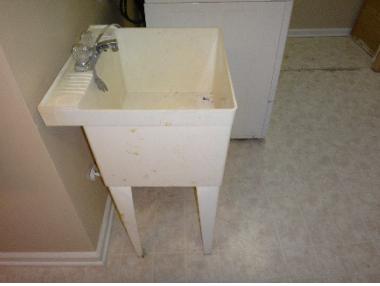
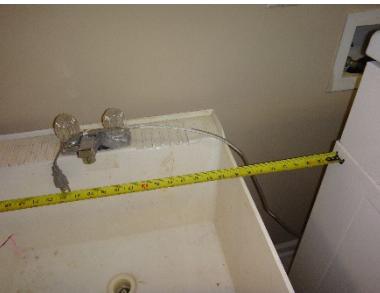
<i>Utility sink in Laundry Room.</i>	<p>The utility sink does not have the minimum clear floor space required for parallel approach. The sink is not centered on a 48- inch wide clear floor space (minimum 24 inches to center of controls required). The centerline is 20 inches from the adjacent equipment.</p>	<p>Remediate to improve the condition.</p>

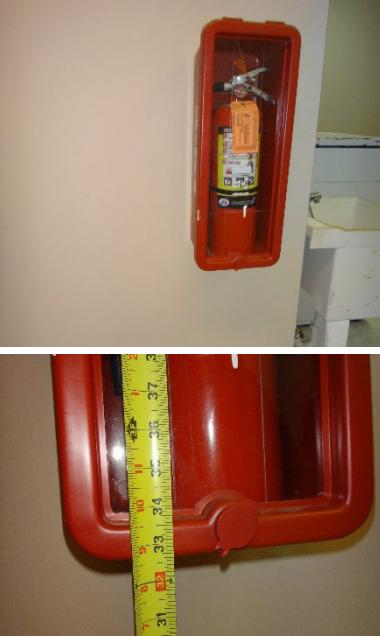
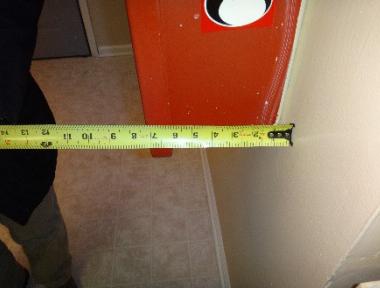
<p>The laundry fire extinguisher protrudes 7-1/8 inches into the circulation path (maximum 4 inches allowed).</p>	<p>Modify protruding objects that project more than 5" into the circulation path to comply with ANSI 4.4.1.</p>

<p><i>Fire extinguisher cabinet in laundry room.</i></p>
