Exhibit 3.2

Hodges Creek Matrix of Required Retrofits to Public and Common Use Areas

HODGES CREEK APARTMENTS: PUBLIC AND COMMON USE AREAS

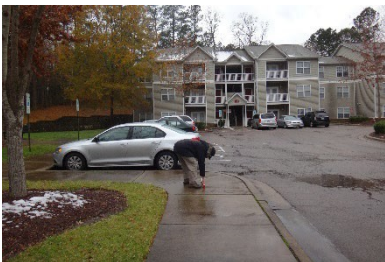
<p>End of parking row northwest of Building 1.</p>

<p>Measurement of cross slope.</p>	<p>Cross slopes of the route are more than 2% (maximum 2% allowed).</p>

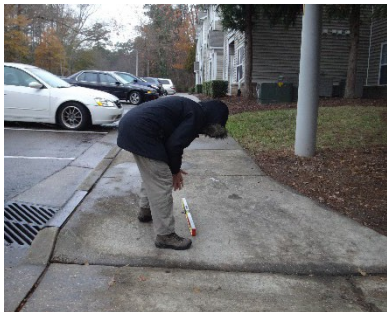
</div> <p><i>Curb ramp southeast of Building 2.</i></p> <div>

</div> <p><i>Measurement of running slope.</i></p>	<p>The running slope of the curb ramp is more than 8.3% (maximum 8.3% allowed).</p>

<u>Location</u>	<u>Slope</u>	Southeast of Building 2 at dumpster	15.3%	East end of south sidewalk	11.3%	<p>Modify running slopes of curb ramps over 8.3%: 15.3% and 11.3% to comply with ANSI.</p>
<u>Location</u>	<u>Slope</u>								
Southeast of Building 2 at dumpster	15.3%								
East end of south sidewalk	11.3%								
	Protruding Objects

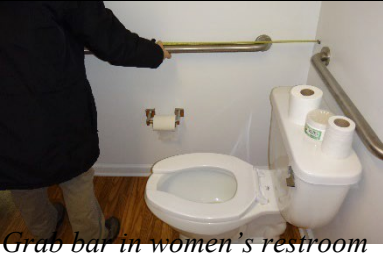
The side wall grab bar at the women's restroom extends 51-1/4 inches from the rear wall (minimum 54 inches required).	Relocate grab bar to comply with ANSI 4.17.6.

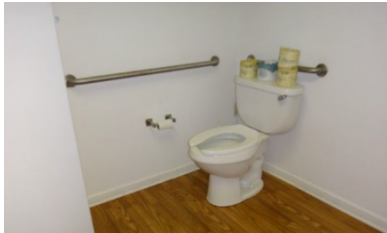
<p><i>Toilet in men's restroom.</i></p>

<p><i>Measurement from wall to opposite end of grab bar</i></p></div>	<p>The rear wall grab bars in the Community Room restrooms are 24 inches long (minimum 36 inches required).</p>

Location	Length (inches)	Men's restroom	24	Women's restroom	24	Relocate grab bar to comply with ANSI 4.17.6.
Location	Length (inches)								
Men's restroom	24								
Women's restroom	24

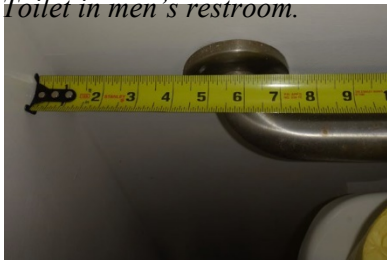
<p><i>Measurement from wall to grab bar.</i></p>

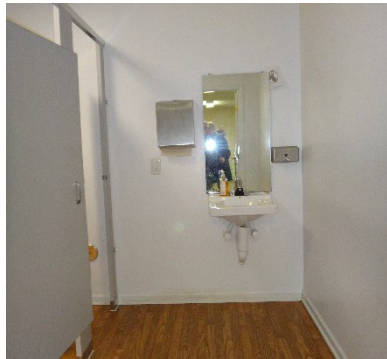
<p><i>Dispenser in women's restroom.</i></p>

<u>Location</u>	<u>Height (inches)</u>	Men's restroom	51	Women's restroom	49-1/4	<p>Accept proposed fix. Modify paper towel dispenser to comply with ANSI 4.25.3.</p>
<u>Location</u>	<u>Height (inches)</u>								
Men's restroom	51								
Women's restroom	49-1/4

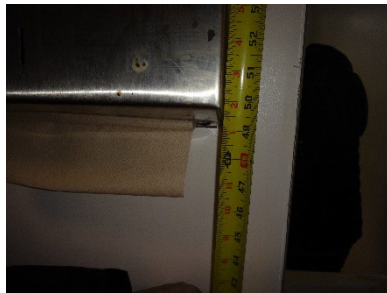
<p><i>Height of dispenser control.</i></p>	<p>The paper towel dispensers are more than 48 inches above the floor (maximum 48 inches allowed).</p>

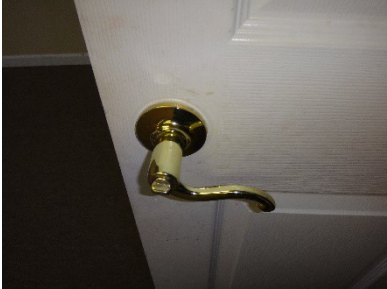
<p><i>Hardware at men's restroom door.</i></p>	The men's and women's restroom doors have locking hardware which requires tight grasping, pinching, or twisting of the wrist (not allowed).	Modify hardware to comply with ANSI 4.13.9
B. INACCESSIBLE ROUTES AT COMMON AREAS <u>Routes from Site Arrival Points to Common Areas and Covered Dwelling Units</u>			
<u>Inaccessible Features – Hodges Creek</u>			
	Lack of Accessible Route

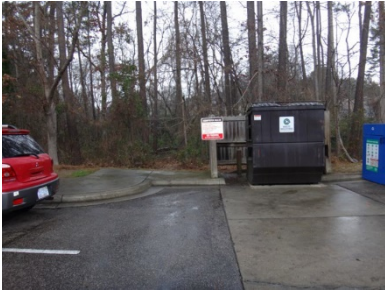
<p><i>Trash/Recycling area adjacent to Building 3</i></p>

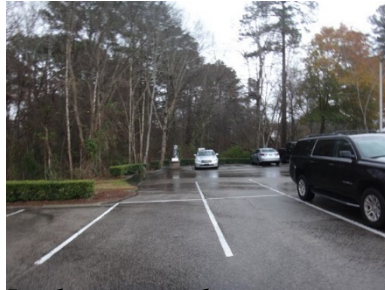
<p><i>Looking toward car care center from Building 3.</i></p>	There is no accessible route between unit entrances and common use areas (accessible route required).	Fix to comply with Requirement 2.
	Inaccessible Changes in Level

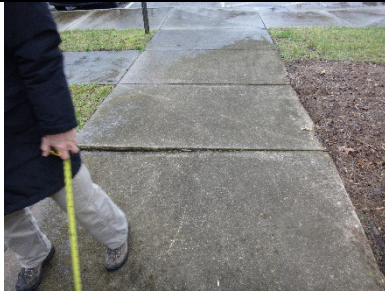
<p><i>Sidewalk leading to playground.</i></p>

Location	Height (inches)	Route to Playground	1-1/4	Building 3, north breezeway	5/8	Northeast of Building 3 at dumpster)	Step	<p>Modify level change to comply with ANSI 4.5.2.</p>
Location	Height (inches)										
Route to Playground	1-1/4										
Building 3, north breezeway	5/8										
Northeast of Building 3 at dumpster)	Step										
	Inaccessible Slopes

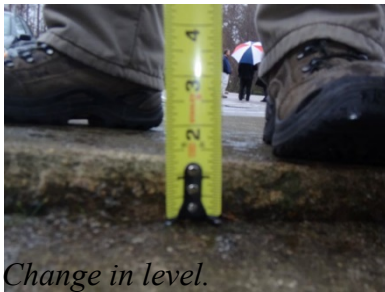
<p><i>Change in level.</i></p>	<p>The route has change in level greater than 1/2 inch (maximum 1/2 inch with bevel allowed).</p>

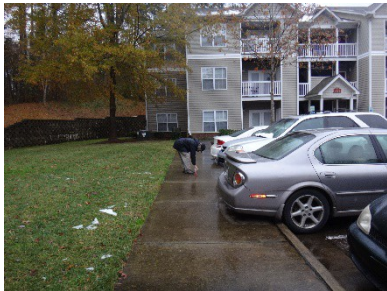
<p><i>Sidewalk between Buildings 1 and 3.</i></p>

<p><i>Measurement of cross slope.</i></p></div>	<p>The cross slopes of the route are more than 2% (maximum 2% allowed).</p>

<u>Location</u>	<u>Slope</u>	Above curb ramp at sidewalk to playground going south	4.1%	Above curb ramp at sidewalk to playground going west	3.4%	Building 3 north curb ramp	4.3%	<p>Modify cross slopes in walkways over 3.0% and curb ramps over 3.3%: 4.1%, 3.4%, 4.3% cross slopes to comply with ANSI 4.3.7 and 4.7.2.</p>
<u>Location</u>	<u>Slope</u>										
Above curb ramp at sidewalk to playground going south	4.1%										
Above curb ramp at sidewalk to playground going west	3.4%										
Building 3 north curb ramp	4.3%										
	Inaccessible Slope at Door Maneuvering Space

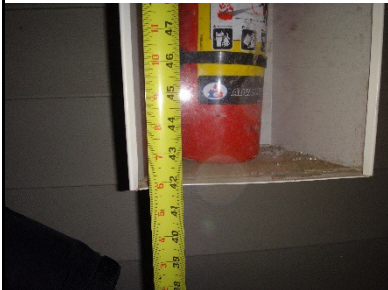
<p><i>Protruding height.</i></p></div>	<p>The fire extinguisher cabinets at breezeways protrude more than 4 inches into the circulation path (maximum 4 inches allowed).</p>

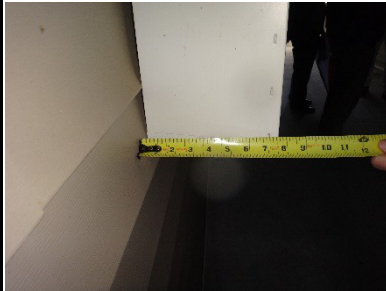
<p><i>Protruding depth.</i></p>								
C. INACCESSIBLE FEATURES AT COMMON AREAS									
	Inaccessible Environmental Controls								
14

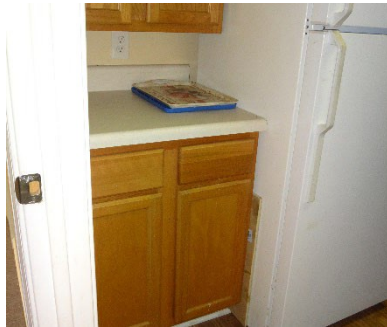
<p><i>Outlet at kitchenette countertop adjacent to refrigerator.</i></p>	<p>The countertop outlet does not have the minimum clear floor space required. Refrigerator blocks parallel approach. The clear space is less than 48 inches wide (minimum 48 inches required for parallel approach).</p> <table> <tr> <td><u>Location</u></td> <td><u>Distance (inches)</u></td> <td></td> </tr> <tr> <td>Kitchen, width of unobstructed 28 space with countertop</td> <td>parallel</td> <td></td> </tr> </table>	<u>Location</u>	<u>Distance (inches)</u>		Kitchen, width of unobstructed 28 space with countertop	parallel		<p>Subject to tolerances contained in the agreed-upon remediation protocols, modify existing outlet or install a GFI-rated, molded, multi-plug outlet with commercial grade components to bring outlet into compliance with Requirement #5. Any such outlet must be approved by the United States prior to installation.</p>
<u>Location</u>	<u>Distance (inches)</u>								
Kitchen, width of unobstructed 28 space with countertop	parallel

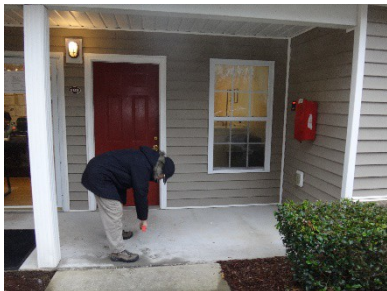
<p>Fire extinguisher cabinet at Leasing Office.</p></div>	<div>Fire extinguisher cabinet top operable parts are located above reach range (maximum 54 inches allowed).</div>

Locations	Height (inches)	Leasing Office	62	Building 2 west breezeway (typical at all breezeways)	62+/-	Modify fire extinguisher cabinet to comply with ANSI 4.6.2.
Locations	Height (inches)								
Leasing Office	62								
Building 2 west breezeway (typical at all breezeways)	62+/-

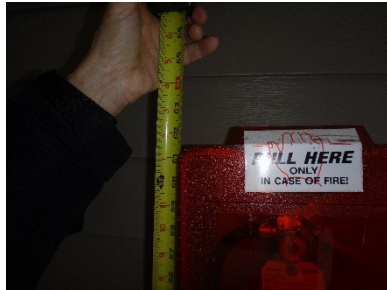
</div> <p>Typical height to top operable part.</p>								
	Inaccessible Common Area Features								
16	<div>

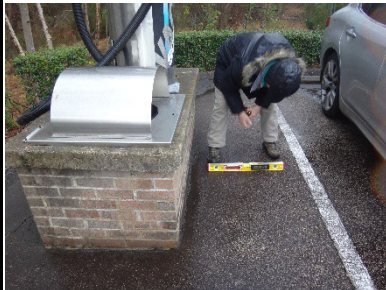
</div> <p>Vacuum station.</p> <div>

</div> <p>Measurement of cross slope at vacuum station.</p>	<p>The common area clear floor space has a slope greater than 2% (maximum 2% allowed).</p>

Location	Slope	Grill east of Building 1	3.2%	Vacuum station	3.2%	<p>Modify the cross slope of vacuum station (3.2%) to comply with ANSI 4.3.7. Modify the cross slope of the grill east of Building 1 (3.2%) to comply with ANSI 4.3.7, relocate the grill to a compliant location, or add a grill in a compliant location.</p>
Location	Slope								
Grill east of Building 1	3.2%								
Vacuum station	3.2%

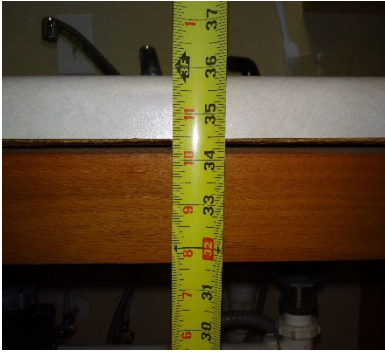
<p><i>Height of kitchen sink.</i></p>	The rim of the kitchenette sink is 35-3/4 inches above the floor (maximum 34 inches allowed).	Modify rim of sink to comply with ANSI 4.19.2.2.
18

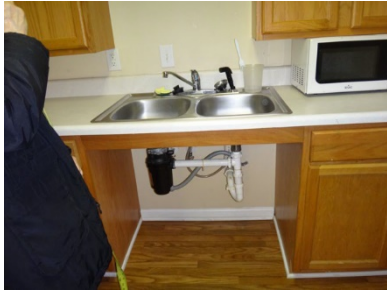
<p><i>Kitchenette sink at the Community Room.</i></p>	Sink at Community Room kitchenette lacks pipe protection (pipe protection required).	Insulate pipes to comply with ANSI 4.19.4.
