Exhibit 4.2

Rollinwood Manor Matrix of Required Retrofits to Public and Common Use Areas

ROLLINWOOD MANOR APARTMENTS: PUBLIC AND COMMON USE AREAS

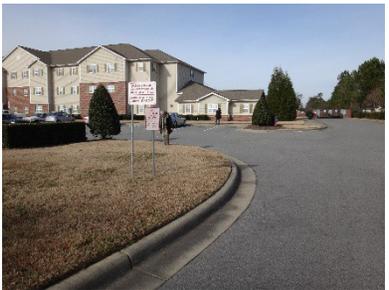
<p><i>Route along drive lane.</i></p>	There is no accessible route between pedestrian site arrival points and leasing office.	Install accessible sidewalk to Rollinwood Drive to the South.
Inaccessible Parking Features			
2

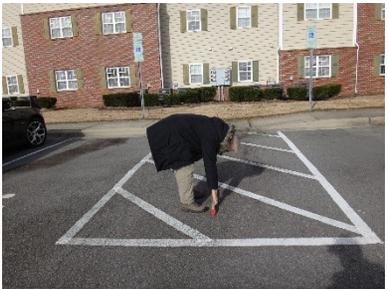
<p><i>Parking aisle location.</i></p>	Designated parking access aisle at leasing has a running slope greater than 2.0% (maximum 2% allowed).	Modify 3.9% running slope to comply with ADA 4.6.2.

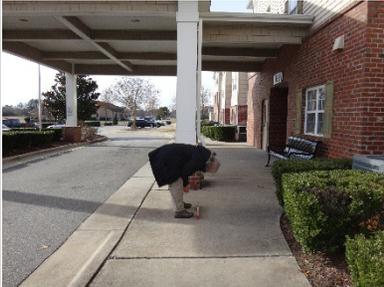
<p data-bbox="317 837 556 873"><i>Route at Location.</i></p>

<p data-bbox="317 1117 478 1153"><i>Cross slope.</i></p>	<p data-bbox="795 529 1346 602">Cross slopes of the route are more than 2% (maximum 2% allowed).</p>

Location	Slope	South of Building (southwest of public entrance)	3.8%	South of Building (southeast of public entrance)	4.3%	South of Building (southeast of public entrance)	3.8%	<p data-bbox="1421 529 1625 691">Modify 3.8%, 4.3%, and 3.8% cross slopes to comply with ANSI 4.3.7.</p>
Location	Slope										
South of Building (southwest of public entrance)	3.8%										
South of Building (southeast of public entrance)	4.3%										
South of Building (southeast of public entrance)	3.8%										
Inaccessible Curb Ramp Features

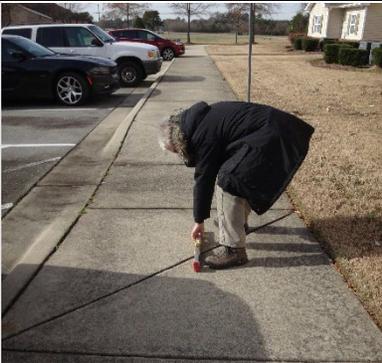
<p><i>Curb ramp south of Building.</i></p>

<p><i>Running slope at curb ramp.</i></p>	<p>The running slope of the ramp leading to the leasing office is more than 8.3% (maximum 8.3% allowed).</p> <table border="0"> <tr> <td><u>Location</u></td> <td><u>Slopes</u></td> </tr> <tr> <td>South of Building (southwest of public entrance)</td> <td>9.2%</td> </tr> </table>	<u>Location</u>	<u>Slopes</u>	South of Building (southwest of public entrance)	9.2%	<p>Modify 9.2% running slopes of curb ramp to comply with ANSI 4.7.2.</p>
<u>Location</u>	<u>Slopes</u>						
South of Building (southwest of public entrance)	9.2%						
Inaccessible Door Features

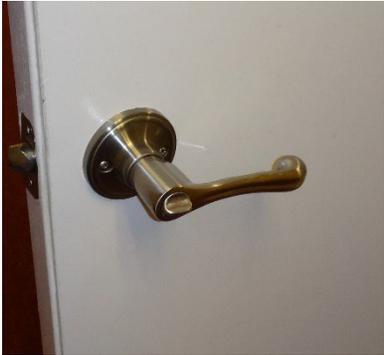
<p data-bbox="317 651 772 683"><i>Hardware at unisex restroom door.</i></p>	<p data-bbox="795 215 1415 370">The unisex restroom (closest to the management offices) door has hardware which requires tight grasping, pinching, or twisting of the wrist (not allowed).</p>	<p data-bbox="1419 215 1631 313">Replace door hardware to comply with ANSI 4.13.9.</p>										
Protruding Objects													
6

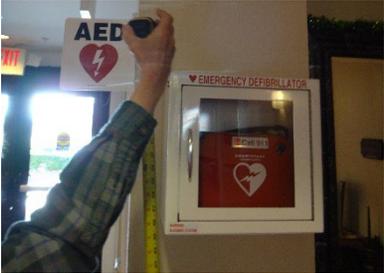
<p data-bbox="317 1192 743 1224"><i>AED box in First Floor corridor.</i></p>	<p data-bbox="795 760 1415 873">The objects protrude more than 4 inches into the circulation path (maximum 4 inches allowed).</p> <p data-bbox="795 881 932 914">Protrusion</p>

<u>Location</u>	<u>(inches)</u>	Corridor 1st Floor AED Box	7	Height of leading edge	57-1/8	1st Floor Drinking Fountain	19	Height of leading edge	32-1/4	<p data-bbox="1419 760 1631 954">Modify protruding objects that project more than 5" into the circulation path to comply with ANSI 4.4.1.</p>
<u>Location</u>	<u>(inches)</u>												
Corridor 1st Floor AED Box	7												
Height of leading edge	57-1/8												
1st Floor Drinking Fountain	19												
Height of leading edge	32-1/4

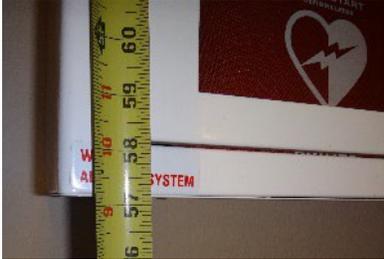
<p><i>AED box height.</i></p>

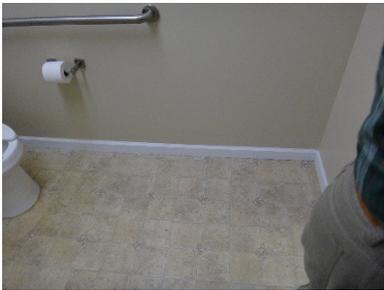
<p><i>Toilet in unisex restroom</i></p>	<p>The leading edge of the toilet paper dispenser is 39-1/2 inches from the rear wall (maximum 36 inches allowed).</p>	<p>Modify toilet paper dispenser to comply with ANSI 4.16.6.</p>

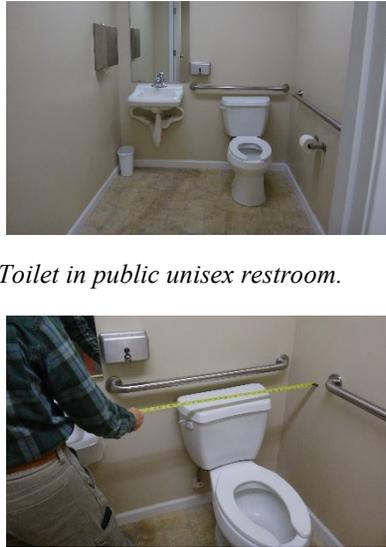
<p data-bbox="317 846 663 873"><i>Toilet in public unisex restroom.</i></p> <p data-bbox="317 1170 768 1230"><i>Width from side wall to lavatory in public unisex restroom.</i></p>	<p data-bbox="795 578 1339 691">The toilet clearance is 42 inches wide (minimum 48 inch width by 66 inch depth required).</p>	<p data-bbox="1419 578 1635 670">Modify toilet clearance to comply with ANSI 4.16.2.</p>

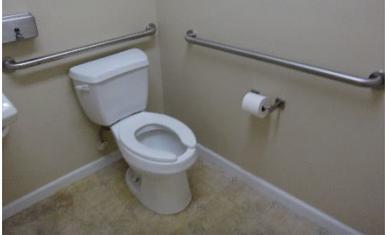
<p data-bbox="317 833 688 865"><i>Grab bar in unisex restroom.</i></p>

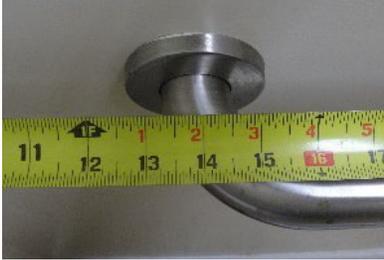
<p data-bbox="317 1157 741 1230"><i>Dimension of side grab bar from rear wall</i></p>	The side wall grab bar starts 13-7/8 inches from the rear wall (maximum 12 inches allowed).	Relocate grab bar to comply with ANSI 4.17.6.
Additional Information Based on ADAAG

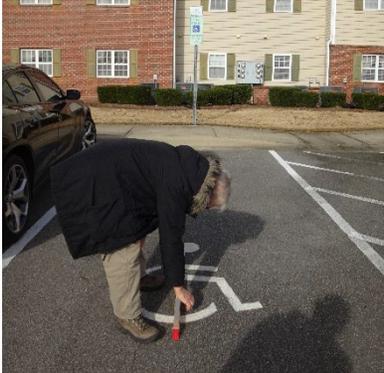
<p data-bbox="317 678 621 711"><i>Parking space location.</i></p>

<p data-bbox="317 1003 730 1036"><i>Running slope at parking space.</i></p>	Designated parking space has a running slope of 3.8% (maximum 2% allowed).	Modify running slope of 3.8% to comply with ADA 4.6.2.

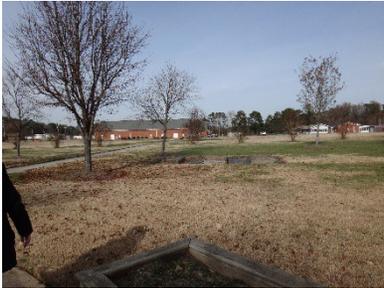
<p data-bbox="317 597 569 630"><i>No route to garden.</i></p>	There is no accessible route to the garden area.	Modify to comply with Requirement 2.
Inaccessible Changes in Level			
12

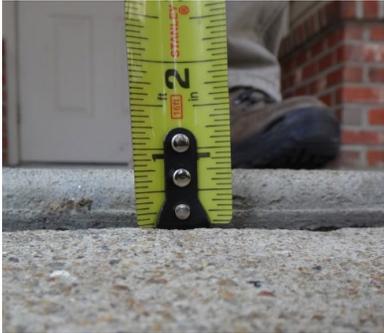
<p data-bbox="317 1175 737 1208"><i>Change in level at east entrance.</i></p>	Outside the east entry, at the edge of the stoop, there a change in level that is 3/4 inches high and is not beveled (maximum 1/4 inch allowed without bevel).	Modify level change to comply with ANSI 4.5.2.
Inaccessible Slopes

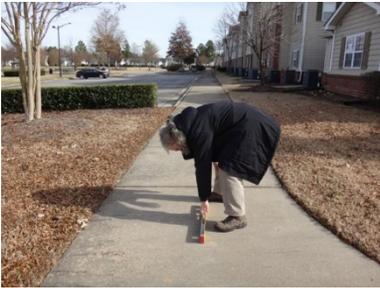
<p data-bbox="317 639 699 711"><i>Northwest of building at west driveway.</i></p>

<p data-bbox="317 959 472 992"><i>Cross slope</i></p>	<p data-bbox="795 215 1314 293">Cross slopes of routes are more than 2% (maximum 2% allowed).</p>

<p data-bbox="795 662 1377 813">A maximum 2% cross slope is allowed at an accessible route. (Guidelines Requirement 1; Guidelines Requirement 2 Chart; ANSI 1986 4.3.7).</p>	Location	Slope	Northwest of Building	3.9%	Northwest of Building	3.3%	Northwest of Building	3.5%	Northwest of Building	3.9%	Northwest of Building	3.4%	Northeast of Building	3.4%	<p data-bbox="1419 215 1625 378">Modify 3.3%, 3.9%, 3.5%, 3.9%, 3.4%, 3.4% cross slopes to comply with ANSI 4.3.7.</p>
Location	Slope																
Northwest of Building	3.9%																
Northwest of Building	3.3%																
Northwest of Building	3.5%																
Northwest of Building	3.9%																
Northwest of Building	3.4%																
Northeast of Building	3.4%

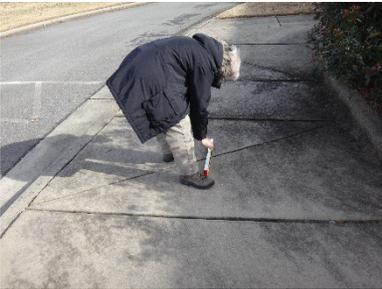
<p><i>Curb ramp measurement location.</i></p>

<p><i>Running slope</i></p>	<p>Running slope of the curb ramp north of the building is 10.1% (maximum 8.3% allowed).</p>	<p>Modify curb ramp to comply with ANSI 4.7.2.</p>										
15

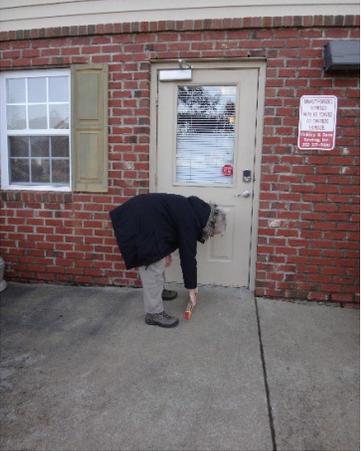
<p><i>North entrance door.</i></p>	<p>Common door maneuvering clearances are sloped greater than 2.0% (maximum 2% allowed).</p>

Location	Slope	Southwest Entrance Door	6.7%	Northwest Entrance Door	5.4%	North Entrance Door	9.4%	Northeast Entrance Door	6.4%	<p>Modify cross slopes to comply with ANSI 4.13.6</p>
Location	Slope												
Southwest Entrance Door	6.7%												
Northwest Entrance Door	5.4%												
North Entrance Door	9.4%												
Northeast Entrance Door	6.4%

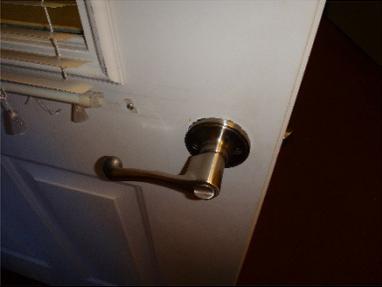
<p data-bbox="317 979 779 1013"><i>Hardware at community room door.</i></p>	<p data-bbox="795 630 1402 740">The doors have hardware which requires tight grasping, pinching, or twisting of the wrist (not allowed) to operate either the latch or the lock.</p> <p data-bbox="795 789 1402 862">This is a typical hardware feature throughout building common areas (not an exhaustive list).</p> <p data-bbox="795 911 1213 1060"><u>Location</u> Third Floor Community Room Third Floor Library First Floor Unisex Restroom 2</p>	<p data-bbox="1421 630 1619 721">Replace hardware to comply with 4.13.9.</p>
Protruding Objects

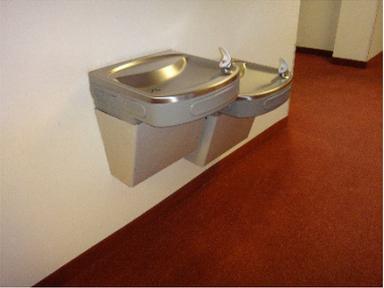
<p data-bbox="317 529 722 602"><i>Drinking fountain in third floor corridor.</i></p>

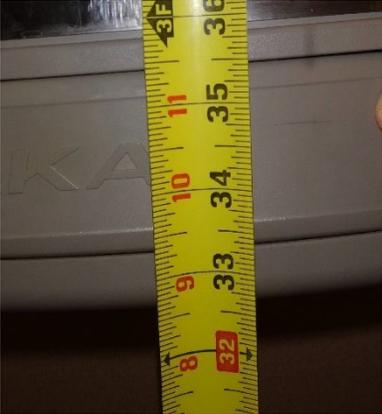
<p data-bbox="317 1052 611 1089"><i>Height of bottom edge.</i></p>	<p data-bbox="795 220 1388 334">Drinking fountain protrudes approximately 19 inches into the circulation path (maximum 4 inches allowed).</p> <p data-bbox="795 383 911 415"><u>Location</u></p> <p data-bbox="795 423 1087 456">Second Floor Corridor</p> <p data-bbox="835 464 1304 496">Height of leading edge 32-3/8</p> <p data-bbox="795 505 1066 537">Third Floor Corridor</p> <p data-bbox="835 545 1304 578">Height of leading edge 32-3/4</p>	<p data-bbox="1419 220 1633 415">Modify protruding objects that project more than 5" into the circulation path to comply with ANSI 4.4.1.</p>

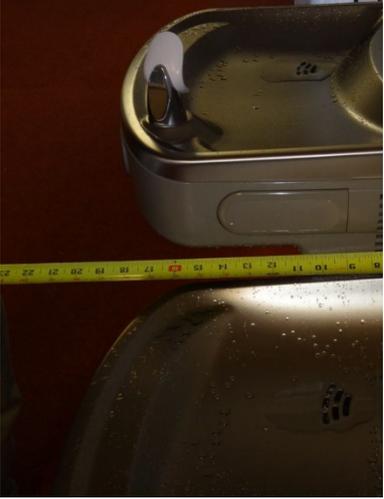
<p data-bbox="317 781 642 820"><i>Projection from the wall.</i></p>

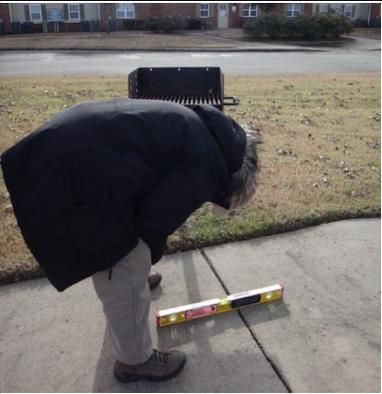
<p><i>Grill at common area</i></p>

<p><i>Cross slope at grill.</i></p>	Clear floor space at the grill northeast of the building slopes 3.5% (maximum 2% allowed).	Modify 3.5% slope to comply with ANSI 4.3.7.
19

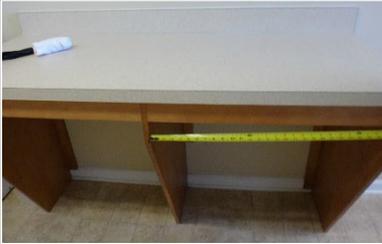
<p><i>Knee space at work surface in Laundry Room</i></p>	The clear width of the knee space at the laundry work surface is 28-5/8 inches (minimum 30 inches clear width required).	Modify knee space to comply with ANSI 4.30.3.

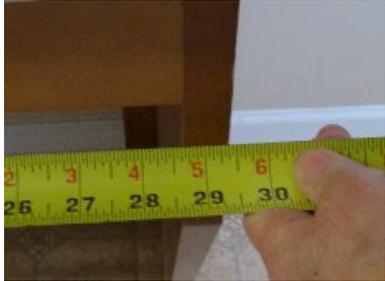
<p data-bbox="317 537 583 574"><i>Width of knee space.</i></p>		
20

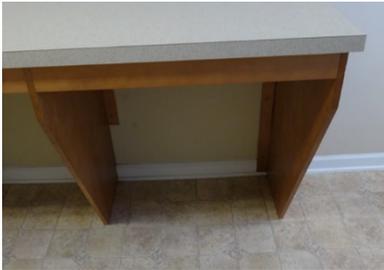
<p data-bbox="317 971 659 1008"><i>Laundry room work space</i></p>

<p data-bbox="317 1333 520 1370"><i>Counter height.</i></p>	<p data-bbox="795 667 1373 781">Countertop at laundry work surface is 36-1/4 inches above the floor (maximum 34 inches allowed).</p>	<p data-bbox="1419 667 1625 760">Modify countertop to comply with ANSI 4.30.4</p>

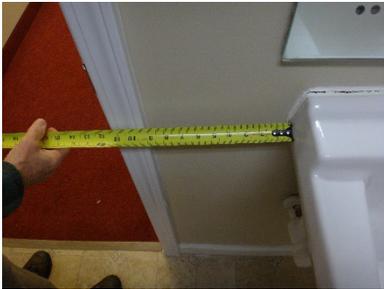
<p><i>Maneuvering clearance at third floor unisex restroom door.</i></p>

<p><i>Maneuvering clearance at unisex restroom door.</i></p>	<p>Door maneuvering clearances are less than 18 inches (minimum 18 inches required).</p>

Location	Clearance (inches)	Unisex Restroom 3 (Second Floor)	13	Unisex Restroom 4 (Second Floor)	12-1/2	Unisex Restroom 5 (Third Floor)	11-1/2	Unisex Restroom 6 (Third Floor)	13-7/8	<p>Remediate first floor public restrooms and one common restroom on the second and third floors.</p> <p>Modify by installing smaller sink or relocate sink to provide 18" minimum clearance to comply with ANSI 4.13.6.</p>
Location	Clearance (inches)												
Unisex Restroom 3 (Second Floor)	13												
Unisex Restroom 4 (Second Floor)	12-1/2												
Unisex Restroom 5 (Third Floor)	11-1/2												
Unisex Restroom 6 (Third Floor)	13-7/8												
	Inaccessible Common Restroom Features

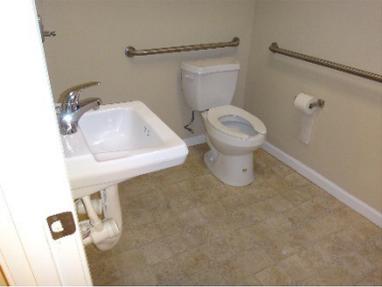
<p data-bbox="317 570 592 605"><i>Single user restroom.</i></p>

<p data-bbox="317 889 569 925"><i>Centerline of toilet.</i></p>	<p data-bbox="795 215 1373 332">The toilet centerline at one third floor single user restroom is 19 inches from the side wall (maximum 18 inches allowed).</p>	<p data-bbox="1419 215 1627 381">Modify toilet by installing offset toilet flange to comply with ANSI 4.16.2.</p>
23

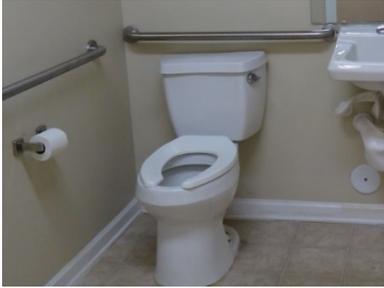
<p data-bbox="317 1336 592 1372"><i>Single user restroom.</i></p>	<p data-bbox="795 958 1400 1117">The rear wall grab bars extends 20 inches from the toilet centerline (minimum 24 inches required). The extension from the sidewall is 37-1/2 inches (minimum 42 inches required).</p>	<p data-bbox="1419 958 1617 1055">Relocate grab bar to comply with ANSI 4.17.6.</p>

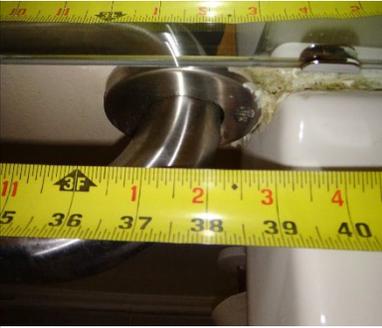
<p data-bbox="317 643 764 675"><i>Grab bar extension from side wall.</i></p>
