IN THE UNITED STATES DISTRICT COURT  
FOR THE EASTERN DISTRICT OF NORTH CAROLINA  
WESTERN DIVISION  
No. 5:21-cv-00395-M

**INDEX OF CONSENT ORDER EXHIBITS**

Milburnie Road Matrix of Required Retrofits to Public and Common Use Areas.

# MILBURNIE ROAD APARTMENTS: PUBLIC AND COMMON USE AREAS

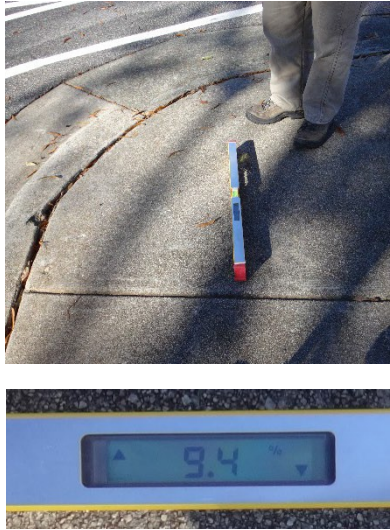
Numbers	Photos	Deficiency	Required Retrofit
3	<p><i>Curb ramp northeast of Building 4 - Picture 1. Running slope -- Picture 2.</i></p>

The running slope of the curb ramp northeast of Building 4 (leading to the leasing office) is 9.4% (maximum 8.3% allowed).	Modify 9.4% running slope of curb ramp to comply with ANSI 4.7.2 and 4.8.2.

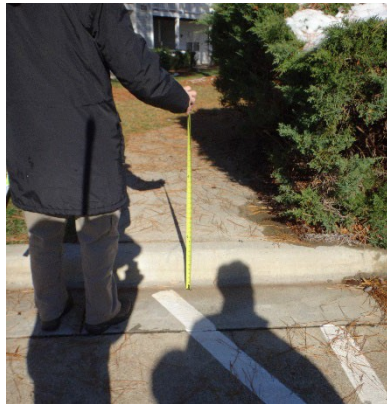
<p><i>Curb at trash area.</i></p>

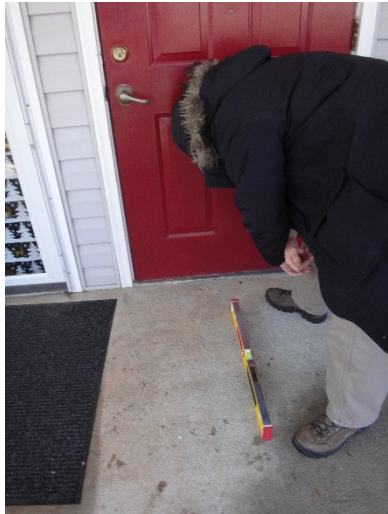
Numbers	Photos	Deficiency	Required Retrofit										
13	<p><i>Door at Laundry room -- Picture 1.</i> <i>Slope at door approach -- Picture 2.</i></p>

<p>Common area door maneuvering clear spaces are sloped greater than 2.0% (maximum 2% allowed).</p>

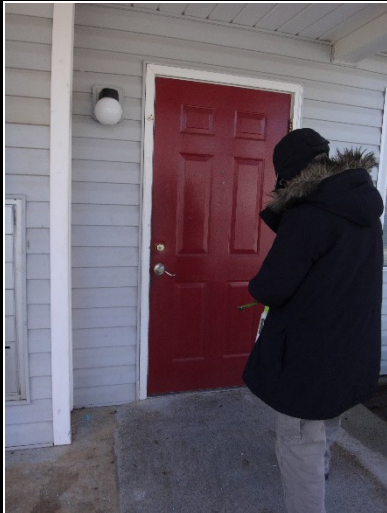
<p><i>Light fixture at entrance to meeting room.</i></p>

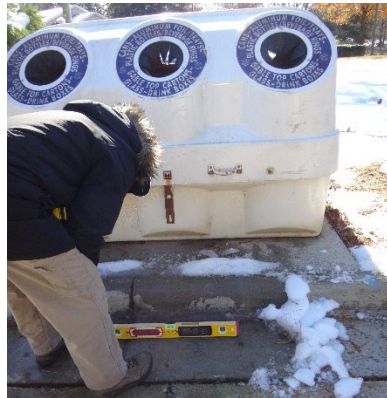
Numbers	Photos	Deficiency	Required Retrofit						
16	<p><i>Slope at recycling center -- Photo 1. Cross slope -- Photo 2.</i></p>

<p>Clear space at the recycling center clear floor space has a cross slope of 3.8% (maximum 2% allowed).</p> <table><tr><th>Location</th><th>Slope</th></tr><tr><td>Southwest of Building 3</td><td>3.8%</td></tr></table>	Location	Slope	Southwest of Building 3	3.8%	<p>Modify 3.8% cross slope to comply with ANSI 4.3.7.</p>		
Location	Slope								
Southwest of Building 3	3.8%								
17	<p><i>Maneuvering clearance at meeting room rear exit (door on the far wall adjacent to the windows).</i></p>

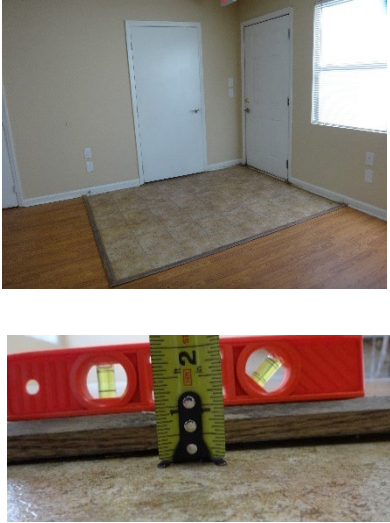
Numbers	Photos	Deficiency	Required Retrofit
18	<p data-bbox="300 219 760 332"><i>Floor transition at meeting room -- Photo 1. Change in level -- Photo 2.</i></p>

<p data-bbox="768 219 1379 397">The meeting room has a 3/4 inch high change in level at the flooring transition near the rear exit door that is not beveled (maximum 1/2 inch with bevel allowed; maximum 1/4 allowed without bevel).</p>	<p data-bbox="1388 219 1713 284">Modify change in level to comply with ANSI 4.5.2.</p>
19

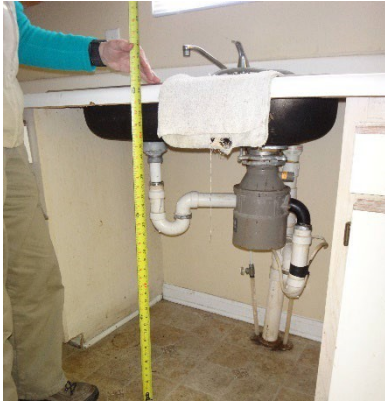
Kitchen sink pipes are not insulated or otherwise protected (insulation or protection required).	Accept proposed fix. Insulate pipe to comply with ANSI 4.19.4.
	<b>Inaccessible Restroom Features</b>		
22	<p><i>Flush control at men's restroom.</i></p>

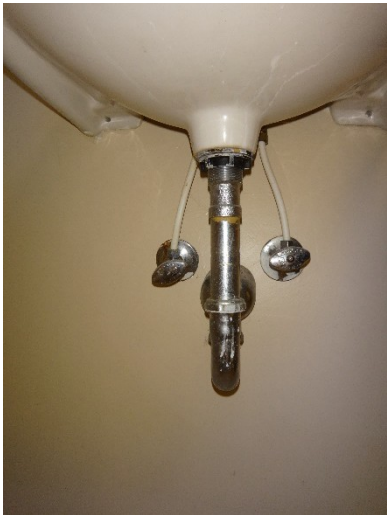
<p><i>Exposed pipes under lavatory in men's restroom</i></p>	Lavatory pipes in both the men's and the women's restrooms are not insulated or otherwise protected (not allowed).	Insulate pipe to comply with ANSI 4.19.4.

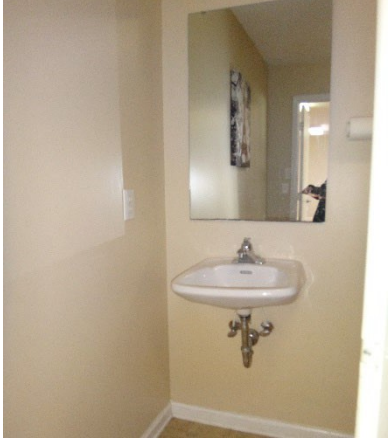
<p><i>Mirror in men's restroom.</i></p>

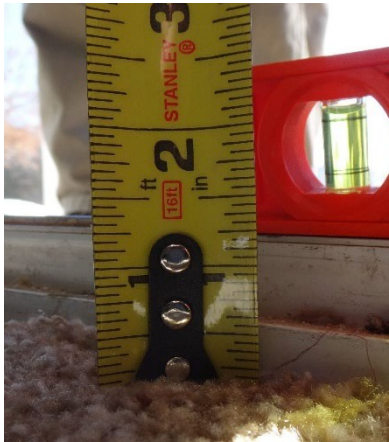
<p>Patio door threshold at Unit 103, Building 2.</p>	<p>Door thresholds are more than 3/4 inch high and are not beveled (maximum 3/4 inch with bevel allowed).</p>

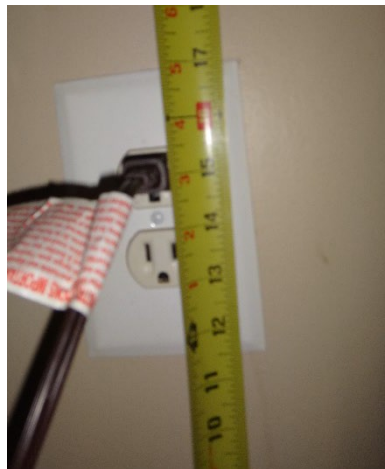
<p><i>Height of outlet in Unit 103, Building 2.</i></p>	<p>Typical outlets are 13-1/2 inches above the floor (minimum 15-inches required).</p>	<p>Subject to tolerances contained in the agreed-upon remediation protocols, modify existing outlet or install a GFI-rated, molded, multi-plug outlet with commercial grade components to bring outlet into compliance with Requirement #5. Any such outlet must be approved by the United States prior to installation. Or, raise one outlet per wall to comply with Requirement #5.</p>

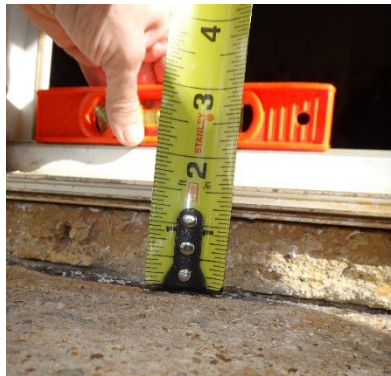
<p><i>Patio door threshold exterior side at Unit 101, Building 1.</i></p>	<p>Door thresholds are more than 3/4 inches high at the interior face and are not beveled (maximum 3/4 inch with bevel allowed).</p> <table><thead><tr><th>Location</th><th>Height (inches)</th></tr></thead><tbody><tr><td>Unit 101, Building 1, Patio</td><td>1-1/4</td></tr></tbody></table>	Location	Height (inches)	Unit 101, Building 1, Patio	1-1/4	<p>Modify threshold to comply with Requirement 4(4).</p>
Location	Height (inches)						
Unit 101, Building 1, Patio	1-1/4

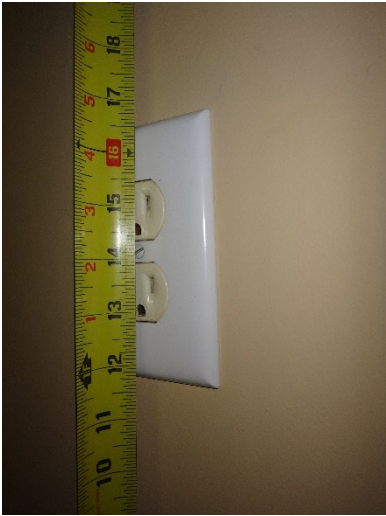
<p><i>Height of outlet in Unit 101, Building 1.</i></p>	Typical outlets are 13-3/8 to 13-1/2 inches above the floor (minimum 15-inches required).	Subject to tolerances contained in the agreed-upon remediation protocols, modify existing outlet or install a GFI-rated, molded, multi-plug outlet with commercial grade components to bring outlet into compliance with Requirement #5. Any such outlet must be approved by the United States prior to installation. Or, raise one outlet per wall to comply with Requirement 5.

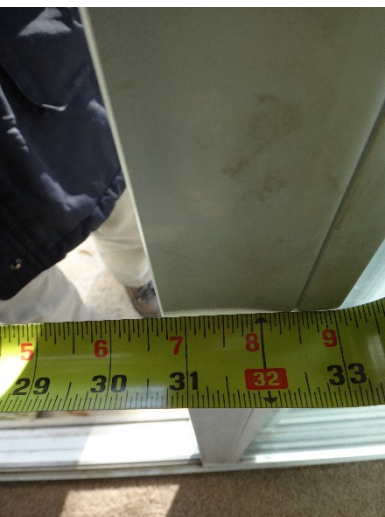
</div> <p><i>Clear patio door opening.</i></p>	<p>Patio and storage closet door clear opening widths are less than 31-5/8 inches (minimum 31-5/8 inch required).</p> <table><thead><tr><th>Location</th><th>Clear Width (inches)</th></tr></thead><tbody><tr><td>Unit 102, Building 3 Patio door</td><td>30-3/4</td></tr><tr><td>Unit 104, Building 3 Patio door</td><td>30-1/2</td></tr></tbody></table>	Location	Clear Width (inches)	Unit 102, Building 3 Patio door	30-3/4	Unit 104, Building 3 Patio door	30-1/2	<p>For sliding door, trim door stop to provide 31 5/8" to comply with Requirement 3(2). For storage door, modify door on-request to comply with Requirement 3(2).</p>		
Location	Clear Width (inches)										
Unit 102, Building 3 Patio door	30-3/4										
Unit 104, Building 3 Patio door	30-1/2

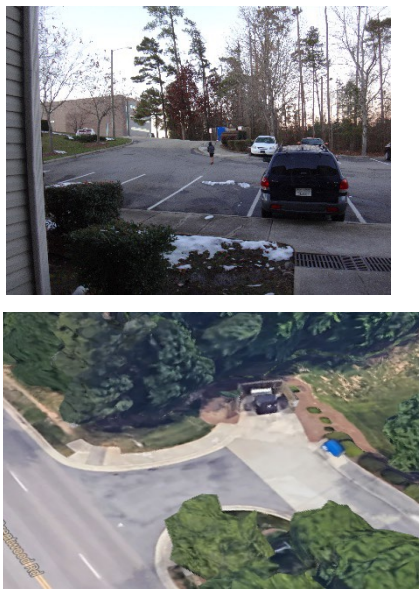
<p><i>Route along drive lane.</i></p>	There is no accessible route between pedestrian site arrival points and leasing office.	Install a new accessible parking (drop-off) space adjacent to the dumpster facility for a vehicular route exception. Space to be located on the east (right) side of the pad so that a vehicle stopped there will not obstruct traffic.

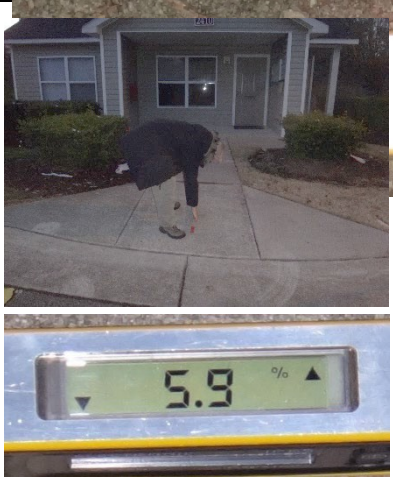
</div> <p><i>Curb ramp leading towards Building 2.</i></p>	<p>Curb ramp cross slopes are more than 2.0% (maximum 2.0% allowed).</p> <p><u>Location</u></p>

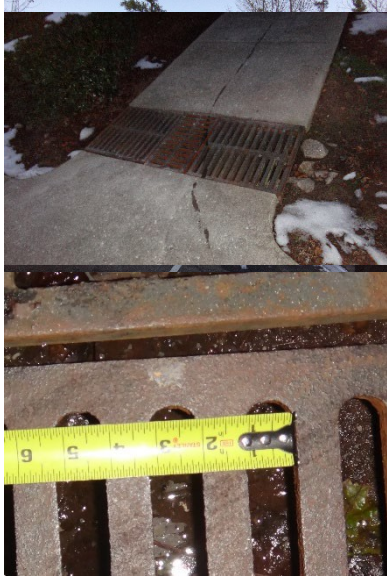
<p><i>Inlet grate at Building 1 west entrance.</i></p>	<p>Gaps at the inlet grate at Building 1 west entrance are 1 inch wide (maximum 1/2 inch allowed).</p> <p><i>Inlet grate at Building 1 west entrance. Measurement of typical gap in grate.</i></p>	<p>Modify gap to comply with ANSI 4.5.</p>
----	--	--	--

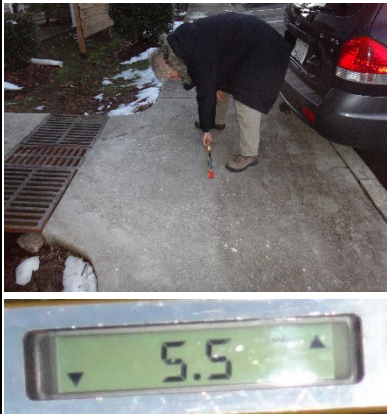
<p><i>Route at turn towards Building 1 unit entrances.</i></p>	Cross slopes of the route North of Building 1 at the turn to Units 101, 102, 103, and 104 are more than 2% (maximum 2% allowed).	Modify 5.5% cross slope to 3.0% maximum to comply with ANSI 4.3.7.
12

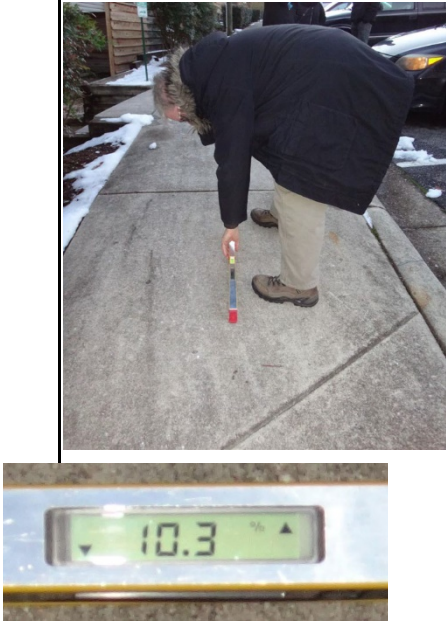
Running slope of ramp at sidewalk north of Building 1 is 10.3% (maximum 8.3% allowed).	Replace sidewalk to comply with ANSI.

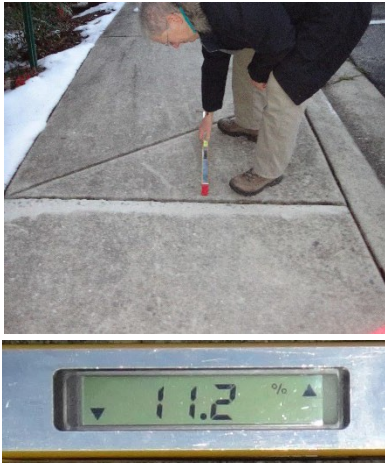
<p><i>Ramp north of Building 1</i></p>	The running slope of the curb ramp apron north of Building 1 is 10.3% to 11.2% (maximum 10% allowed, ANSI 1986, maximum 8.3% at ramps).	Install a new sidewalk to bypass this curb ramp to connect to walkway toward accessible parking space on the south side of the building or replace curb ramp with new sidewalk to comply with ANSI.

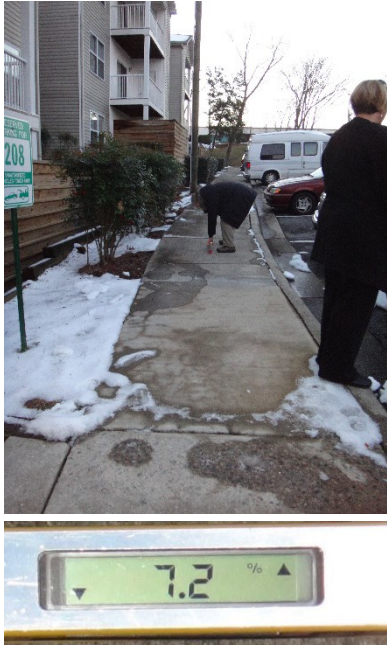
<p><i>Ramp north of Building 1.</i></p>	The sidewalk north of Building 1 has slopes of 5.8%, 6.3%, 6.8%, and 7.2%; has a rise greater than 6 inches, is a ramp, and lacks handrails and edge protection (handrails and edge protection required on both sides).	Modify 6.3%, 6.8% and 7.2% by installing handrails on both sides of walkway or replace walkway to provide 6% maximum running slopes to comply with ANSI.
	<b>Protruding Objects</b>

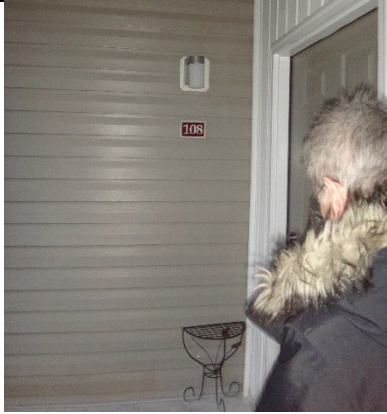
<p>Lights and fire extinguisher cabinets protrude approximately 7 inches into the circulation path (maximum 4 inches allowed where the bottom of the object is more than 27 inches and less than 80 inches above the adjacent walking surface).</p> <p><u>Locations:</u>  West breezeway fire ext. cabinet  East breezeway fire ext. cabinet  East breezeway passage light fixture  West breezeway passage light fixture  Light fixture at Unit 101 entry  Light fixture at Unit 102 entry  Light fixture at Unit 103 entry  Light fixture at Unit 104 entry  Light fixture at Unit 105 entry  Light fixture at Unit 106 entry  Light fixture at Unit 107 entry  Light fixture at Unit 108 entry</p>	<p>Modify protruding objects that project more than 5" into the circulation path to comply with ANSI 4.4.1.</p>

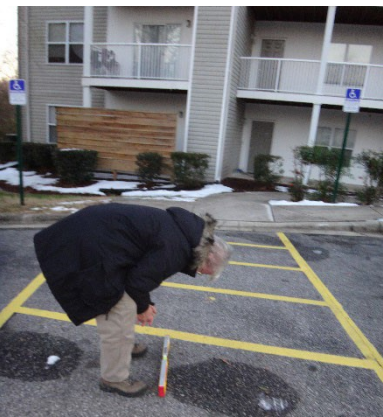
At the parking north of Building 1, the designated parking aisle has cross slopes of 6.5% to 7.1% (maximum 2% allowed).	Modify 6.5% to 7.1% running slopes of access aisle to 5% maximum running slopes to compliant with ANSI.

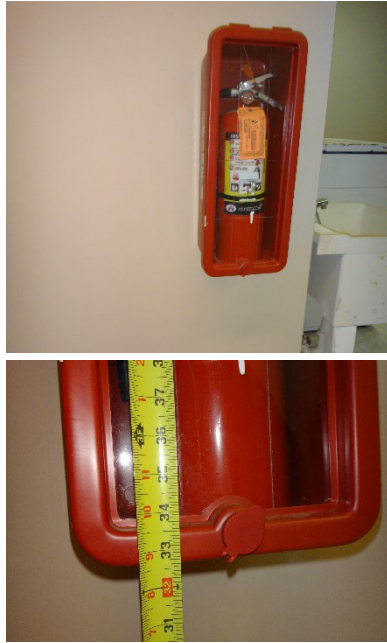
The laundry fire extinguisher protrudes 7-1/8 inches into the circulation path (maximum 4 inches allowed).	Modify protruding objects that project more than 5" into the circulation path to comply with ANSI 4.4.1.

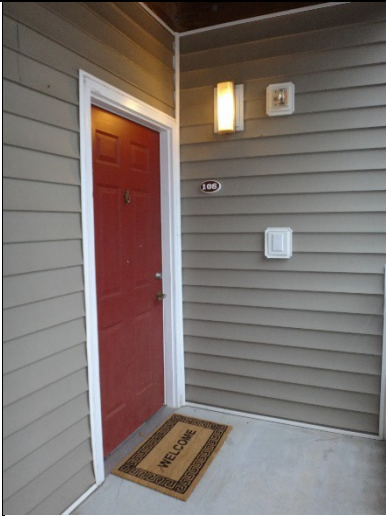
<p><i>Door at Unit 2051-108 – Building 2.</i></p>

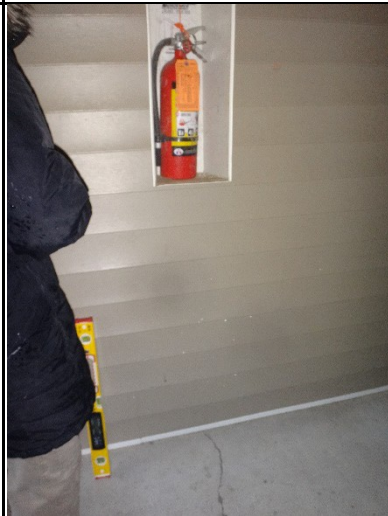
<p><i>Fire extinguisher cabinet at Building 3 breezeway.</i></p>

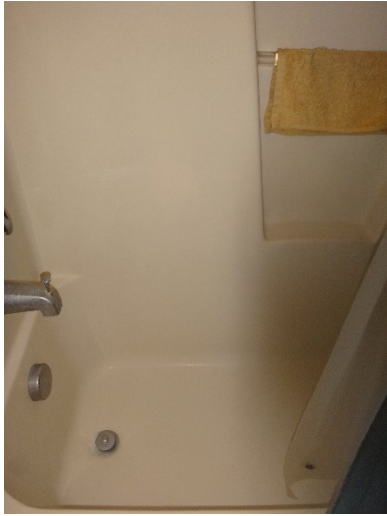
<p><i>Bathtub/shower surround in Unit 2051-102.</i></p>	The shape of the bathtub surrounds precludes the installation of future grab bars with firm attachment to blocking (ability to install grab bars required).	Remediate upon resident request.

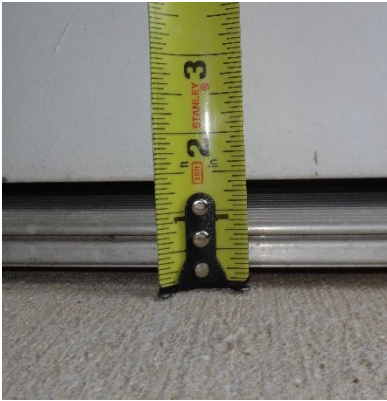
<p><i>Measurement of storage room threshold at Unit 2020- 101.</i></p>	Door thresholds are 3/4 inch high and are not beveled (maximum 1/4 inch without bevel allowed).	Modify door thresholds to comply with Requirement 4(4).

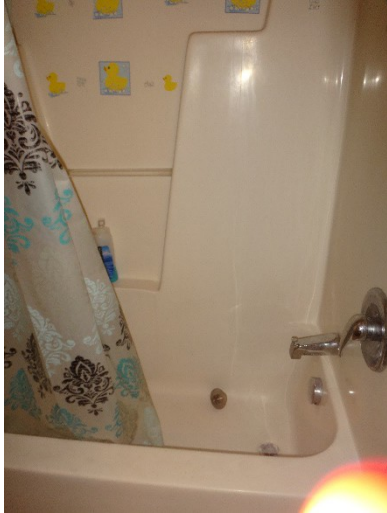
<p><i>Bathtub/shower surround in Unit 2020-101 hall bathroom.</i></p>	The shape of the bathtub surrounds precludes the installation of future grab bars with firm attachment to blocking (ability to install grab bars required).	Remediate upon resident request.
33

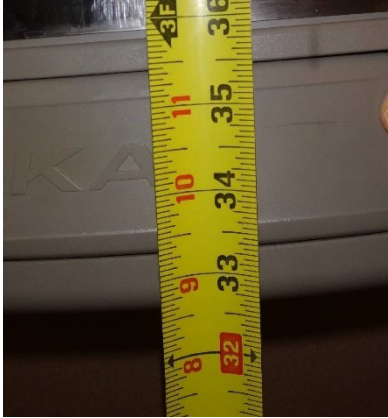
<p><i>Height of bottom edge.</i></p>	<p>Drinking fountain protrudes approximately 19 inches into the circulation path (maximum 4 inches allowed).</p> <p><u>Location</u>  Second Floor Corridor  Height of leading edge                      32-3/8  Third Floor Corridor  Height of leading edge                      32-3/4</p>	<p>Modify protruding objects that project more than 5" into the circulation path to comply with ANSI 4.4.1.</p>

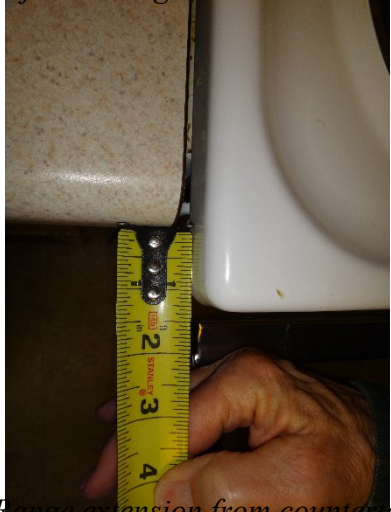
<p><i>Range extension from countertop. Unit 167.</i></p>	<p>The outlet above the kitchen counter between the stove and the sidewall lacks the required clear floor space for approach (at least 1 outlet in each counter area must have clear floor space for approach). The range is approximately 26-1/2 inches depth (maximum depth obstruction is 25-1/2 inches).</p>	<p>Subject to tolerances contained in the agreed-upon remediation protocols, modify existing outlet or install a GFI-rated, molded, multi-plug outlet with commercial grade components to bring outlet into compliance with Requirement #5. Any such outlet must be approved by the United States prior to installation.</p>

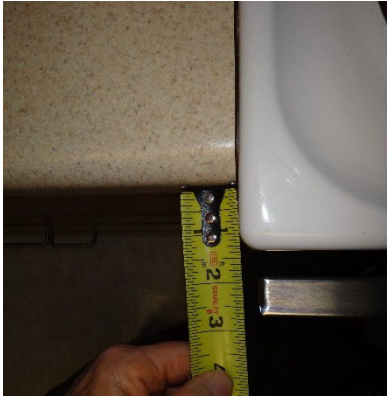
<p><i>Range extension from countertop. Unit 102 – Building 3</i></p>	<p>The outlet above the kitchen countertop between the stove and the side wall lacks the required clear floor space for approach (at least 1 outlet in each counter area must have clear floor space for approach). The range is approximately 26-1/2 inches depth (maximum depth obstruction is 25-1/2 inches).</p> <p>This occurs in all units surveyed.</p>	<p>Subject to tolerances contained in the agreed-upon remediation protocols, modify existing outlet or install a GFI-rated, molded, multi-plug outlet with commercial grade components to bring outlet into compliance with Requirement #5. Any such outlet must be approved by the United States prior to installation.</p>
29		<p>Extent of blocking in bathrooms cannot be determined without destructive testing.</p>	<p>Provide affidavits to confirm that reinforcement is installed to comply with Requirement 6.</p>

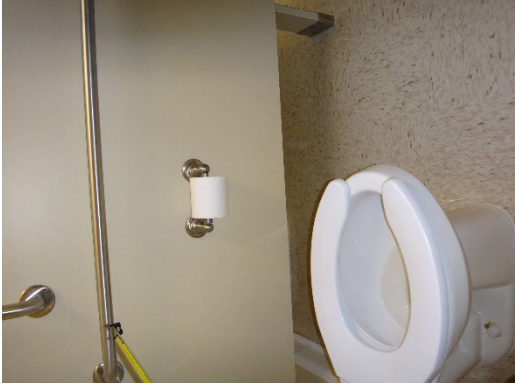
<p><i>Toilet in women's restroom.</i></p>	<p>The toilet paper dispensers are not in front of the nose of the toilets, are less than 7 inches from the nose of the toilet, and are less than 36 inches from the back wall (minimum 7 inches and maximum 9 inches required from nose of toilet).</p>	<p>Modify toilet paper dispenser to comply with ANSI 4.16.6.</p>

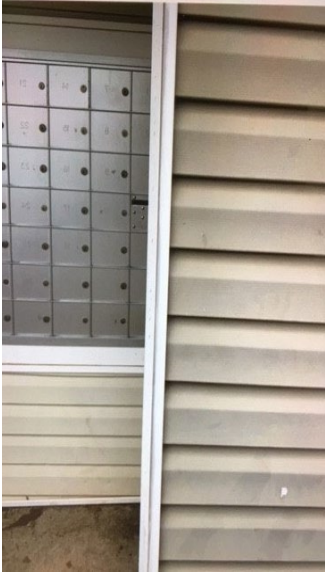
<p>The mailboxes are inaccessible--the two top rows are 58.75 and 64 inches above the slab.</p>	<p>Lower mailboxes so that the topmost lock is no more than 54 inches about the adjacent concrete to comply with ANSI 4.2.6. Alternatively, provide written confirmation that all ground-floor units are assigned mailboxes with locks no more than 54" above the ground level.</p>
8		<p>The leasing office/clubhouse entry and all the interior clubhouse doors have inaccessible knob type hardware that requires tight grasping, pinching, and/or turning.</p>	<p>Install accessible lever door hardware where the existing hardware is knob style to comply with ANSI 4.13.9.</p>

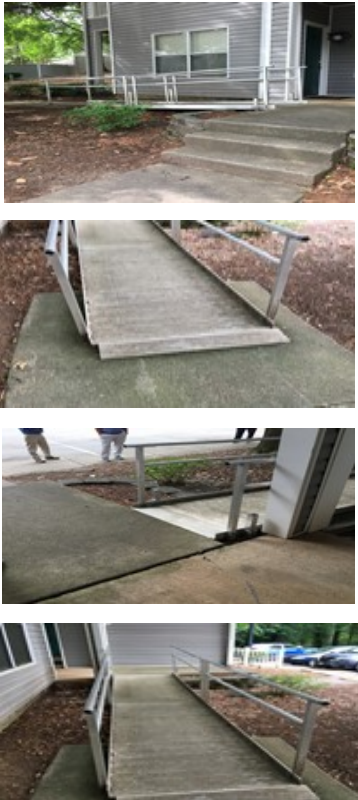
There is no permanent accessible route to Building 2117.	Install a permanent and compliant accessible route to Building 2117. See Accessible Route Plan for location.
5	See Accessible Route Plan and Key Plan.	There is a lack of accessible parking at the recycling center.	Install an accessible parking space at the recycling center. See Key Plan #5 for location. Alternatively, relocate the recycling center to a compliant location.

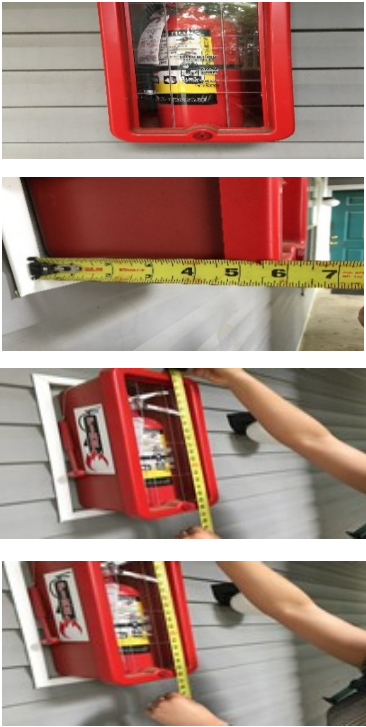
<p>At all the breezeways, fire extinguishers protrude more than 4" into the accessible route and are mounted higher than 27" above the ground level; measured at 5 3/4" from adjacent wall.</p>	<p>Relocate fire extinguishers in all the breezeways to a compliant location or install permanent cane detectable barrier to comply with ANSI 4.4.1.</p>
7

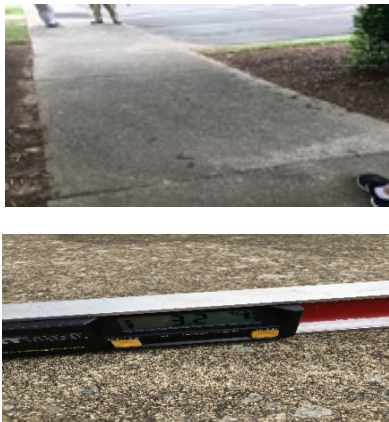
<p>The cross slopes of the sidewalk are more than 2% maximum at the following three locations: 1. Along the accessible route parallel to Flavion Drive at the sidewalk parallel to, and in between, Units 105 and 106; 2. At the sidewalk parallel to, and to the west of, Unit 105; and 3. At the sidewalk parallel to, at the intersection with the sidewalk to, Unit 103.</p>	<p>Modify cross slopes to comply with ANSI 4.3.7.</p>

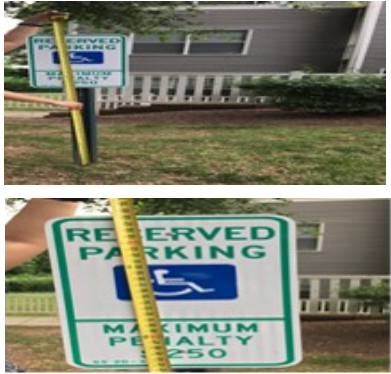
<p>The parking signs at designated accessible spaces were mounted too low with the bottom of the sign less than 60" above the ground level. This condition was occurred at the following three locations: 1. At the leasing office; 2. At building 2120; and 3. Along Flavion Drive and Ruark Court.</p>	<p>Reinstall parking signs at designated accessible spaces such that the bottom of the sign is 60" above the ground level to comply with ANSI 4.6.2.</p>
12

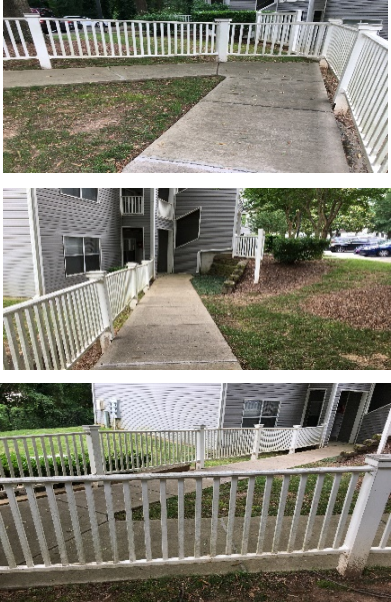
<p>At building 2100, the ramp to the lower level has severe running slopes without required handrails on both sides.</p>	<p>Install compliant handrails at both sides of the ramp to comply with ANSI 4.8.5.</p>
