Consent Order, United States v. Lanier Pointe, LLC, et al. (E.D.NC.)

Cottages at Azalea Apartments Retrofit Plan -2

Azalea Gardens Apartments Retrofit Plan - 1

Lanier Pointe II Retrofit Plan – 6

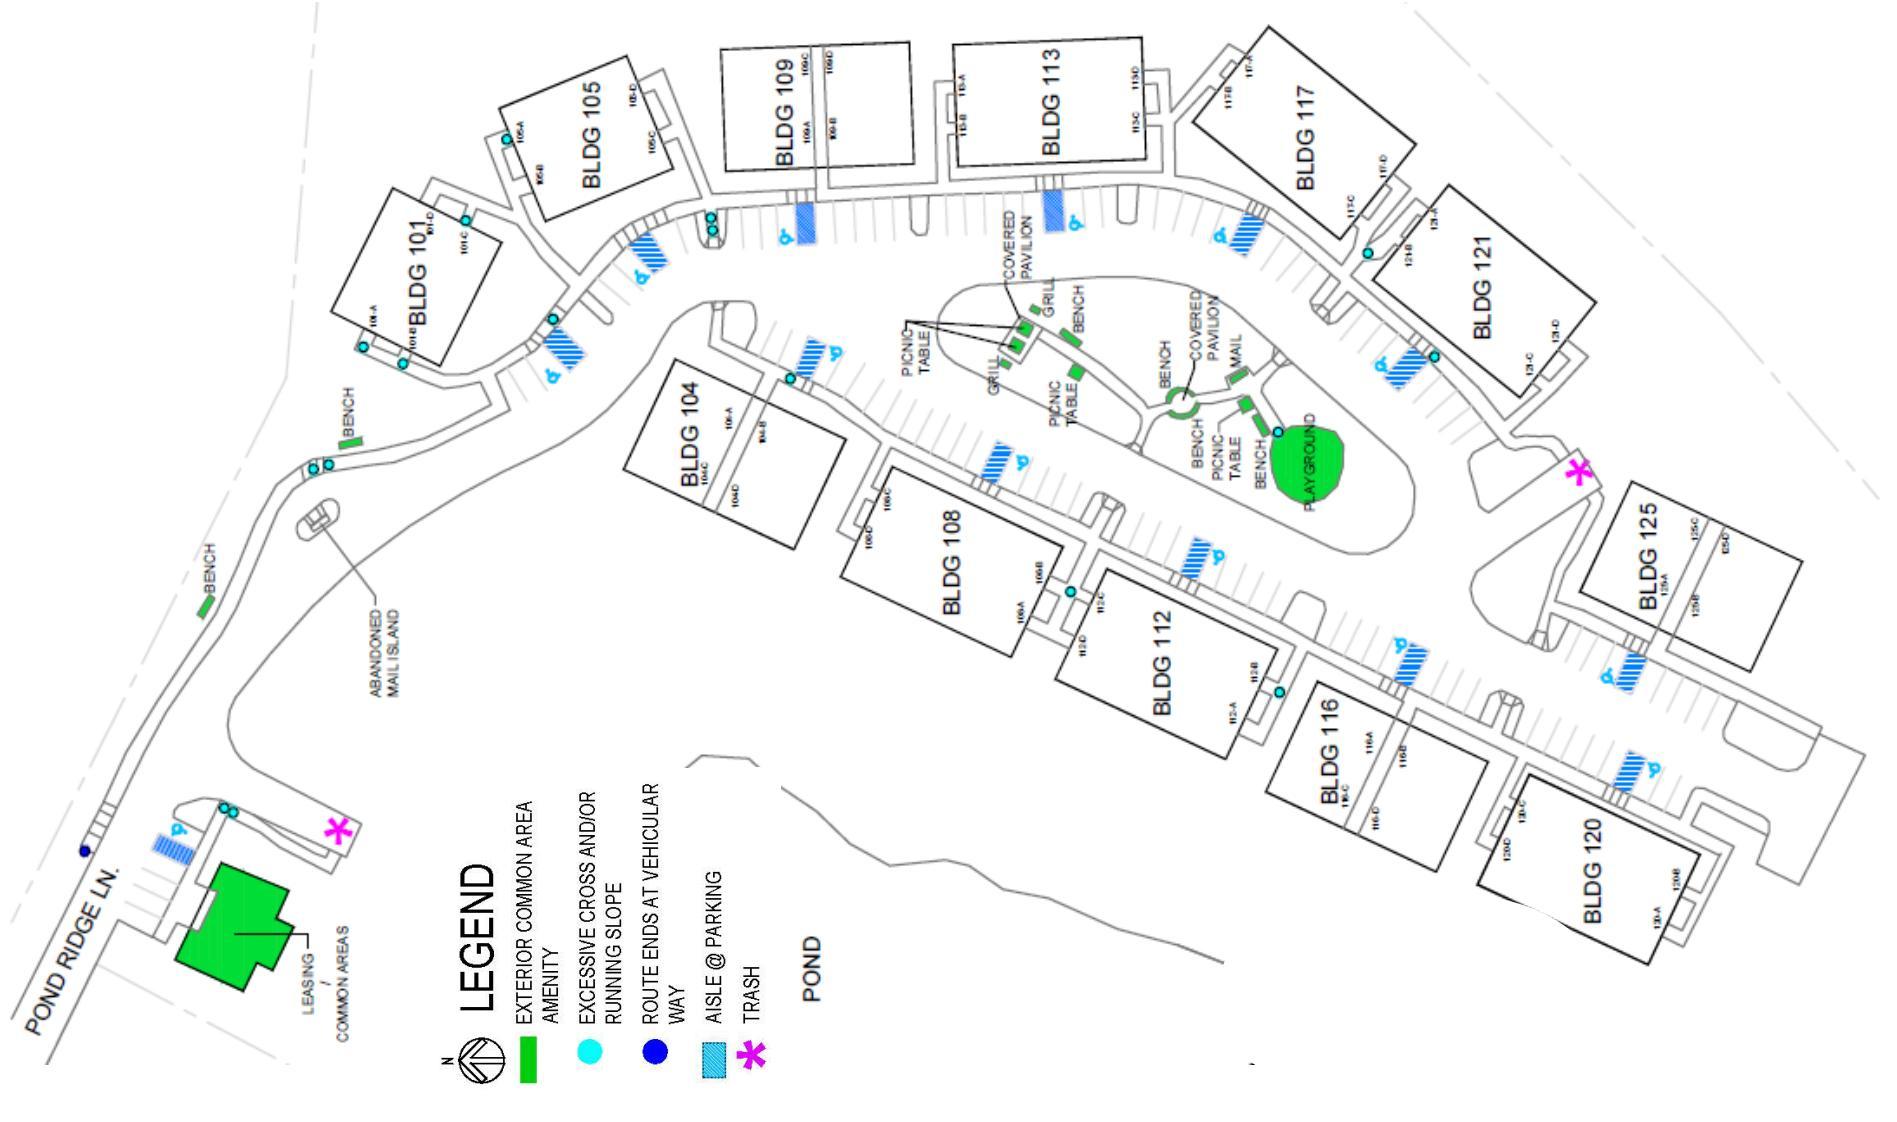
Gap In Sidewalk		
7		Gaps in the pavement are wider than 1/2 inch (maximum 1/2 inch allowed).	Install filler at gaps.
		GapLocation of Example(inches)South of Building 1201	
	Location south of Building 120.		
	Gap width.		
	Inaccessible Slopes at Sidewalks		
8		The cross slopes of the route are more than 2% (maximum 2% allowed).LocationSlopeWest of Building 1013.2%Southwest of Building 1053.3%Southwest of Building 1053.1%	Replace sidewalks at accessible route(s) as required to retrofit sections with excessive cross slope.
	Location of level, southwest of Building 112	North of Building 1213.2%Southwest of Building 1123.2%West of Building 1213.1%East of Leasing Office3.9%

Cross slope.	East of Leasing Office	4.0%	
	Inaccessible Slopes			
9	Summary stateFurb ramp measurementlocation (level positioned tomeasure cross slope).Summary slope.	At old mail center 9. on walk towards units.	% (maximum <u>lope</u> .1% .1%	Replace sidewalks and ramps at accessible route(s) as required to retrofit sections with excessive running slope.

10	Weasurement location. Cross slope. Crosswalks	The cross slope of the sidewalk at the curb ramp east of Building 104 is 3.1% (maximum 2.0% allowed).	Replace sidewalk at accessible routes as required to retrofit sections with excessive cross slope.
11	See Accessible Route Diagram.	Crosswalks at vehicular drives are incorporated into the accessible route(s).	Stripe crosswalks.

Inaccessible Slope at Door Maneuvering Space		
12 Image: Constrained of the second of t	Common unit door maneuvering clearances are sloped more than 2.0% (maximum 2% allowed). <u>Location Slope</u> Unit 101C 3.1%	Replace concrete at door maneuvering clear space.

Change in Level			
13	Change in level at Unit 101D porch slab.	There are changes in level great inch that are not beveled (maxi- inch with no bevel allowed, ma- inch allowed with bevel). <u>Location of Example</u> Unit 101D	mum 1/4	Bevel the change in level, replace concrete with raised edge, or grind the edge of concrete to make compliant.

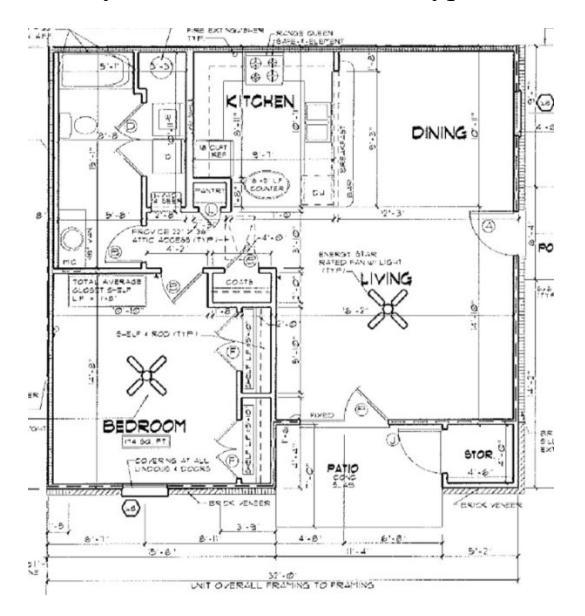
Surveyed Unit 101A, 105A - Typical for 7 total units

18		The outlets above kitchen countertops lack the required clear floor space for approach. Obstructions require reaches greater than 25- 1/2 inches (at least 1 outlet in each counter area must have clear floor space for approach.)	Replace range or add outlet(s) at accessible location serving the counter area.
	Clear floor space obstructed by adjacent refrigerator.

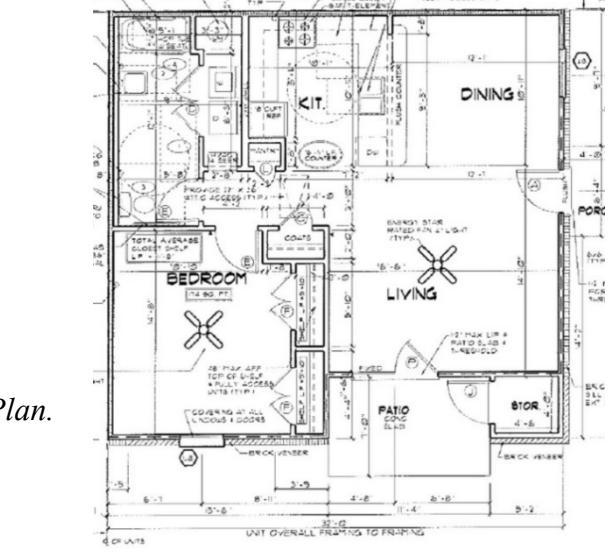
Surveyed Unit 101C – Typical for 1 unit only

19		The outlets above kitchen countertops lack the required clear floor space for approach (at least 1 outlet in each counter area must have clear floor space for approach.)	Replace range or add outlet(s) at accessible location serving the counter area. Work may require relocation of range or an outlet at the front face of a cabinet.
	Clear floor space obstructed by adjacent refrigerator.

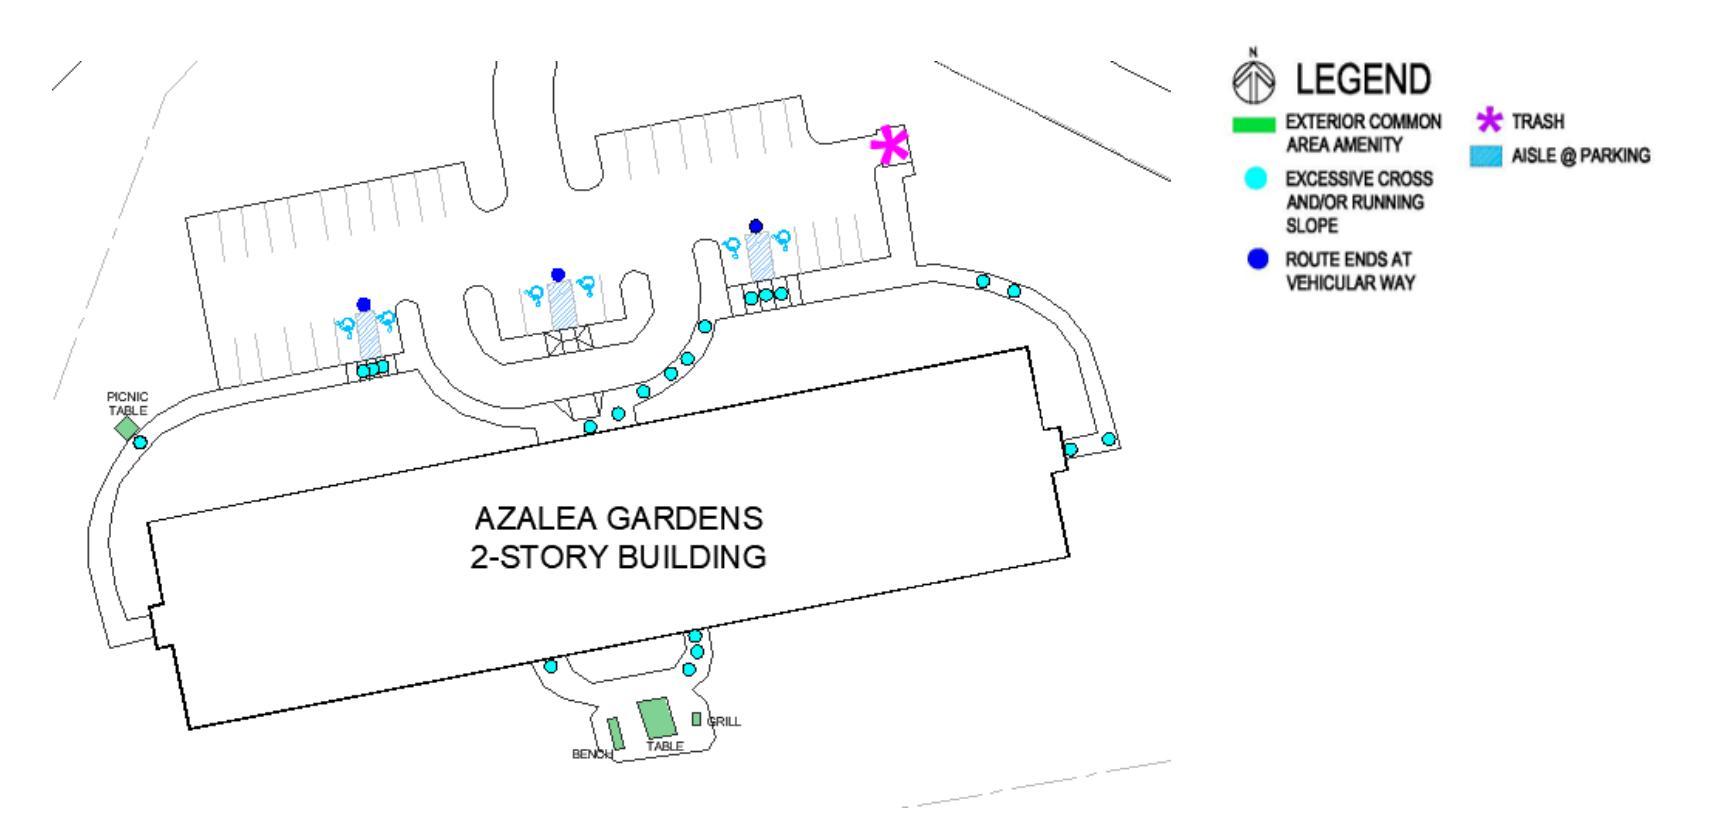
Inaccessible Cross Slopes		
8		Cross slopes at sidewalks and curb ramps are more than 2.0% (maximum 2.0% allowed).	Replace sidewalks and curb ramps at accessible route(s) as required to retrofit sections with excessive cross slopes.
		LocationSlopeNorthwest of building,4.4%east of the curb rampCrossing west curb ramp4.0%Northwest of building,3.9%west edge of the curb ramp	
	Location of cross slope	Sidewalk south of building 4.1% to door east of picnic area	
	condition northwest of building.	Sidewalk south of building 3.7% to door east of picnic area	
	Cross slope.

Width of Route			
9 Image: Display intervent of the second	The clear width of the route area grill is 27 inches (mini required). Grill lacks 30 inch by 48 in space for approach and use (clear floor space is require <u>Location</u> Width between grill and table Width between grill tray and table	mum 36 inches ch clear floor of the amenity	Relocate the picnic grill.

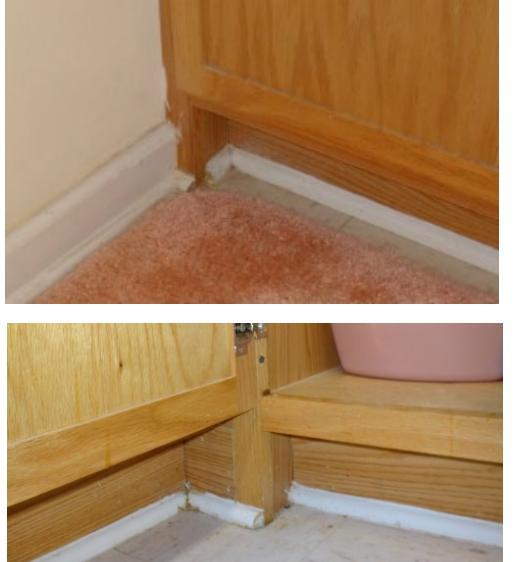
Base trim across the toe kick at the lavatory base, Unit 109. (0705.jpg).

Base trim across the toe kick at the sink base, Unit 204. (0777.jpg).

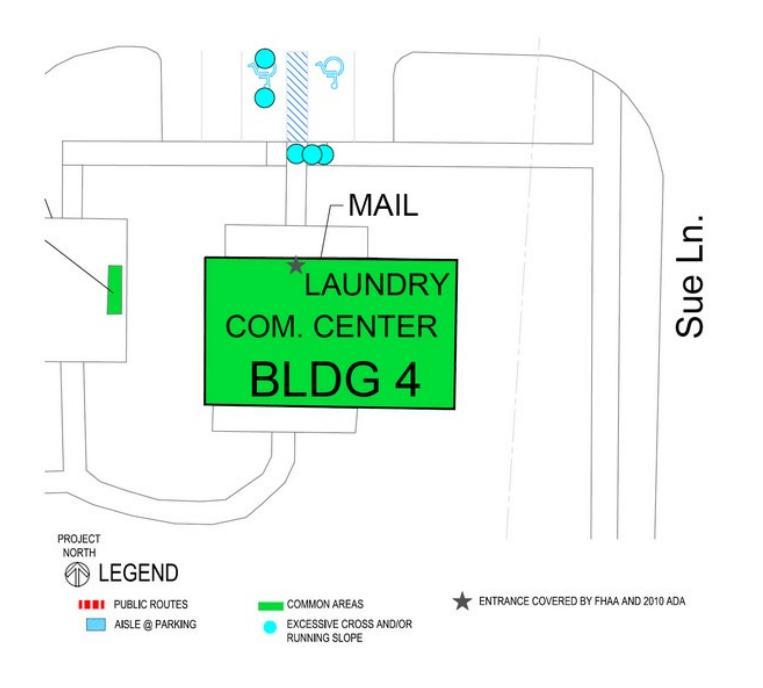
Inaccessible Parking Features			
1		Designated accessible parking above) has cross slopes greater (maximum 2% allowed).	- ·	Repave/overlay asphalt at parking space and access aisle. Restripe parking space and access aisle.
		Location Building 4/Leasing Office,	Slope	
		west designated	5.9%	
		space, foot Building 4/Leasing Office west designated space, middle	3.3%	
	Measuring parking space.	space, madie		
	A 5.5 *			
	Cross slope at parking space.

Inaccessible Surfaces and Slopes		
2	Fast curb ramp north of Building 4.Cross slope	Cross slopes at the east curb ramp/sidewalk north of Leasing Office/Clubhouse are more than 2.0% (maximum 2.0% allowed).LocationSlope North of Building 4: East ramp, top3.6%	Replace east curb ramp.

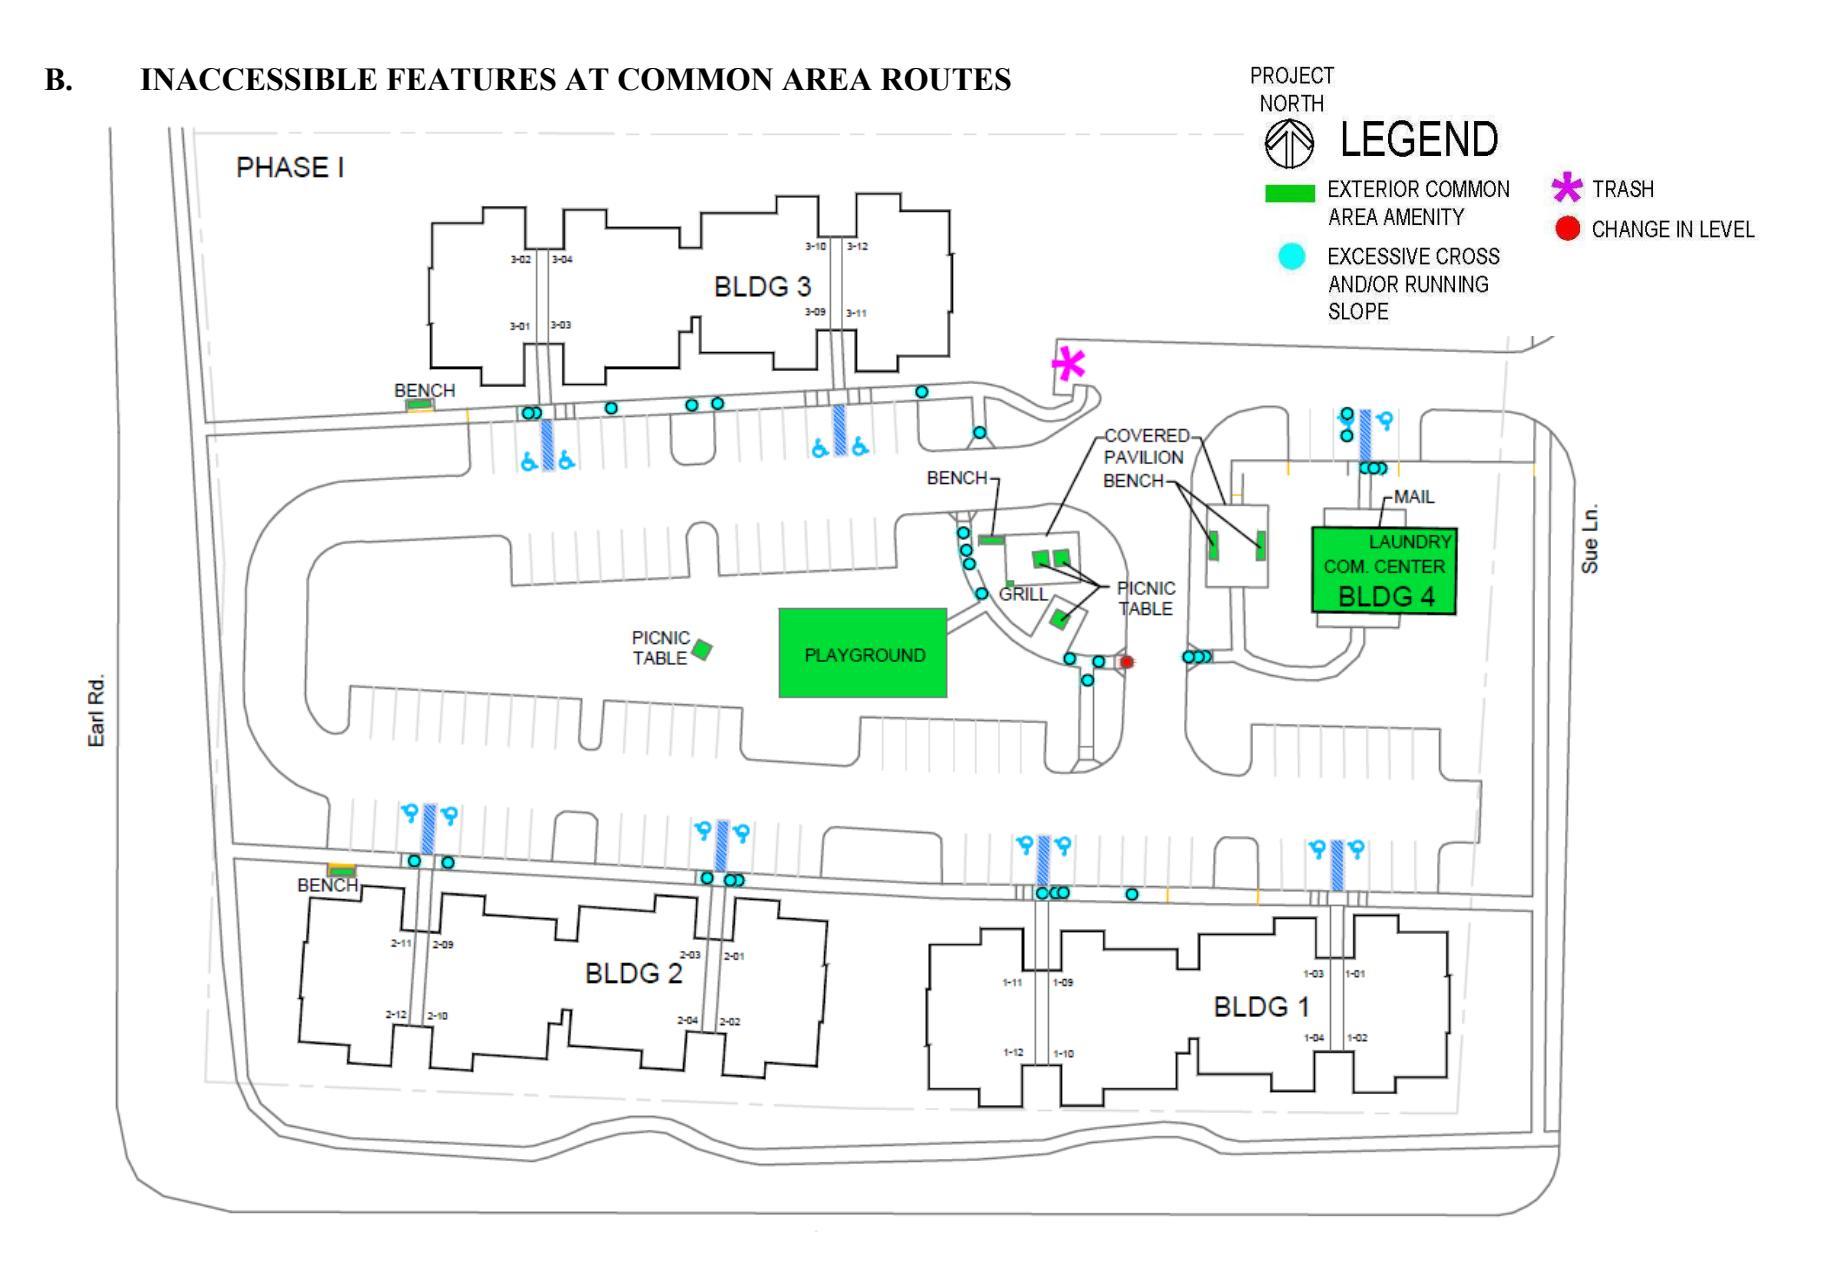
Inaccessible Changes in Level		
5	Image: Second systemImage: Second sy	The route has a 1-1/4 inch change in level at the bottom of the curb ramp leading to the playground from the clubhouse (maximum 1/2 inch with bevel allowed).	Repave asphalt surface even with surface of curb ramp concrete.

Inaccessible Slopes at Sidewalks		
6	Foute by Building 1.Cross slope.	Cross slopes of routes are more than 2% (maximum 2% allowed). <u>Location Slope</u> Building 1 middle of west 3.4% row of parking	Replace sidewalks at accessible route(s) as required to retrofit sections with excessive cross slope.

Inaccessible Curb Ramp Features		
7	Curb ramp at west entry to Building 3.Cross slope.	The cross slope of the curb ramp is more than2.0% (maximum 2.0% allowed).LocationSlopeBuilding 4, bottom of west3.4%curb rampWest of Building 4, crossing3.4%to playground, top of rampBuilding 3, west entry, bottom3.7%of west rampBuilding 1, west entry, bottom3.1%of east rampBuilding 2, east entry, bottom3.2%of west rampBuilding 2, west entry, bottom3.1%of west rampBuilding 2, west entry, bottom3.1%of west ramp	Replace curb ramps at accessible route(s) as required to retrofit sections with excessive cross slope.
	Crosswalks		
8	See Accessible Route Diagram.	Crosswalks at vehicular drives are incorporated into the accessible route(s).	Stripe crosswalks.

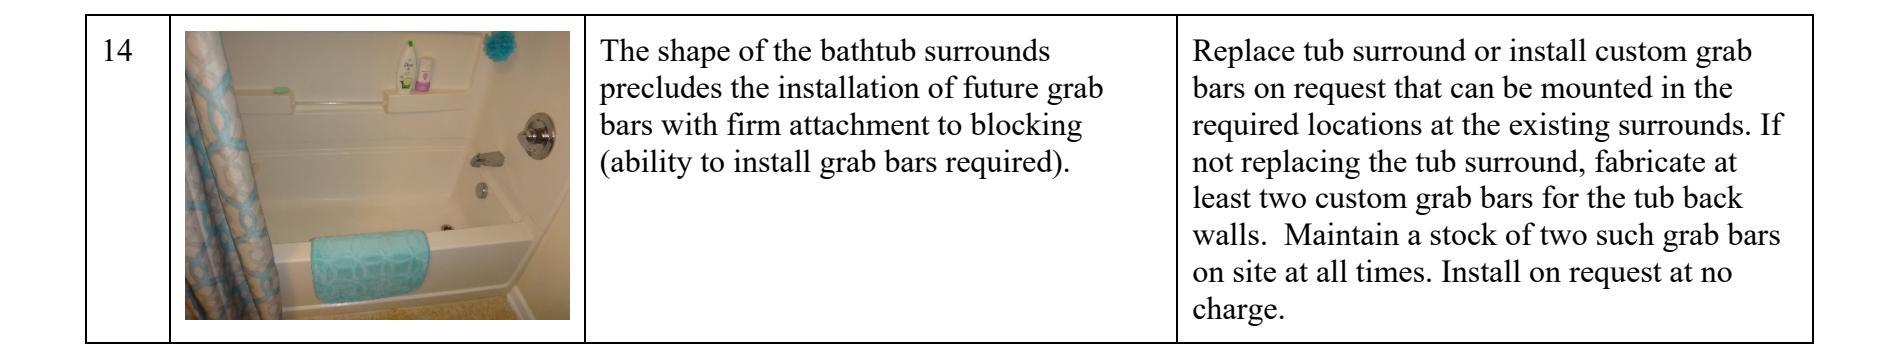
Bathtub/shower surround in Unit 2-01.		
15	<image/>	Lavatory centerlines are less than 24 inches to the side wall (minimum 24 inches required) and the cabinets are not removable. <u>Distance</u> <u>Location (inches)</u> Unit 2-01, hall bathroom. 12-1/2	Install removable base cabinet with 30 inch wide knee space in compliance with safe harbor knee and toe clearance requirements. Attach a durable-material placard stating: "THIS CABINET IS REMOVABLE FOR PERSONS WITH DISABILITIES. CONTACT MANAGEMENT."

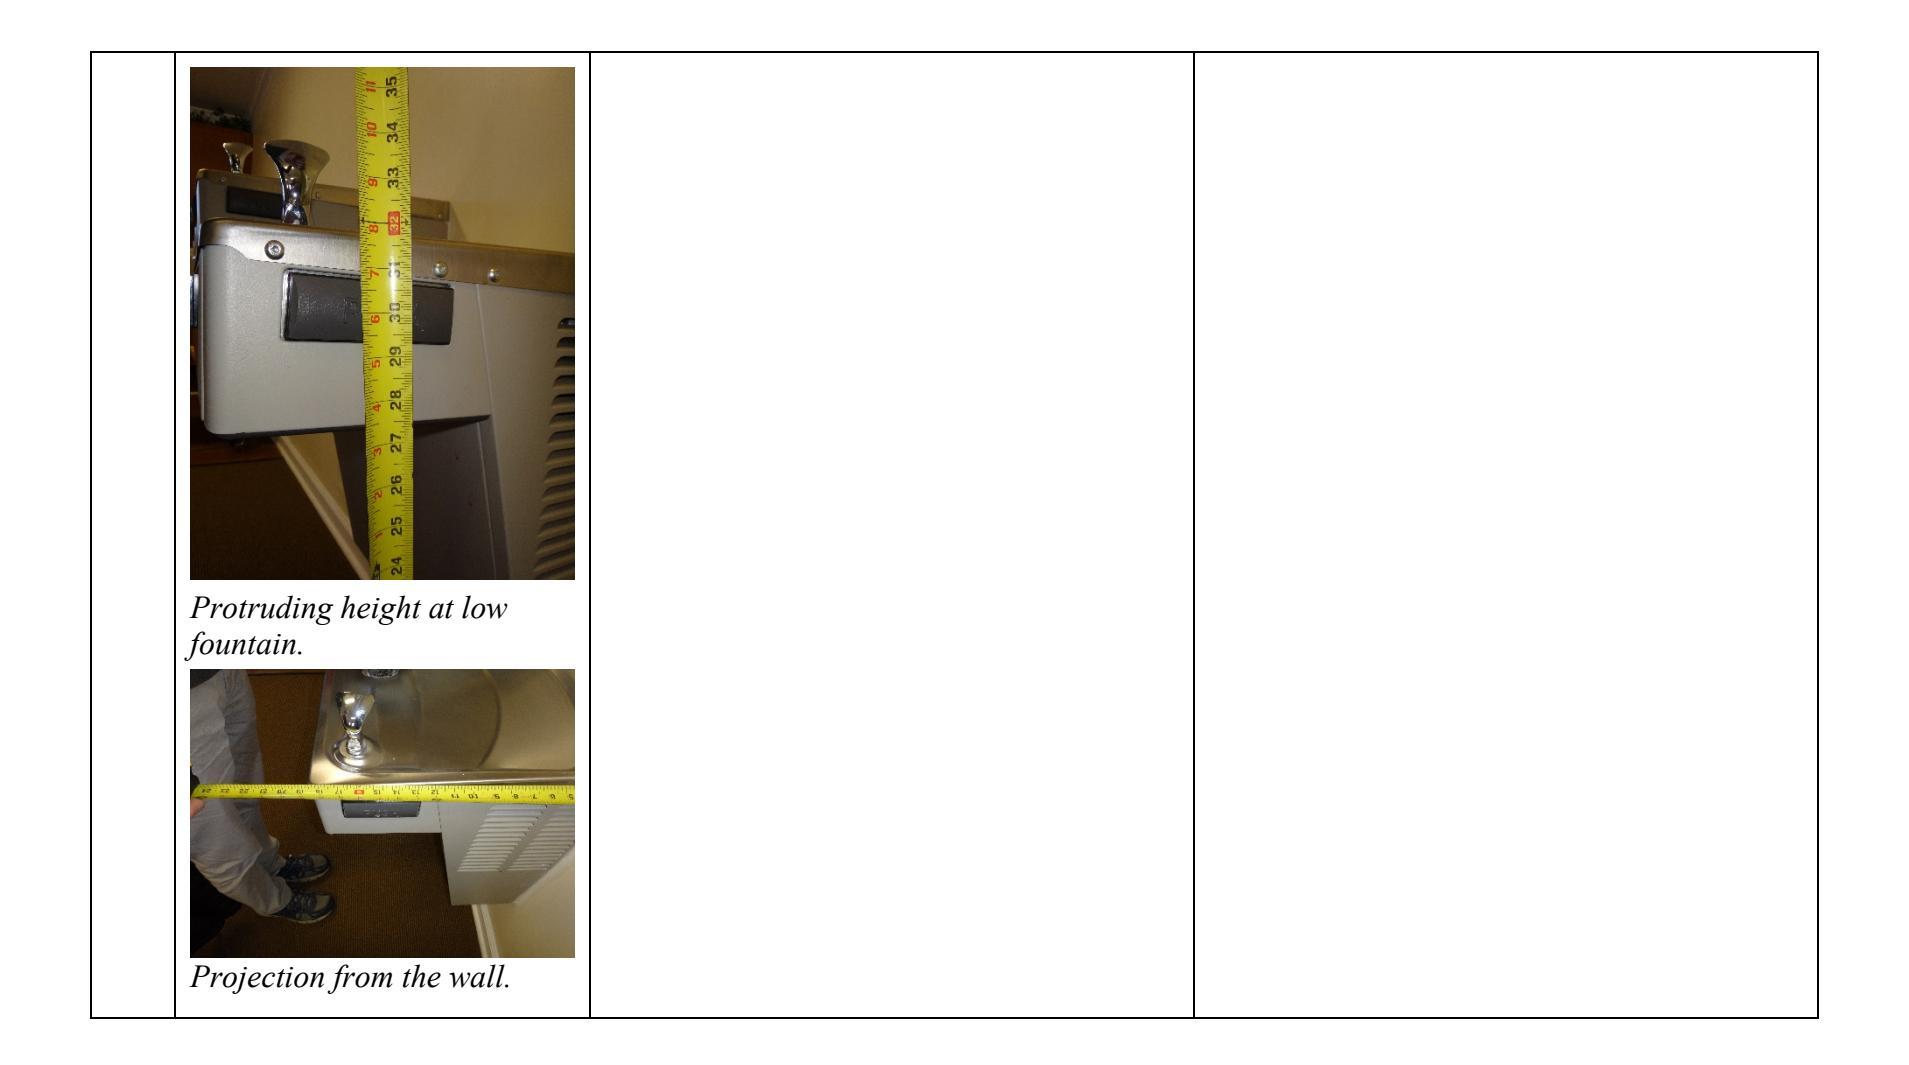
Inaccessible Restroom Features		
1	Flush control at women's restroom.	Toilet flush control in the women's restroom is located on the side opposite the side of approach (not allowed).	Replace tank.
	Protruding Object		
2	Drinking fountain in community center.	The leasing office/community center drinking fountain protrudes 19 inches into the circulation path at a height of 27-1/2 inches at the low fountain and at a height of approximately 31 inches at the high fountain (maximum 4 inch protrusion allowed at heights between 27 inches and 80 inches above the floor).	Install shroud or other cane detectable barrier. Barrier may not obstruct required knee and toe space at lower unit.

Α	ADA		
	Mensurement of centerline of men's restroom sign.	The men's restroom signage is not centered on an 18 inch clear floor space (minimum 9 inches from door jamb to centerline of sign required). <u>Centerline Location (inches)</u> Men's Restroom 7-1/2	Relocate sign.

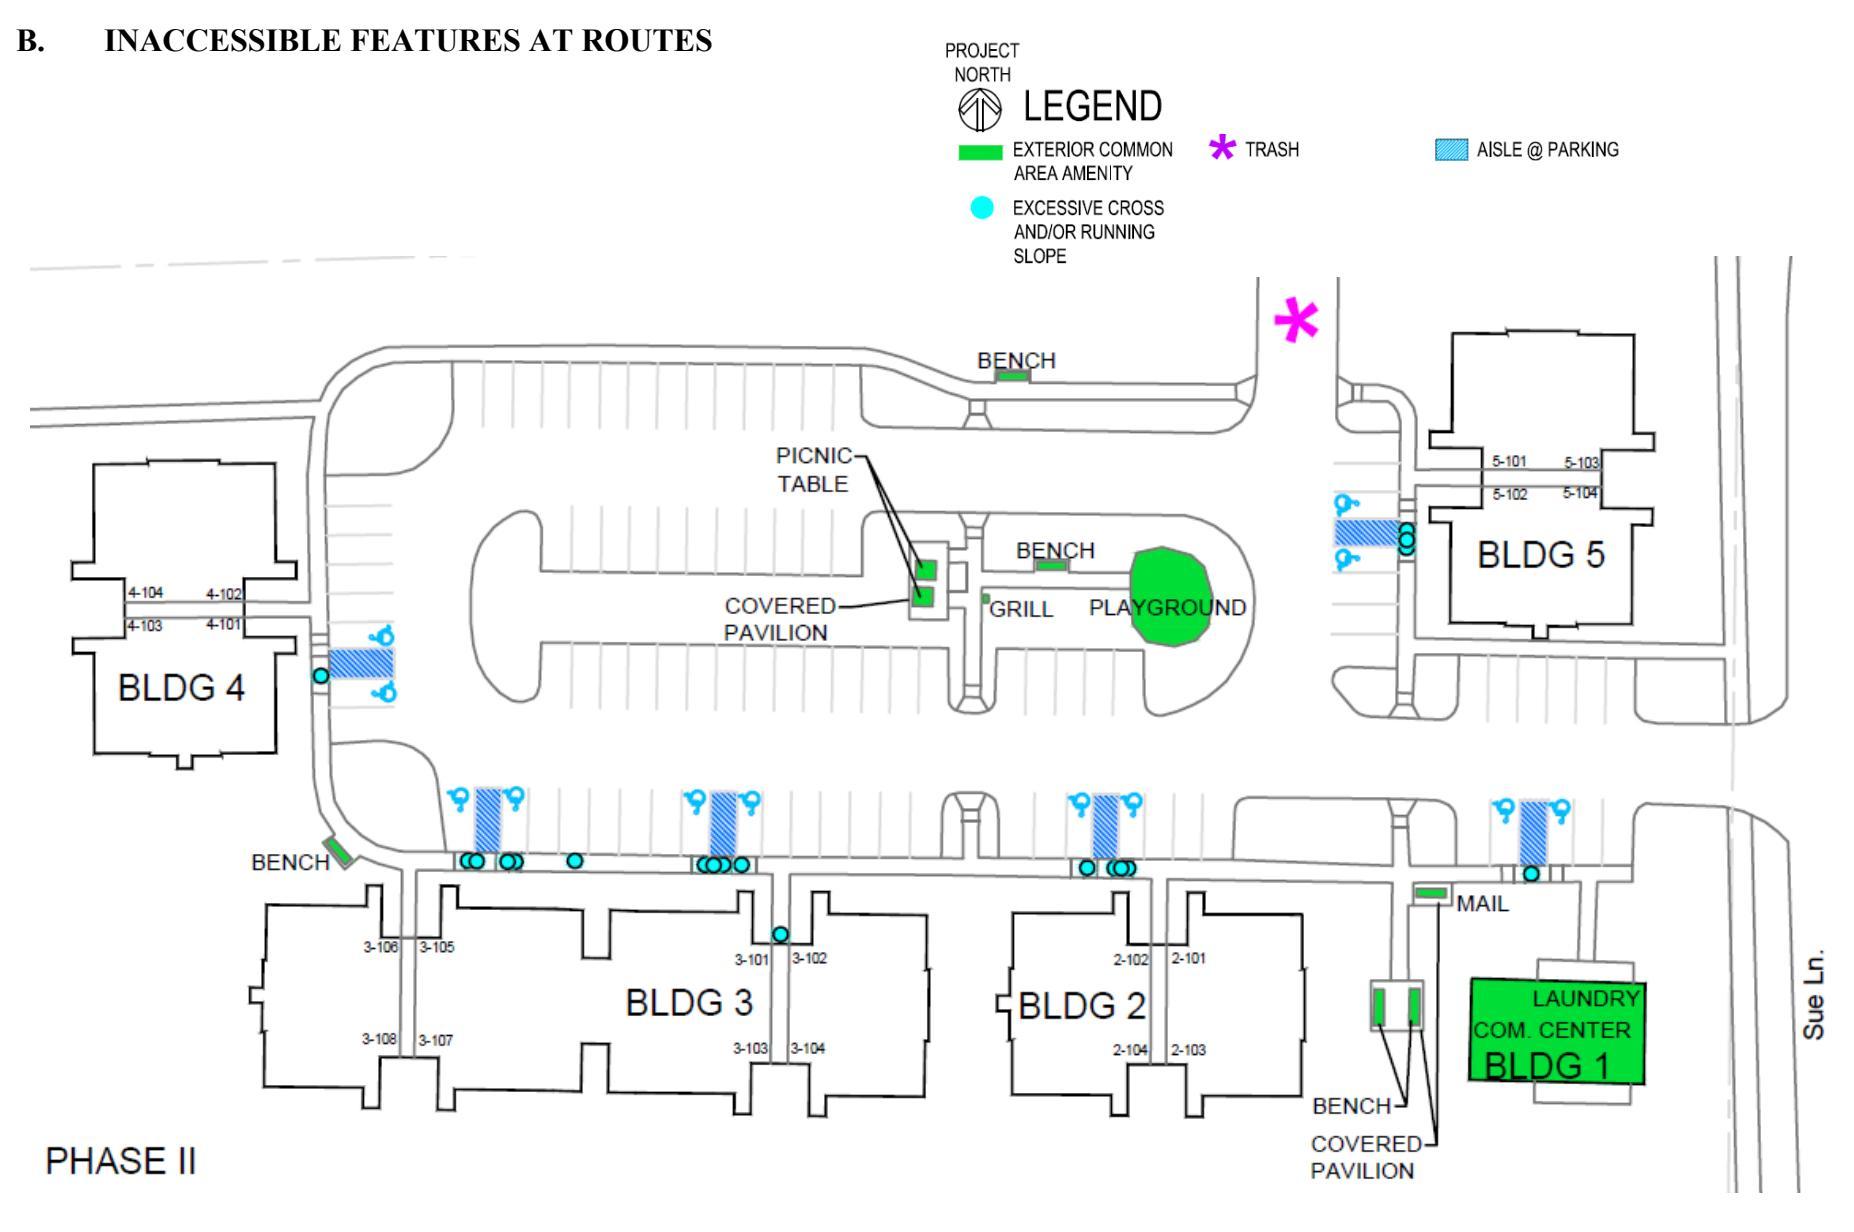
Inaccessible Curb Ramp Features		
6	West curb ramp north of Building 3.Measurement of running slope.	Running slopes of curb ramps a 8.3% (maximum 8.3% allowed Location North of Building 2, top of east curb ramp North of Building 2, top of west curb ramp North of Building 3, east entry, top of east curb ramp North of Building 3, east entry, top of west curb ramp North of Building 3, west entry, top of west curb ramp	Replace curb ramps at accessible route(s) as required to retrofit sections with excessive running slope.

7		Cross slopes of curb ramps are 2.0% (maximum 2.0% allowed		Replace curb ramps at accessible route(s) as required to retrofit sections with excessive cross slope.
		Location	Slope	
		Building 5, top of south curb ramp	3.2%	
		Building 2, top of east curb ramp	3.2%	
		Building 3, east entry, bottom of west curb ramp	3.6%	
		Building 3, west entry, top of east curb ramp	3.3%	
	Curb ramp at the east entry			
	of Building 3.			
	Measurement of cross slope.

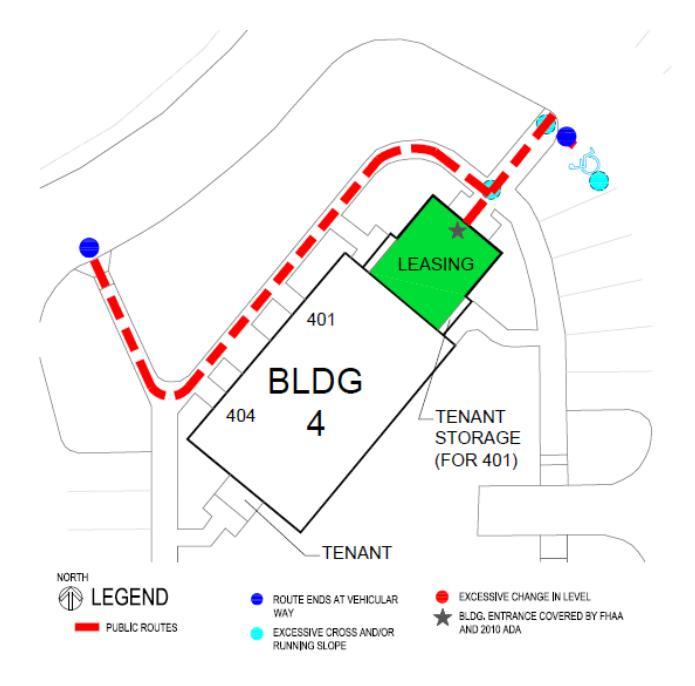
Lack of Accessible Route		
1	View looking west from north of Building 8.	There is no accessible route between pedestrian site arrival points and leasing office; existing route ends at vehicular way (accessible route required).	Provide new sidewalk and curb ramps from Earns Rd. to the existing walk in front of the leasing office building (see Accessible Route Diagram).

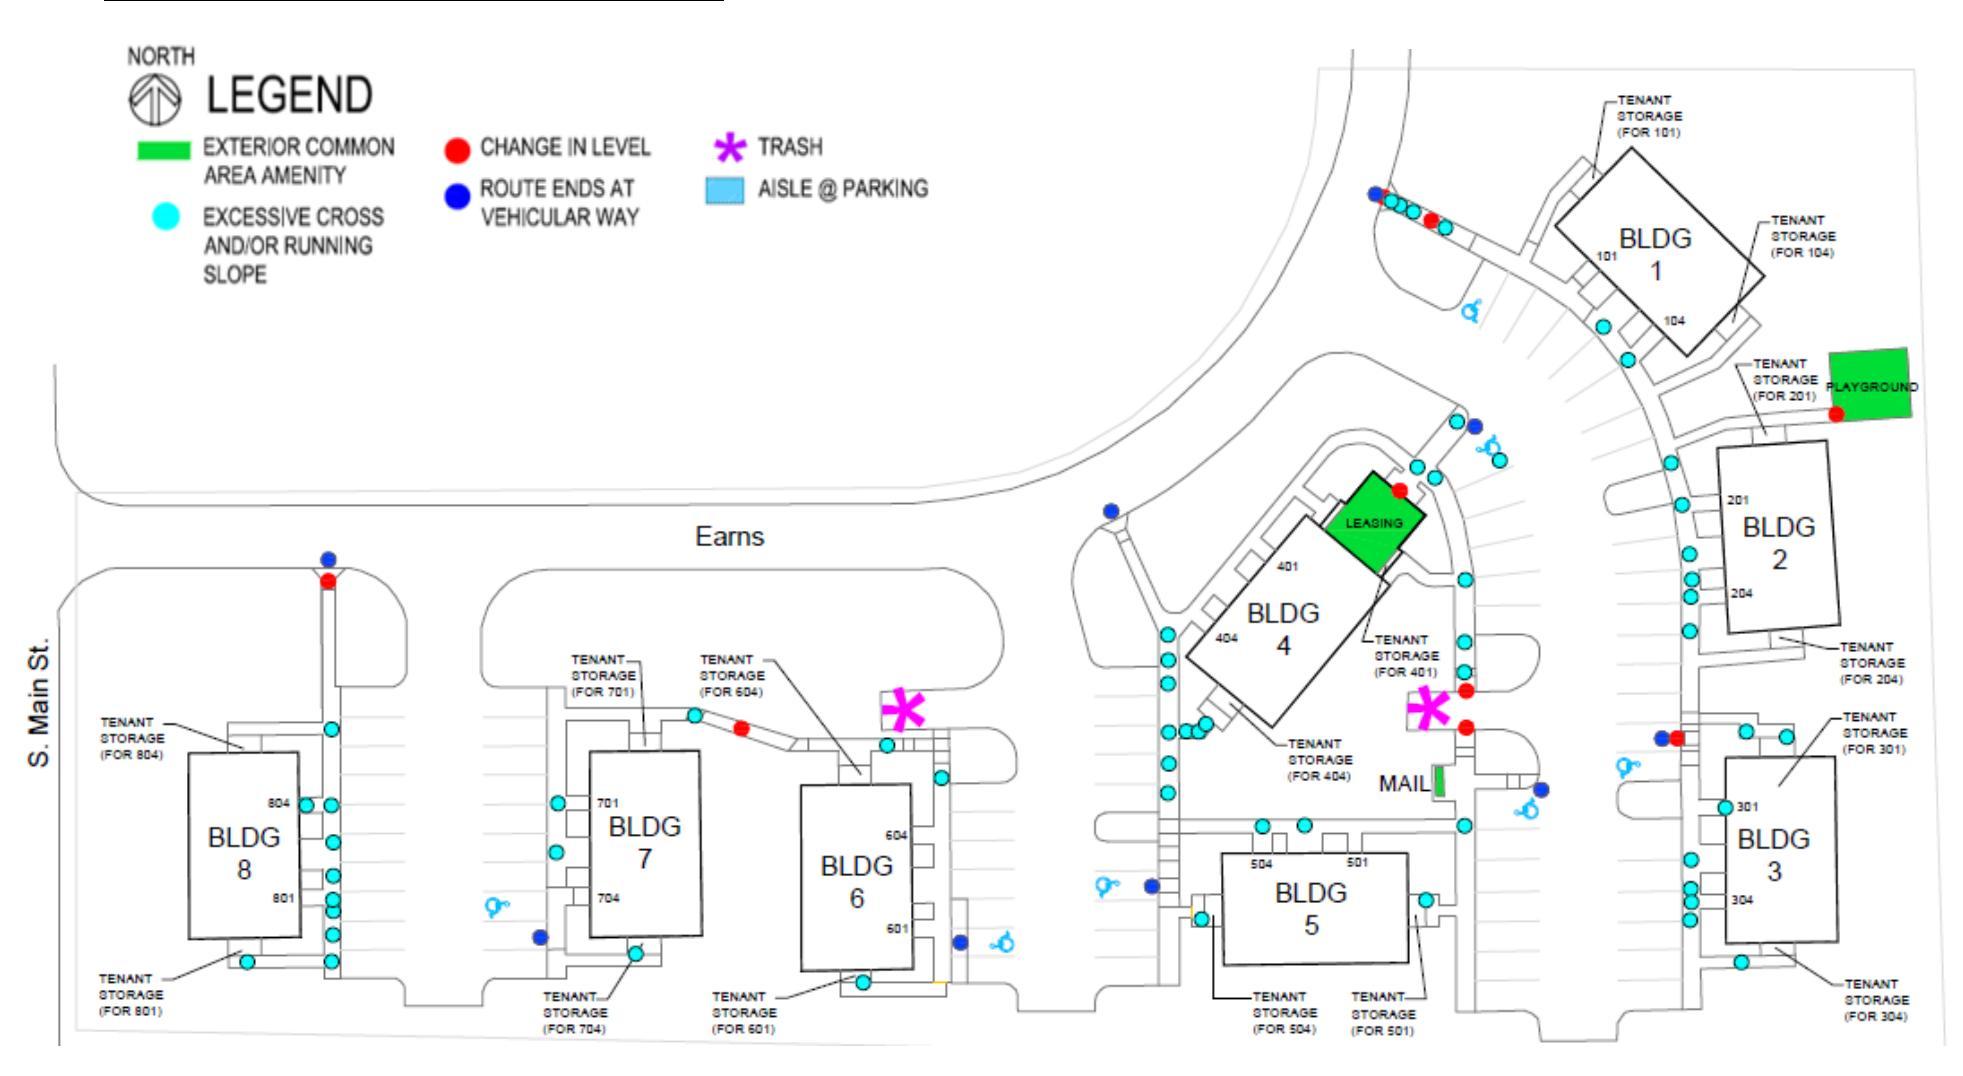
Manor Ridge Apartments Retrofit Plan - 9

Lack of Accessible Route/Inaccessible Width		
9	See map diagrams.	There is no accessible route from covered dwelling units to common area buildings, site arrival points, leasing office, and exterior common areas and amenities (routes required).	Replace concrete as required to retrofit sections with excessive cross slope. Repave/overlay asphalt at parking spaces and access aisles. Restripe parking spaces and access aisles.
10	Sidewalk south of Building 6.	The route south of Building 6 has vegetation overhanging the sidewalk and the clear width is 24 inches (minimum 36 inches required).	Trim vegetation.

Weasurement of sidewalk width. State Close up of tape.		
	Inaccessible Changes in Level		
11		The route has changes in level greater than 1/2 inch (maximum 1/2 inch with bevel allowed). Height Location (inches) West of Building 1 at curb 1-1/4 of Earns	Replace, bevel, or grind the edge of concrete as required to retrofit sections with excessive cross slope.

Curb ramp west of Building 1 at Earns. Measurement of change in level.	West of Building 1, east of curb ramp at Earns End of walk at playground Northwest of Building 3 at parking Dumpster apron at mail center Dumpster apron at walk to Building 4 North of Building 8 at top of curb ramp at Earns	1/2 no bevel 1-3/4 3/4 1 1/2 no bevel	
	Inaccessible Gaps in Route			
12	For the set of Building 2	Gaps in the pavement are wider (maximum 1/2 inch allowed).	Gap (inches) 3/4 1 1-1/8 3/4 1-1/8 1 1-1/8	Fill gaps flush with walk surfaces.

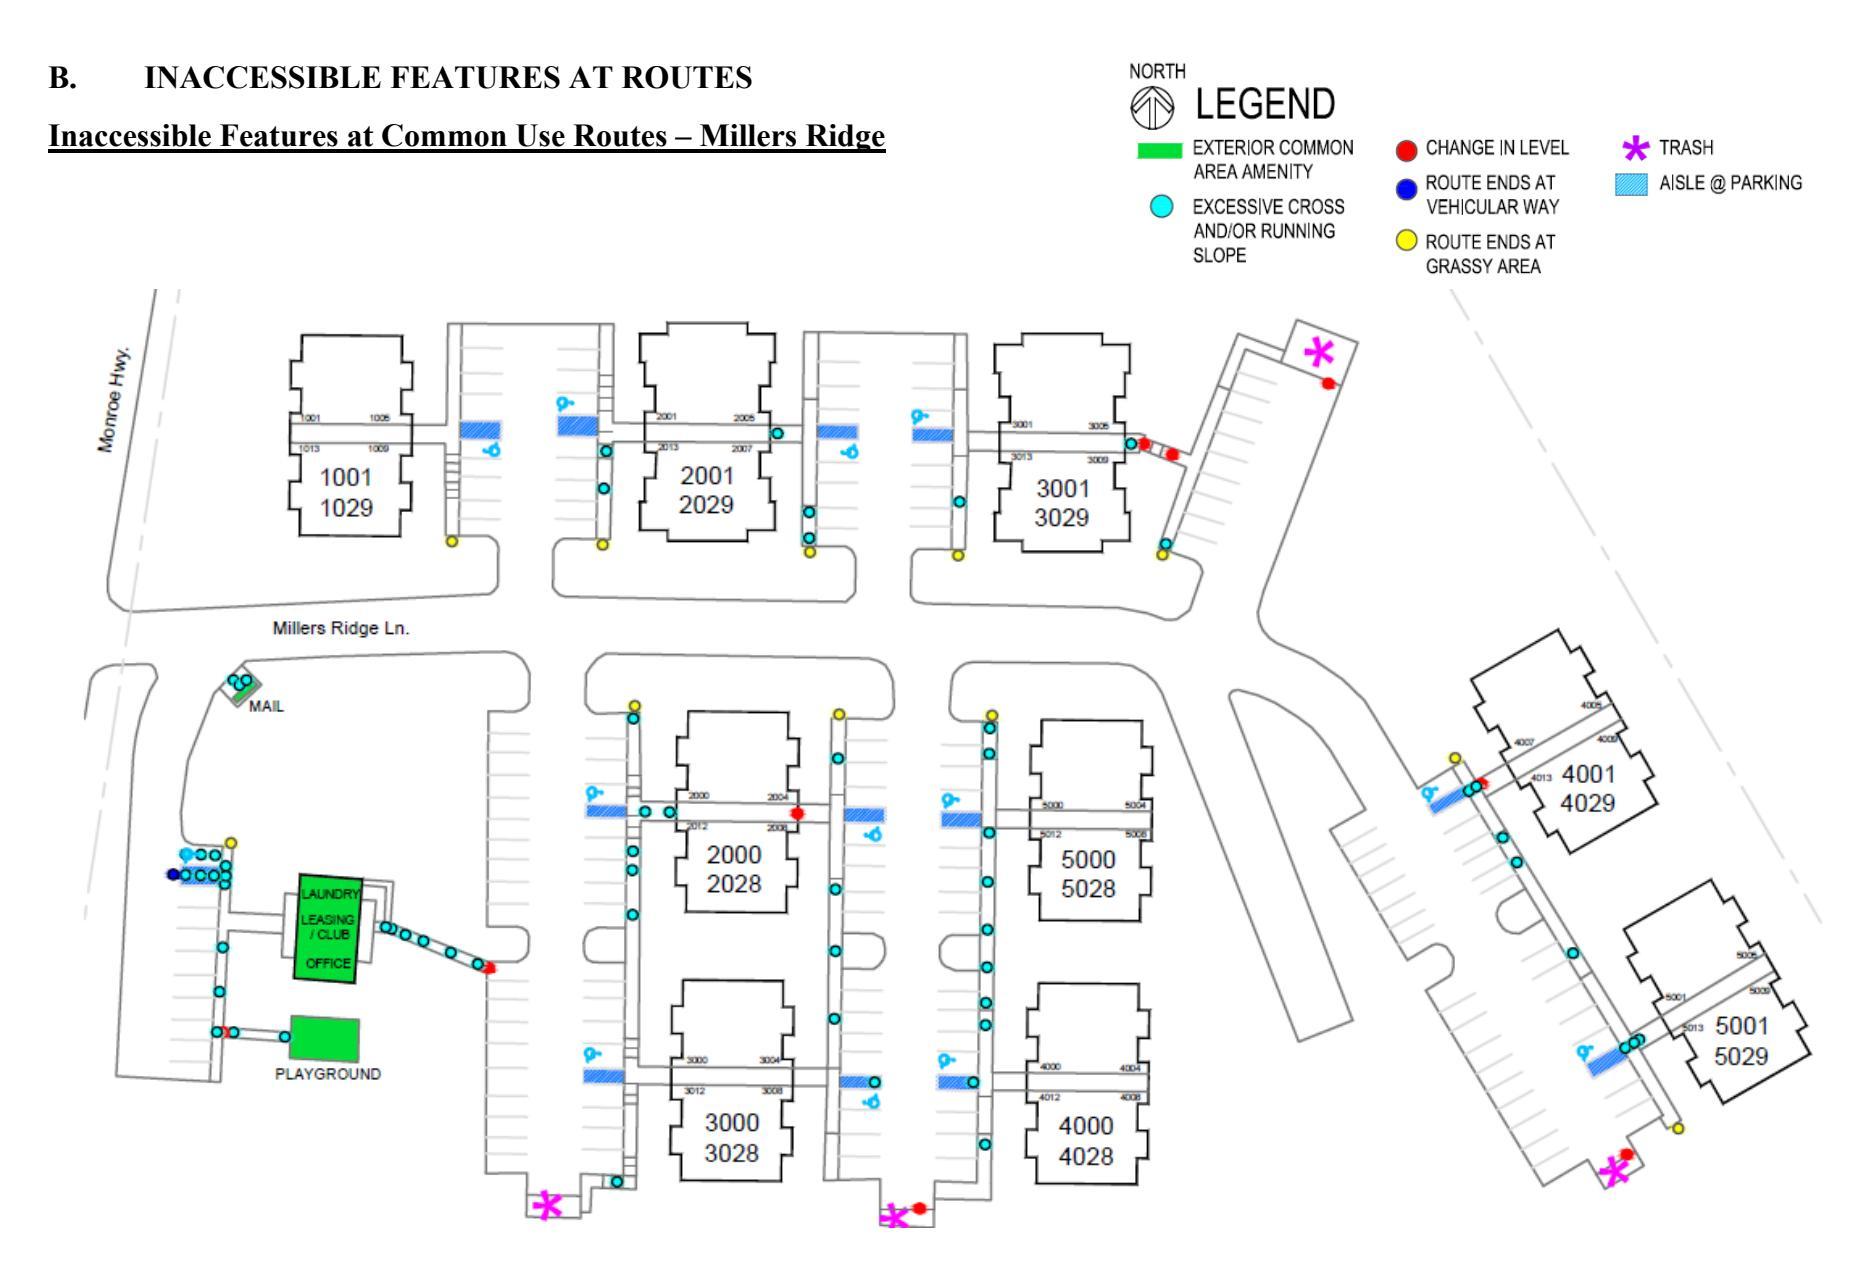
Millers Ridge Apartments Retrofit Plan - 10

Inaccessible Change in Level		
11	Dumpster east of 3001-3029. Measurement of curb.	The route has changes in level greater than1/4 inch (maximum 1/4 inch allowedwithout a bevel and 1/2 inch with a bevel).HeightLocation(inches)Playground entrance3/4West of 4001-40293/4	Replace or grind paving at playground entrance, location west of 4001-4029, and approach to trash south of 5001-5029 as required to provide a route that is free of changes in level.
11a	<i>Dumpster east of 3001-3029</i> .	The route has changes in level greater than 1/4 inch (maximum 1/4 inch allowed without a bevel and 1/2 inch with a bevel) at trash areas. <u>Height</u> <u>Location (inches)</u> Trash east of 3001-3029 5-3/4 Trash south of 5001-5029 3/4 Trash south of 4000-4028 6-1/4	 Provide new curb ramp and route to trash dumpsters south of 5001-5029 and south of 4000-4028. Relocate the trash dumpster east of 3001-3029 to the parking area between 2001-2029 and 3001-3029. Provide accessible route to the new location. Note: alternate locations for the trash north of Millers Ridge Lane may be considered. Submit any revisions for approval prior to beginning design or construction.

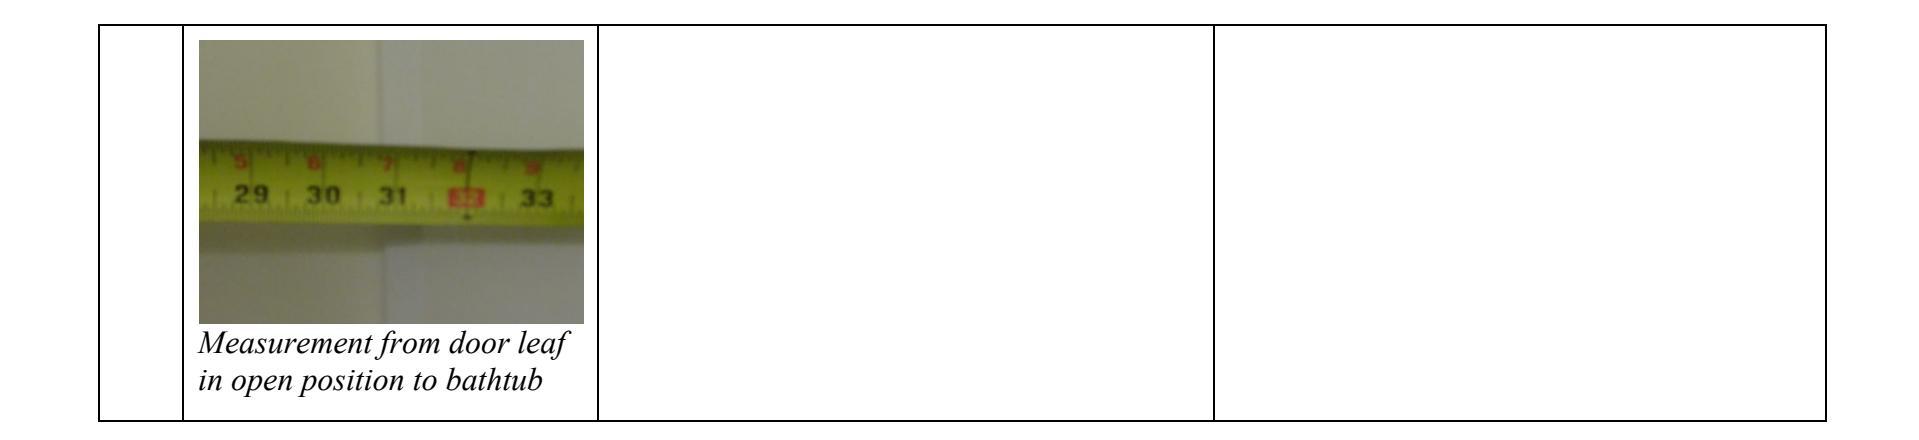
Vanity base interior in Unit 1005.		
25	Bathroom door leaf in open position at Unit 1005.	The clear floor space in the bathroom is less than 48-inches long (minimum 48-inches required).DistanceLocation (inches)Unit 100530-7/8Unit 300431-3/8	Reverse the door so that it does not swing into the bathroom.

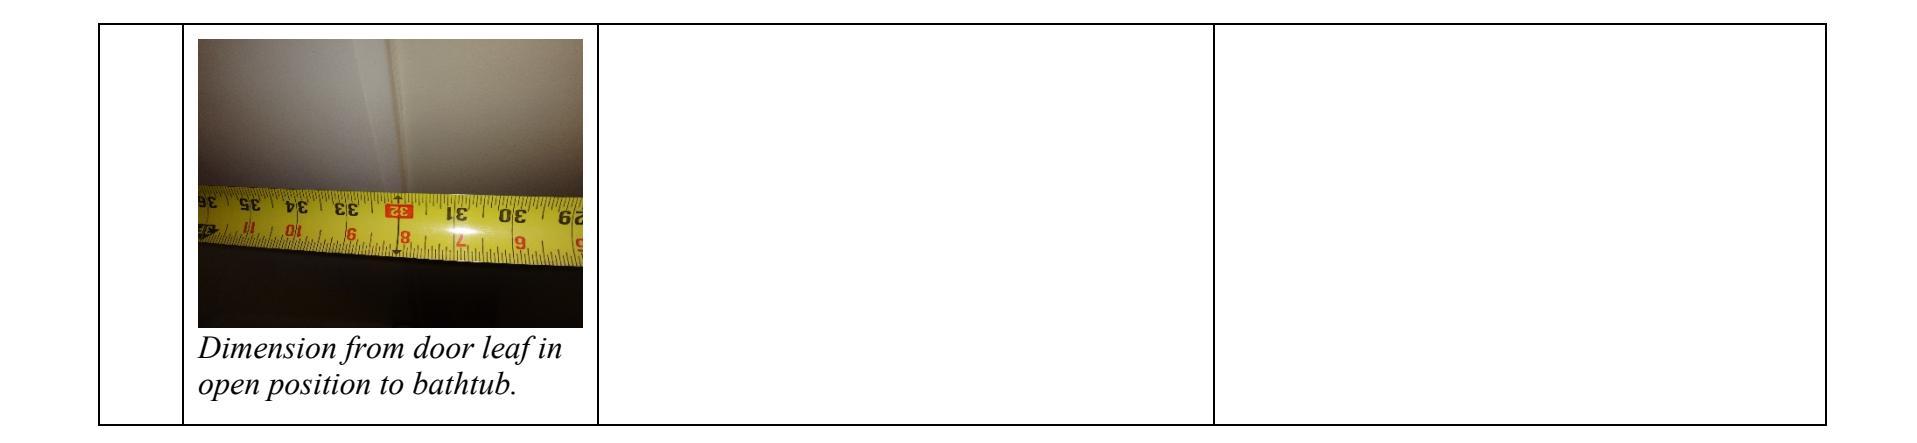
36	Measurement to hall bathroom toilet centerline in Unit 2001	Toilet centerlines are less than 18 inches to the bathtub on the side opposite the direction of approach (minimum 18 inches required). Distance Location (inches) Unit 2001 master bathroom 12-1/4	Install offset flange at master bathroom to shift toilet centerline to a position as close to 18 inches from the tub as is possible without requiring changes to the waste line or flooring.
37	Bathroom door leaf in open position at Unit 2001.	The clear floor space in the bathroom is less than 48 inches long (minimum 48-inches required).Length Location (inches) Unit 2001 hall bathroom 32 Unit 2001 master bathroom 24-3/8 Unit 2005 hall bathroom 32	Reverse the door so that it does not swing into the bathroom.
