APPENDIX D
RETROFIT PLAN FOR AZALEA GARDENS APARTMENTS

ACCESSIBLE ROUTE DIAGRAM

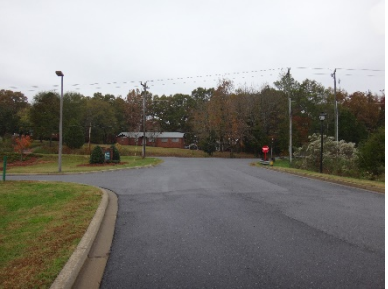
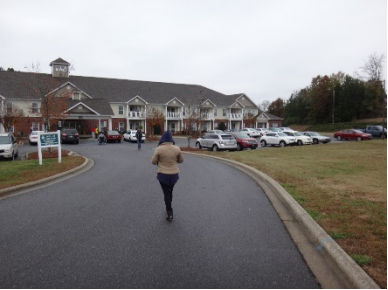
Lack of Accessible Route		
1

<p><i>Route along drive lane looking towards street.</i></p>

<p><i>Route along drive lane looking towards building.</i></p>	<p>There is no accessible route between the public street, public right-of-way, pedestrian site arrival points, and the accessible building entrance.</p>	<p>Provide new sidewalk and curb ramps from Cowell Farm Rd. along Pond Ridge Lane to the existing walk east of the main building entry (see diagram).</p>

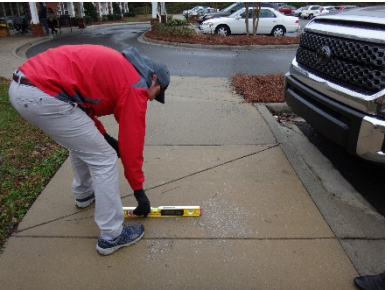
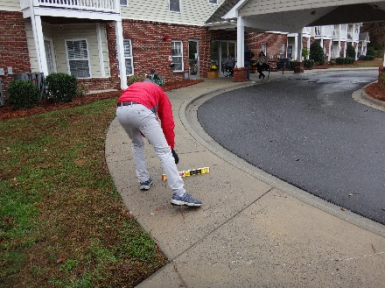
Inaccessible Features at Public Route & Entry																				
2

<p><i>Curb ramp measurement location.</i></p>

<p><i>Cross slope.</i></p>

<p><i>Route at east side of front door</i></p>	<p>Cross slopes at sidewalks are more than 2.0% (maximum 2.0% allowed).</p>

<u>Location</u>	<u>Slope</u>	Northeast of building, west of the curb ramp	4.2%	Northeast of building west of the curb ramp	3.2%	Northeast of building west of the curb ramp	4.2%	Crossing east curb ramp	4.2%	Walk at east circle drive	3.1%	Walk at east circle drive	3.6%	Walk at east circle drive	4.7%	East of building entry	3.9%	<p>Replace existing curb ramps and sidewalks at east and west parking spaces. Replace sidewalk sections at entry area and east side of the drop-off area.</p>
<u>Location</u>	<u>Slope</u>																				
Northeast of building, west of the curb ramp	4.2%																				
Northeast of building west of the curb ramp	3.2%																				
Northeast of building west of the curb ramp	4.2%																				
Crossing east curb ramp	4.2%																				
Walk at east circle drive	3.1%																				
Walk at east circle drive	3.6%																				
Walk at east circle drive	4.7%																				
East of building entry	3.9%

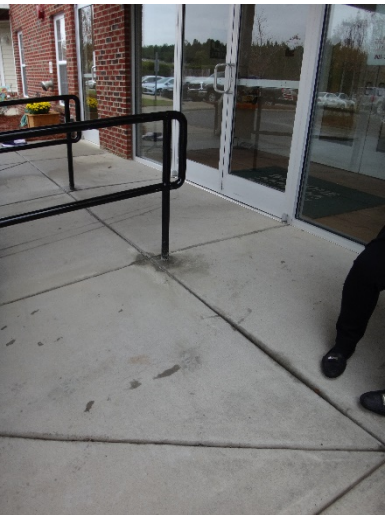
<p><i>Cross slope.</i></p>		
3

<p><i>Entrance door location.</i></p>

<p><i>Slope at entrance door approach.</i></p>	<p>Building main entrance doors have maneuvering clearances slopes as high as 4.9% to 7.3% (maximum 2% allowed).</p>	<p>Replace concrete at approach to entry door area. Coordinate with new concrete noted in Item 2 above.</p>

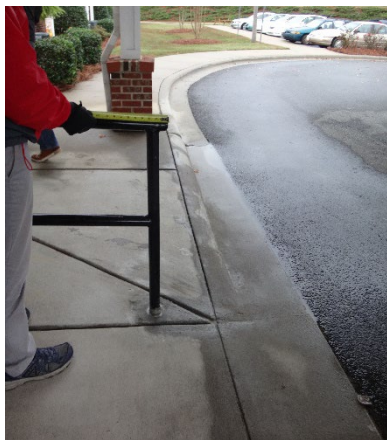
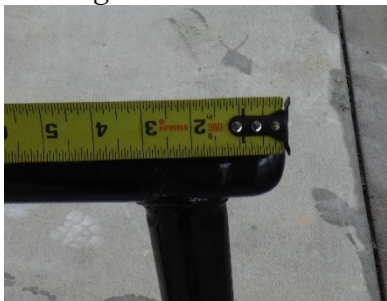
Handrail at ramp leading to building entrance.

The ramp handrails at the main entry extend less than 12 inches beyond the ramp surface (minimum 12 inches required).

<u>Location</u>	<u>(inches)</u>
Entrance ramp	1-1/2
Entrance ramp	1-1/4
Entrance ramp	4
Entrance ramp	4

Remove handrails. Confirm that rise is 6 inches or less.

Note: if ramp rise exceeds 6 inches or if handrails are desired by property management, install new handrails with 12 inch extensions.

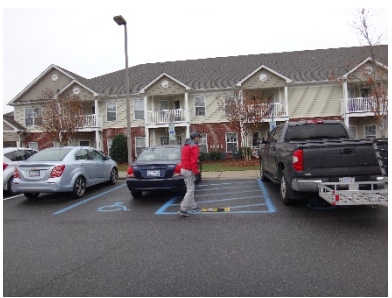
<p>5</p>

<p><i>Parking aisle location</i></p>

<p><i>Running slope at parking aisle.</i></p>	<p>Designated van accessible parking access aisle has slopes greater than 2.0% (maximum 2% allowed).</p> <table border="1" data-bbox="701 354 1136 548"> <thead> <tr> <th><u>Location</u></th> <th><u>Slope</u></th> </tr> </thead> <tbody> <tr> <td>Van Space (near foot of aisle)</td> <td>3.7%</td> </tr> <tr> <td>Van Space (2 locations)</td> <td>3.4%</td> </tr> </tbody> </table>	<u>Location</u>	<u>Slope</u>	Van Space (near foot of aisle)	3.7%	Van Space (2 locations)	3.4%	<p>Repave/overlay asphalt at parking space and access aisle. Restripe parking space and access aisle.</p>
<u>Location</u>	<u>Slope</u>							
Van Space (near foot of aisle)	3.7%							
Van Space (2 locations)	3.4%							
<p>6</p>

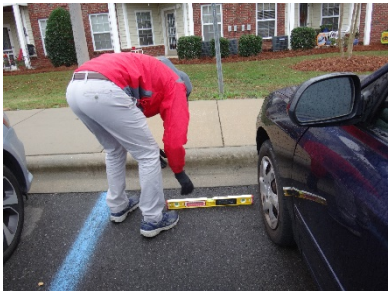
<p><i>Parking space location.</i></p>

<p><i>Running slope at parking space.</i></p>	<p>Designated van accessible parking space has slopes greater than 2.0% (maximum 2% allowed).</p> <table border="1" data-bbox="701 894 1136 1008"> <thead> <tr> <th><u>Location</u></th> <th><u>Slope</u></th> </tr> </thead> <tbody> <tr> <td>Van Space</td> <td>3.3%</td> </tr> <tr> <td>Van Space</td> <td>4.2%</td> </tr> </tbody> </table>	<u>Location</u>	<u>Slope</u>	Van Space	3.3%	Van Space	4.2%	<p>Repave/overlay asphalt at parking space and access aisle. Restripe parking space and access aisle.</p>

<u>Location</u>	<u>Slope</u>							
Van Space	3.3%							
Van Space	4.2%

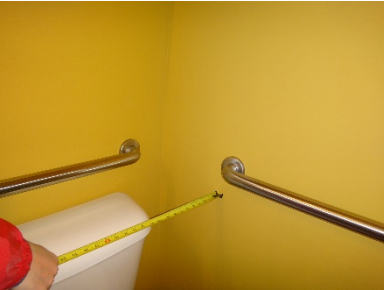
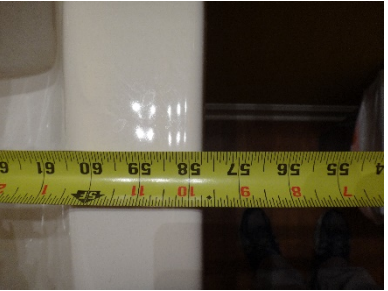
Inaccessible Restroom Features		
7

<p><i>Dimension from toilet side wall to vanity.</i></p>

<p><i>Dimension from toilet side wall to vanity.</i></p>	<p>Clear space at the toilet clearance is 57-3/4 inches wide (minimum 60 inches by 56 inches required by 2010 ADA).</p>	<p>Relocate/replace lavatory as required to provide 60 inch wide clear space at toilet.</p>

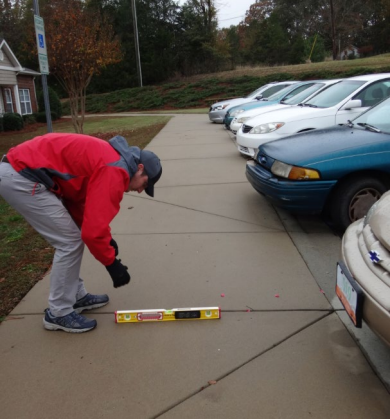
Inaccessible Cross Slopes														
8

<p><i>Location of cross slope condition northwest of building.</i></p>

<p><i>Cross slope.</i></p>	<p>Cross slopes at sidewalks and curb ramps are more than 2.0% (maximum 2.0% allowed).</p>

<table><tr> <th><u>Location</u></th> <th><u>Slope</u></th> </tr><tr> <td>Northwest of building, east of the curb ramp</td> <td>4.4%</td> </tr><tr> <td>Crossing west curb ramp</td> <td>4.0%</td> </tr><tr> <td>Northwest of building, west edge of the curb ramp</td> <td>3.9%</td> </tr><tr> <td>Sidewalk south of building to door east of picnic area</td> <td>4.1%</td> </tr><tr> <td>Sidewalk south of building to door east of picnic area</td> <td>3.7%</td> </tr></table>

<p>Replace sidewalks and curb ramps at accessible route(s) as required to retrofit sections with excessive cross slopes.</p>	<u>Location</u>	<u>Slope</u>	Northwest of building, east of the curb ramp	4.4%	Crossing west curb ramp	4.0%	Northwest of building, west edge of the curb ramp	3.9%	Sidewalk south of building to door east of picnic area	4.1%	Sidewalk south of building to door east of picnic area	3.7%
<u>Location</u>	<u>Slope</u>													
Northwest of building, east of the curb ramp	4.4%													
Crossing west curb ramp	4.0%													
Northwest of building, west edge of the curb ramp	3.9%													
Sidewalk south of building to door east of picnic area	4.1%													
Sidewalk south of building to door east of picnic area	3.7%

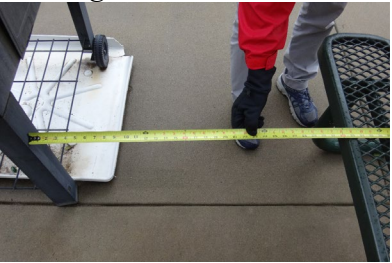
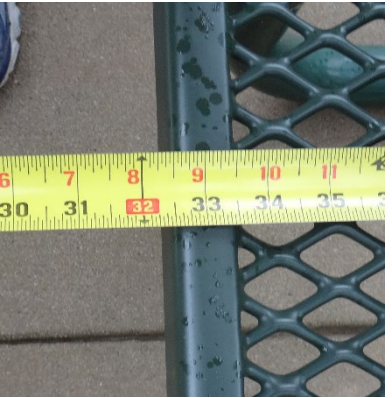
Width of Route								
9

<p><i>Picnic/grill area.</i></p>

<p><i>Route between grill and picnic table.</i></p>

<p><i>Width between grill and table.</i></p>	<p>The clear width of the route at the picnic area grill is 27 inches (minimum 36 inches required).</p> <p>Grill lacks 30 inch by 48 inch clear floor space for approach and use of the amenity (clear floor space is required).</p>

<table><tr> <th data-bbox="703 610 1024 643"><u>Location</u></th> <th data-bbox="1083 570 1192 643"><u>Width (inches)</u></th> </tr><tr> <td data-bbox="703 651 1024 721">Width between grill and table</td> <td data-bbox="1083 651 1192 683">32-1/2</td> </tr><tr> <td data-bbox="703 729 1024 799">Width between grill tray and table</td> <td data-bbox="1083 729 1192 761">27</td> </tr></table>

<u>Location</u>	<u>Width (inches)</u>	Width between grill and table	32-1/2	Width between grill tray and table	27	Relocate the picnic grill.
<u>Location</u>	<u>Width (inches)</u>								
Width between grill and table	32-1/2								
Width between grill tray and table	27

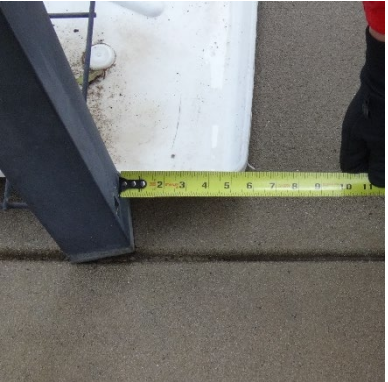
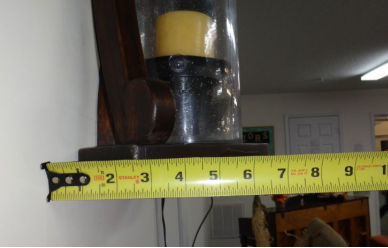
<p><i>Tray extends beyond the face of the grill.</i></p>		
	<p>Protruding Objects</p>		
<p>10</p>

<p><i>Depth of projection.</i></p>	<p>Clubroom wall brackets project 6-1/2 inches into the circulation path at a height of 60 inches above the floor (maximum 4 inches allowed at heights greater than 27 inches and less than 80 inches above the circulation path).</p>	<p>Remove decorative brackets.</p>

<p><i>Location of brackets.</i></p>

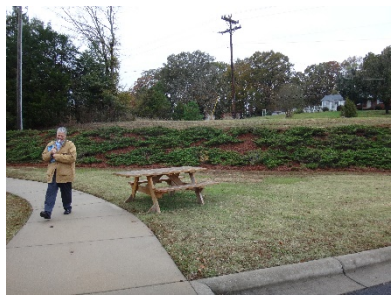
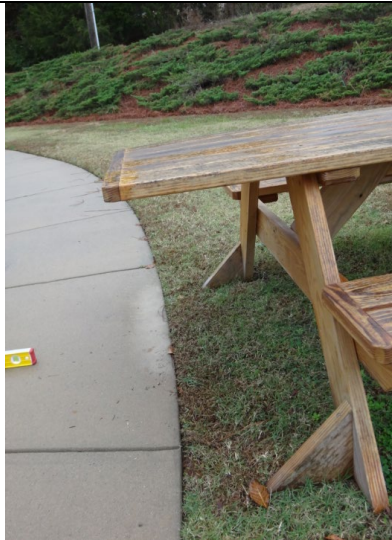
Inaccessible Common Area Feature		
11

<p><i>Picnic table along sidewalk west of building.</i></p>	<p>The route to the east end of the north picnic table is not stable, firm and slip resistant. The clear space at the west end of the picnic table is partly paved and partly grass with a level change at the change of material. There is no seat or access to this amenity.</p>	<p>Install concrete slab under picnic table area.</p>

Close up of west end seating space overhanging sidewalk.

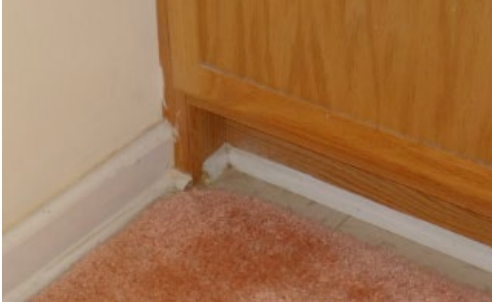
Note: Lavatory and sink cabinets in the standard units have varying conditions some of which have cleats added for knee space panels. However, the cabinets do not seem to be removable and, in many units, the trim at the base continues around the toe kick even where cleats have been added. The cabinets are not removable without the use of specialized tools or knowledge.

Base trim across the toe kick at the lavatory base, Unit 109. (0705.jpg).

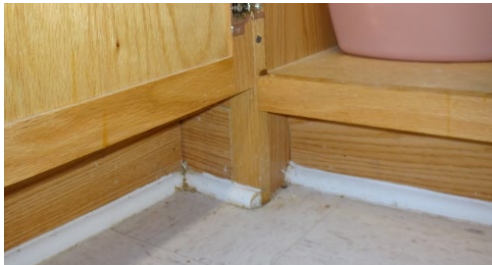
Base trim across the toe kick at the sink base, Unit 204. (0777.jpg).

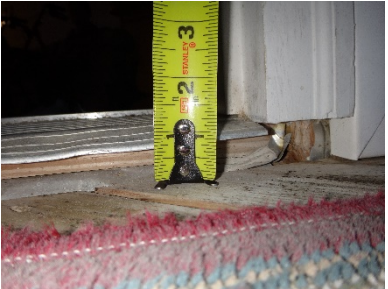
<p>12</p>

<p><i>Patio door threshold interior side at Unit 204</i></p>	<p>Patio door interior threshold is 3/4 inches high at the front edge and is not beveled (maximum 1/4 inch vertical edge allowed with no bevel). The overall height of the threshold is 1-3/8 inches (maximum 3/4 inch height allowed).</p>	<p>Provide beveled transition strip or offer remediation upon request of tenants. If offered on tenant request, a durable-material placard, contrasting black text on white background, in minimum 14-point font, must be placed on the side of the patio door stating: “A BEVEL TO ASSIST PERSONS WITH DISABILITIES FOR THIS</p>
---	---	---

THRESHOLD IS AVAILABLE UPON REQUEST. CONTACT MANAGEMENT.”						
13

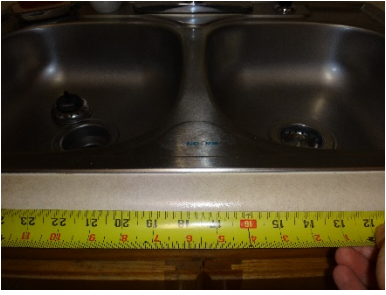
<p><i>Sink in Unit 105.</i></p>	<p>Kitchen sink centerlines are less than 24 inches to the adjacent countertop (minimum 24 inches required) and the base cabinet is not removable.</p>

<table><tr> <th><u>Location</u></th> <th><u>Centerline (inches)</u></th> </tr><tr> <td>Unit 105, kitchen</td> <td>17-3/4</td> </tr><tr> <td>Unit 204, kitchen</td> <td>17-1/2</td> </tr></table>

<u>Location</u>	<u>Centerline (inches)</u>	Unit 105, kitchen	17-3/4	Unit 204, kitchen	17-1/2	<p>Install removable base with 30 inch wide knee space in compliance with safe harbor knee and toe clearance requirements.</p> <p>Attach a durable-material placard stating: “THIS CABINET IS REMOVABLE FOR PERSONS WITH DISABILITIES. CONTACT MANAGEMENT.”</p>
<u>Location</u>	<u>Centerline (inches)</u>								
Unit 105, kitchen	17-3/4								
Unit 204, kitchen	17-1/2

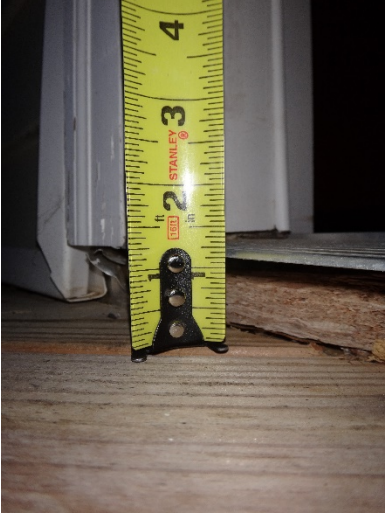
<p>14</p>

<p><i>Patio door threshold interior side at Unit 214.</i></p>	<p>Patio door interior threshold is 1-1/8 inches high at the front edge and is not beveled (maximum 1/4 inch vertical edge allowed with no bevel). The overall height of the threshold is 1-3/8 inches (maximum 3/4 inch height allowed).</p>	<p>Provide beveled transition strip or offer remediation upon request of tenants. If offered on tenant request, a durable-material placard, contrasting black text on white background, in minimum 14-point font, must be placed on the side of the patio door stating: “A BEVEL TO ASSIST PERSONS WITH DISABILITIES FOR THIS THRESHOLD IS AVAILABLE UPON REQUEST. CONTACT MANAGEMENT.”</p>						
<p>15</p>

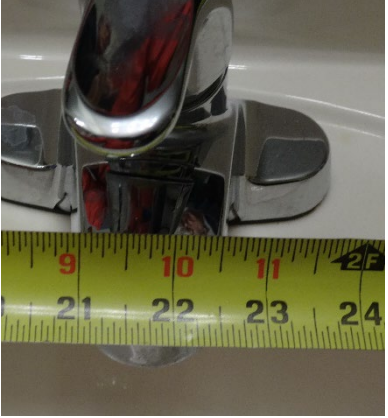
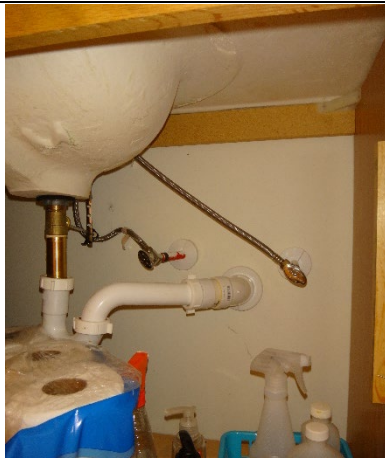
<p><i>Center line of lavatory, Unit 214.</i></p>	<p>Lavatory centerlines are less than 24 inches to the side wall (minimum 24 inches required) and the cabinets are not removable.</p>

<table><tr> <th><u>Location</u></th> <th><u>Distance (inches)</u></th> </tr><tr> <td>Unit 109, master bathroom</td> <td>18-1/2</td> </tr><tr> <td>Unit 214, master bathroom</td> <td>18-1/4</td> </tr></table>

Base cabinet interior of lavatory in Unit 214.

Base cabinet of lavatory in Unit 214.

<u>Location</u>	<u>Distance (inches)</u>	Unit 109, master bathroom	18-1/2	Unit 214, master bathroom	18-1/4	<p>Install removable base with 30 inch wide knee space in compliance with safe harbor knee and toe clearance requirements.</p> <p>Attach a durable-material placard stating: “THIS CABINET IS REMOVABLE FOR PERSONS WITH DISABILITIES. CONTACT MANAGEMENT.”</p>
<u>Location</u>	<u>Distance (inches)</u>								
Unit 109, master bathroom	18-1/2								
Unit 214, master bathroom	18-1/4

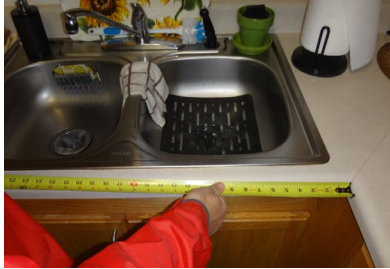
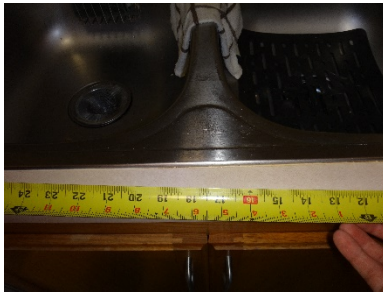
16

Kitchen sink.

Sink centerline, Unit 109.

Kitchen sink centerlines are less than 24 inches to the adjacent countertop (minimum 24 inches required) and the base cabinet is not removable.

<u>Location</u>	<u>Centerline (inches)</u>
Unit 109, kitchen	17-1/2
Unit 214, kitchen	similar

Install removable base with 30 inch wide knee space in compliance with safe harbor knee and toe clearance requirements.

Attach a durable-material placard stating: "THIS CABINET IS REMOVABLE FOR PERSONS WITH DISABILITIES. CONTACT MANAGEMENT."
