Exhibit 1.3

Milburnie Road Matrix of Required Retrofits to Covered Unit Interiors

MILBURNIE ROAD APARTMENTS: COVERED UNIT INTERIORS

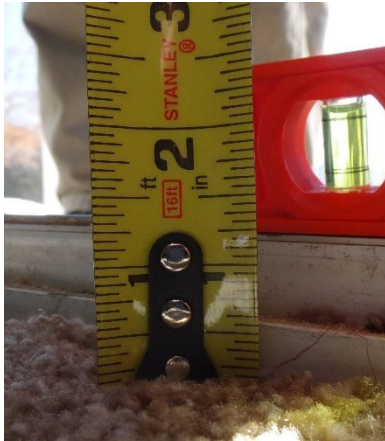
</div> <p><i>Patio door threshold at Unit 103, Building 2.</i></p>	<p>Door thresholds are more than 3/4 inch high and are not beveled (maximum 3/4 inch with bevel allowed).</p>

<table><tr><th>Height</th><th>Location</th><th>(inches)</th></tr><tr><td>1-1/4</td><td>Unit 103, Building 2 Patio interior side</td><td></td></tr><tr><td>1-3/8</td><td>Unit 101, Building 6 Patio interior side</td><td></td></tr><tr><td>1-3/8</td><td>Unit 101, Building 6 Storage exterior side</td><td></td></tr></table>

Height	Location	(inches)	1-1/4	Unit 103, Building 2 Patio interior side		1-3/8	Unit 101, Building 6 Patio interior side		1-3/8	Unit 101, Building 6 Storage exterior side		<p>Modify door thresholds to comply with Requirement 4(4).</p>
Height	Location	(inches)													
1-1/4	Unit 103, Building 2 Patio interior side														
1-3/8	Unit 101, Building 6 Patio interior side														
1-3/8	Unit 101, Building 6 Storage exterior side

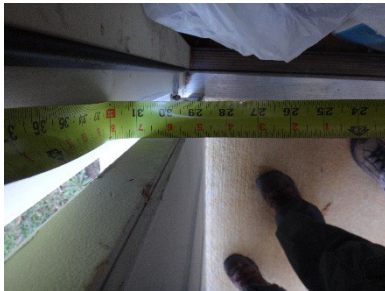
<p><i>Clear opening at storage closet door.</i></p>	<p>Doors at patios and storage closets have clear openings less than 31-5/8 inches wide (minimum 31-5/8 inch required).</p>

<table><tr><th>Location</th><th>Clear Width (inches)</th></tr><tr><td>Unit 103, Building 2 Patio door</td><td>30-1/2</td></tr><tr><td>Unit 103, Building 2 Storage door (approx.)</td><td>29-1/2</td></tr><tr><td>Unit 101, Building 6 Patio door</td><td>30-5/8</td></tr><tr><td>Unit 101, Building 6 Storage door</td><td>29-1/2</td></tr></table>

Location	Clear Width (inches)	Unit 103, Building 2 Patio door	30-1/2	Unit 103, Building 2 Storage door (approx.)	29-1/2	Unit 101, Building 6 Patio door	30-5/8	Unit 101, Building 6 Storage door	29-1/2	<p>For sliding door, trim door stop to provide 31 5/8" to comply with Requirement 3(2). For storage door, modify door on-request to comply with Requirement 3(2).</p>
Location	Clear Width (inches)												
Unit 103, Building 2 Patio door	30-1/2												
Unit 103, Building 2 Storage door (approx.)	29-1/2												
Unit 101, Building 6 Patio door	30-5/8												
Unit 101, Building 6 Storage door	29-1/2												
31

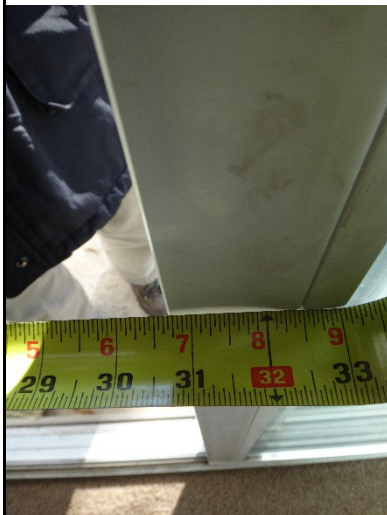
</div> <p><i>Clear patio door opening.</i></p>	<p>Patio and storage closet door clear opening widths are less than 31-5/8 inches (minimum 31-5/8 inch required).</p> <table><thead><tr><th>Location</th><th>Clear Width (inches)</th></tr></thead><tbody><tr><td>Unit 102, Building 3 Patio door</td><td>30-3/4</td></tr><tr><td>Unit 104, Building 3 Patio door</td><td>30-1/2</td></tr></tbody></table>	Location	Clear Width (inches)	Unit 102, Building 3 Patio door	30-3/4	Unit 104, Building 3 Patio door	30-1/2	<p>For sliding door, trim door stop to provide 31 5/8" to comply with Requirement 3(2). For storage door, modify door on-request to comply with Requirement 3(2).</p>		
Location	Clear Width (inches)										
Unit 102, Building 3 Patio door	30-3/4										
Unit 104, Building 3 Patio door	30-1/2

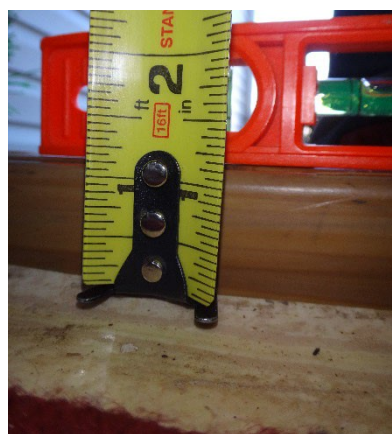
<p>Door thresholds are more than 3/4 inches high at the interior face and are not beveled (maximum 3/4 inch with bevel allowed).</p> <p><u>Location</u></p>

<table><tr><td>Unit 101, Building 2</td><td>1-1/8</td></tr><tr><td>Entry interior side</td><td></td></tr><tr><td>Patio interior side</td><td></td></tr><tr><td>Unit 101, Building 2</td><td>3/4</td></tr><tr><td>Storage exterior side</td><td></td></tr></table>

Entry door threshold interior side at Unit 101, Building 2.

Unit 101, Building 2	1-1/8	Entry interior side		Unit 101, Building 2	1-1/8	Patio interior side		Unit 101, Building 2	3/4	Storage exterior side		<p>Install a bevel at 1:2 on the interior side of the sliding door. Accept proposed fix for entry door and on-request for storage door.</p>
Unit 101, Building 2	1-1/8														
Entry interior side															
Unit 101, Building 2	1-1/8														
Patio interior side															
Unit 101, Building 2	3/4														
Storage exterior side

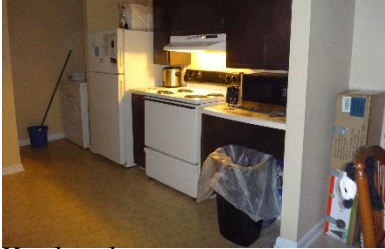
<p><i>Kitchen layout.</i></p>

<p><i>Clear floor space obstructed by adjacent refrigerator and range. Unit 101, Building 2.</i></p>	The outlets above kitchen countertops lack the required clear floor space for approach. (At least 1 outlet in each counter area must have clear floor space for approach.)	Install power strip within reach range requirement.
