APPENDIX C
RETROFIT PLAN FOR COTTAGES AT AZALEA APARTMENTS

Cottages at Azalea Apartments Retrofit Plan – 2

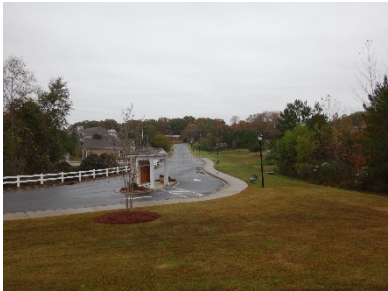
Lack of Accessible Route		
1

<p><i>Route along drive lane north of leasing office.</i></p>	There is no accessible route between pedestrian site arrival points at the public street and the leasing office (accessible route required).	Provide new sidewalk to Cowell Farm Road (northwest of the leasing office/clubhouse (see Azalea Gardens scope of work and diagram).
	Inaccessible Public Area Features		
2

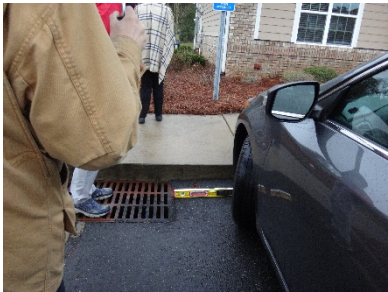
<p><i>Parking space – location of area with cross slope.</i></p>	Designated accessible parking space at the leasing office has cross slopes as high as 6.1% (maximum 2% allowed - ADA).	Repave/overlay asphalt at parking space and access aisle. Restripe parking space and access aisle or designate a new compliant accessible parking space and access aisle serving the leasing office. Location of new designated space to be as close as possible to the leasing office entry.

<p><i>Cross slope at parking space.</i></p>		
3

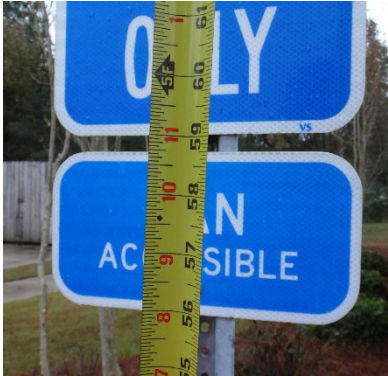
<p><i>Parking space identification sign.</i></p>	<p>The designated parking space sign at the leasing office is 56 inches above the parking surface to the bottom of the Van tag and 59 inches above the parking surface to the bottom of the parking sign above the parking surface (minimum 60 inches required).</p>	<p>Raise parking sign. Provide new post if necessary.</p>

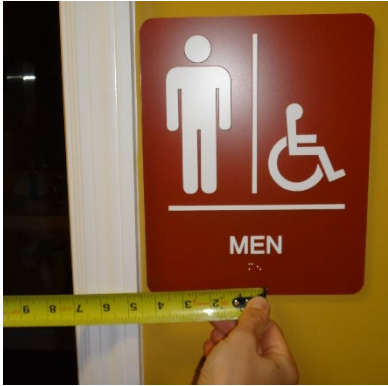
<p><i>Centerline of men's restroom sign.</i></p>	<p>The restroom signage is not centered on an 18 inch wide clear floor space (minimum 9 inches from door jamb required).</p>	<p>Relocate sign.</p>
---	--	--	-----------------------

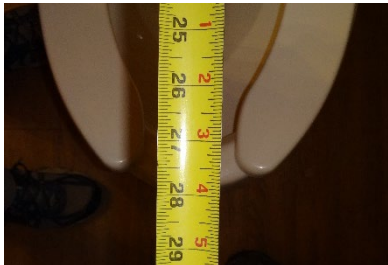
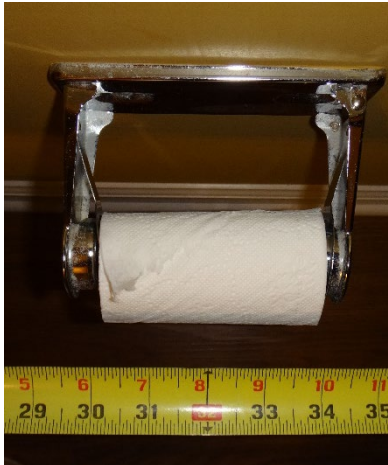
<p><i>Dimension from rear wall to nose of toilet.</i></p>

<p><i>Dimension from rear wall to toilet paper dispenser.</i></p></div>	<p>The toilet paper dispenser is less than 7 inches from the nose of the toilet (minimum 7 inches required).</p>

<u>Location</u>	<u>Distance from nose (inches)</u>	Men's	4	Women's	3-1/2	Relocate toilet paper dispensers.
<u>Location</u>	<u>Distance from nose (inches)</u>								
Men's	4								
Women's	3-1/2

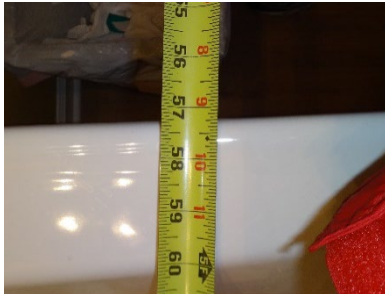
6	<p>The toilet clearance is too small (minimum 60 inches by 56 inches required by 2010 ADA).</p>

<p><i>Dimension from toilet side wall to vanity.</i></p>

<p><i>Dimension from toilet side wall to vanity</i></p>		Width	<u>Location</u>	<u>(inches)</u>	Men's	57-1/4	<p>Relocate/replace lavatory as required to provide 60 inch wide clear space at toilet.</p>
	Width							
<u>Location</u>	<u>(inches)</u>							
Men's	57-1/4

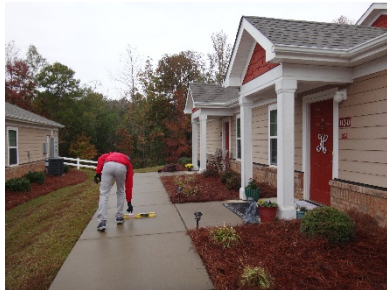
<p>Gap width.</p>	<p>Gaps in the pavement are wider than 1/2 inch (maximum 1/2 inch allowed).</p> <table><tr><td><u>Location of Example</u></td><td><u>Gap (inches)</u></td></tr><tr><td>South of Building 120</td><td>1</td></tr></table>	<u>Location of Example</u>	<u>Gap (inches)</u>	South of Building 120	1	<p>Install filler at gaps.</p>												
<u>Location of Example</u>	<u>Gap (inches)</u>																		
South of Building 120	1																		
	Inaccessible Slopes at Sidewalks																		
8

<p>Location of level, southwest of Building 112</p>	<p>The cross slopes of the route are more than 2% (maximum 2% allowed).</p> <table><tr><td><u>Location</u></td><td><u>Slope</u></td></tr><tr><td>West of Building 101</td><td>3.2%</td></tr><tr><td>Southwest of Building 105</td><td>3.3%</td></tr><tr><td>Southwest of Building 105</td><td>3.1%</td></tr><tr><td>North of Building 121</td><td>3.2%</td></tr><tr><td>Southwest of Building 112</td><td>3.2%</td></tr><tr><td>West of Building 121</td><td>3.1%</td></tr><tr><td>East of Leasing Office</td><td>3.9%</td></tr></table>	<u>Location</u>	<u>Slope</u>	West of Building 101	3.2%	Southwest of Building 105	3.3%	Southwest of Building 105	3.1%	North of Building 121	3.2%	Southwest of Building 112	3.2%	West of Building 121	3.1%	East of Leasing Office	3.9%	<p>Replace sidewalks at accessible route(s) as required to retrofit sections with excessive cross slope.</p>

<i>Cross slope.</i>	East of Leasing Office 4.0%							
	Inaccessible Slopes								
9

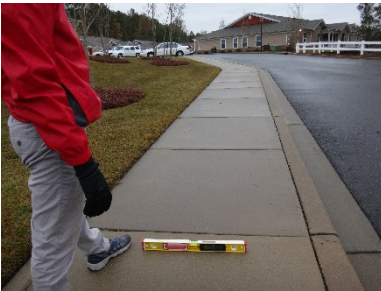
<i>Curb ramp measurement location (level positioned to measure cross slope).</i>

<i>Running slope.</i>	<p>The running slopes exceed 8.3% (maximum 8.3% allowed).</p>

<u>Location</u>	<u>Slope</u>	At old mail center on walk towards units.	9.1%	West of Building 105	9.1%	Replace sidewalks and ramps at accessible route(s) as required to retrofit sections with excessive running slope.
<u>Location</u>	<u>Slope</u>								
At old mail center on walk towards units.	9.1%								
West of Building 105	9.1%

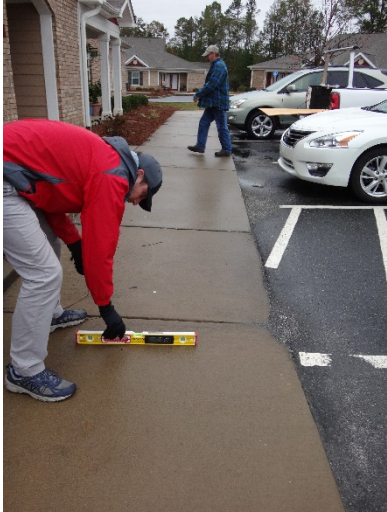
<p><i>Measurement location.</i></p>

<p><i>Cross slope.</i></p>	<p>The cross slope of the sidewalk at the curb ramp east of Building 104 is 3.1% (maximum 2.0% allowed).</p>	<p>Replace sidewalk at accessible routes as required to retrofit sections with excessive cross slope.</p>
	Crosswalks		
11	<i>See Accessible Route Diagram.</i>	<p>Crosswalks at vehicular drives are incorporated into the accessible route(s).</p>	<p>Stripe crosswalks.</p>

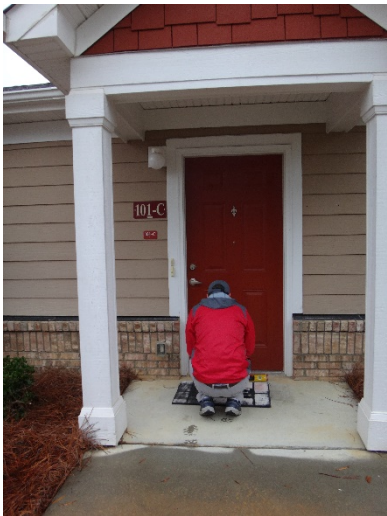
<p><i>Entrance door at Unit 101C.</i></p>

<p><i>Slope at door approach.</i></p></div>	<p>Common unit door maneuvering clearances are sloped more than 2.0% (maximum 2% allowed).</p> <table><tr><td><u>Location</u></td><td><u>Slope</u></td></tr><tr><td>Unit 101C</td><td>3.1%</td></tr></table>	<u>Location</u>	<u>Slope</u>	Unit 101C	3.1%	<p>Replace concrete at door maneuvering clear space.</p>
<u>Location</u>	<u>Slope</u>						
Unit 101C	3.1%

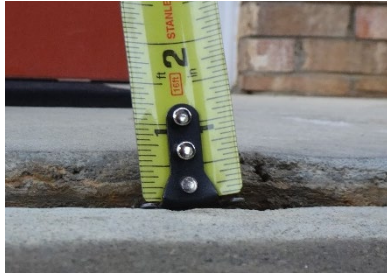
<p><i>Change in level at Unit 101D porch slab.</i></p></div>	<p>There are changes in level greater than 1/4 inch that are not beveled (maximum 1/4 inch with no bevel allowed, maximum 1/2 inch allowed with bevel).</p> <table><tr><td><u>Location of Example</u></td><td><u>Height (inches)</u></td></tr><tr><td>Unit 101D</td><td>5/8</td></tr></table>	<u>Location of Example</u>	<u>Height (inches)</u>	Unit 101D	5/8	<p>Bevel the change in level, replace concrete with raised edge, or grind the edge of concrete to make compliant.</p>
<u>Location of Example</u>	<u>Height (inches)</u>						
Unit 101D	5/8

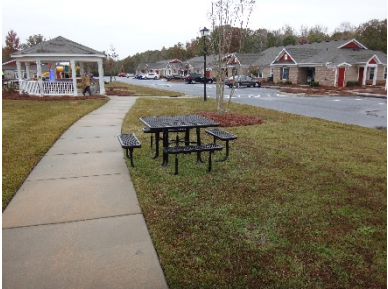
<p><i>Table located in grass area adjacent to sidewalk.</i></p>	<p>Approach to common area picnic tables are not firm, stable, and slip resistant.</p> <p><u>Location</u></p> <p>Table at common area</p> <p>Table at playground</p>	<p>Install concrete slab under picnic table areas.</p>
	Inaccessible Mail Feature		
15

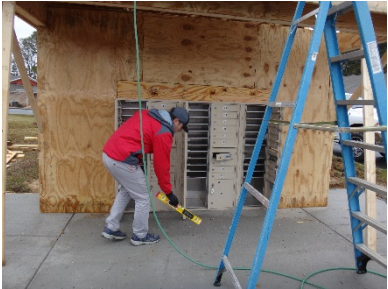
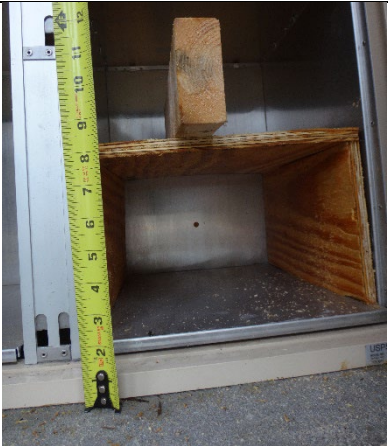
<p><i>Mailbox center.</i></p>	<p>Mailbox Center at Common Area</p> <p>Of 5 parcel boxes at this location, all have shelves located below reach range (minimum 9 inches allowed).</p>	<p>Raise bottom shelves of parcel boxes, or add two compliant parcel boxes to the mail center.</p>

<p><i>Typical height to parcel box shelf.</i></p>

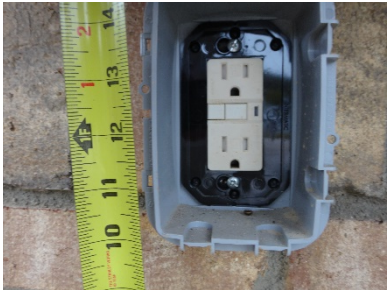
<p><i>Patio outlet at Unit 101A.</i></p>	<p>Typical Unit patio outlets are less than 15-inches above the floor (minimum 15-inches required). These outlets are for the use of unit residents, not common area outlets for use of all residents and their guests.</p>

<u>Patio Outlet</u>	<u>Height (inches)</u>	Unit 101A	11-3/8	Unit 101B	12-1/8	Unit 101C	11	Unit 101D	11	Unit 105A	11-3/4	Unit 105B	12	Unit 105C	12	Unit 105D	12-1/4	Unit 108A	12	Unit 108B	11-3/4	Unit 108C	11-3/4	Unit 108D	12-1/4	Unit 112A	11-1/2	Unit 112B	12	Unit 112C	11-3/4	Unit 112D	11-3/4	<p>Raise outlets.</p>
<u>Patio Outlet</u>	<u>Height (inches)</u>																																				
Unit 101A	11-3/8																																				
Unit 101B	12-1/8																																				
Unit 101C	11																																				
Unit 101D	11																																				
Unit 105A	11-3/4																																				
Unit 105B	12																																				
Unit 105C	12																																				
Unit 105D	12-1/4																																				
Unit 108A	12																																				
Unit 108B	11-3/4																																				
Unit 108C	11-3/4																																				
Unit 108D	12-1/4																																				
Unit 112A	11-1/2																																				
Unit 112B	12																																				
Unit 112C	11-3/4																																				
Unit 112D	11-3/4

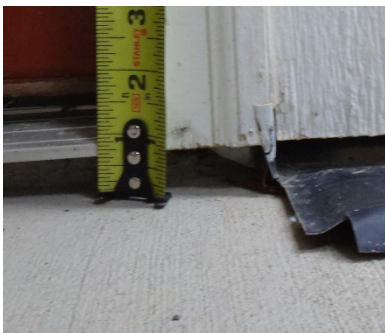
<p><i>Balcony door threshold exterior side at Unit 105A</i></p>	<p>Patio door threshold is more than 3/4 inches high at the exterior face and is not beveled (maximum 3/4 inch threshold with bevel allowed).</p> <table><tr><th><u>Location</u></th><th><u>Height (inches)</u></th></tr><tr><td>Unit 105A, balcony</td><td>1-1/4</td></tr></table>	<u>Location</u>	<u>Height (inches)</u>	Unit 105A, balcony	1-1/4	<p>Provide beveled transition strip or offer remediation upon request of tenants. If offered on tenant request, a durable-material placard, contrasting black text on white background, in minimum 14-point font, must be placed on the side of the patio door stating: “A BEVEL TO ASSIST PERSONS WITH DISABILITIES FOR THIS THRESHOLD IS AVAILABLE UPON REQUEST. CONTACT MANAGEMENT.”</p>
<u>Location</u>	<u>Height (inches)</u>						
Unit 105A, balcony	1-1/4

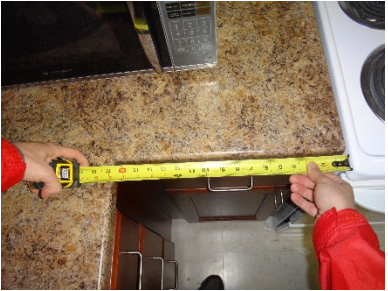
<p>18</p>	<p><i>Clear floor space obstructed by adjacent refrigerator.</i></p>

<p><i>Clear floor space obstructed by adjacent range. Unit 101A.</i></p>	<p>The outlets above kitchen countertops lack the required clear floor space for approach. Obstructions require reaches greater than 25-1/2 inches (at least 1 outlet in each counter area must have clear floor space for approach.)</p>	<p>Replace range or add outlet(s) at accessible location serving the counter area.</p>
-----------	---	---	--

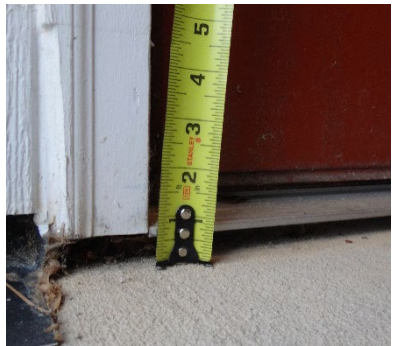
<p><i>Entrance door threshold exterior side at Unit 120B.</i></p>	<p>Door thresholds are more than 3/4 inches high at the exterior face and are not beveled (maximum 3/4 inch with bevel allowed).</p>

<u>Location</u>	<u>Height (inches)</u>	Unit 117C, storage	1-3/8	Unit 120B, entrance	1	<p>At unit entry doors: Provide beveled transition strips.</p> <p>At storage doors: Provide beveled transition strip or offer remediation upon request of tenants. If offered on tenant request, a durable-material placard, contrasting black text on white background, in minimum 14-point font, must be placed on the side of the patio door stating: “A BEVEL TO ASSIST PERSONS WITH DISABILITIES FOR THIS</p>
<u>Location</u>	<u>Height (inches)</u>								
Unit 117C, storage	1-3/8								
Unit 120B, entrance	1

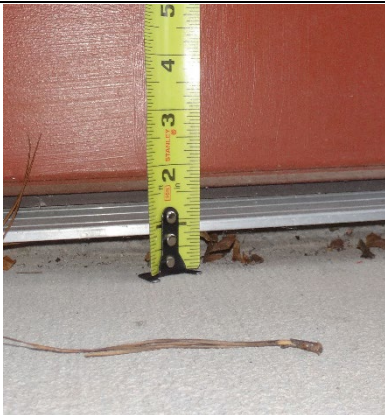
<p><i>Storage door threshold exterior side at Unit 117C.</i></p>		THRESHOLD IS AVAILABLE UPON REQUEST. CONTACT MANAGEMENT.”						
21	<p><i>Pantry closet depth in Unit 117C.</i></p>	<p>The door clear openings are less than 31-5/8 inches at pantries and closets which are more than 24 inches deep (minimum 31-5/8 inch required).</p>

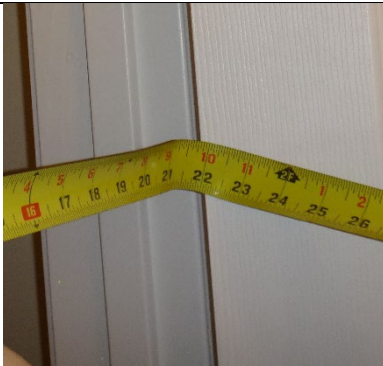
<p><i>Clear door opening.</i></p>						
22

<u>Location</u>	<u>Clear Width (inches)</u>	117C	21-1/2	120B	22	Widen door or install new back wall at closet such that closet depth is reduced to 24 inches.
<u>Location</u>	<u>Clear Width (inches)</u>								
117C	21-1/2								
120B	22

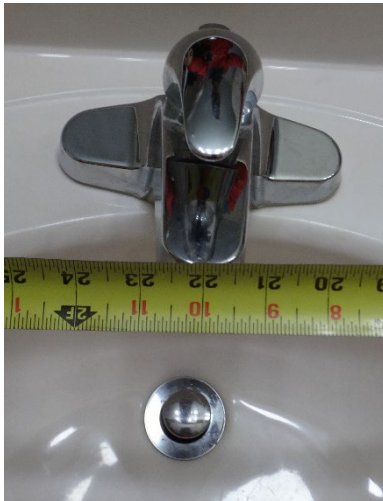
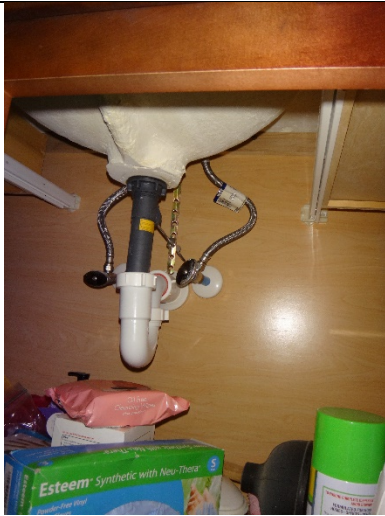
<p><i>Dimension from side wall to centerline of lavatory in Unit 117C.</i></p>	<p>The lavatory centerlines are less than 24 inches to the side wall (minimum 24 inches required) and the cabinets are not removable.</p> <table><tr><th><u>Location</u></th><th><u>Distance (inches)</u></th></tr><tr><td>Unit 120B bathroom.</td><td>18-3/4</td></tr></table>	<u>Location</u>	<u>Distance (inches)</u>	Unit 120B bathroom.	18-3/4	<p>Install removable base cabinet at lavatory.</p> <p>Attach a durable-material placard stating: “THIS CABINET IS REMOVABLE FOR PERSONS WITH DISABILITIES. CONTACT MANAGEMENT.”</p>
<u>Location</u>	<u>Distance (inches)</u>						
Unit 120B bathroom.	18-3/4

Vanity base interior in Unit 120B.

Vanity base in Unit 120B.

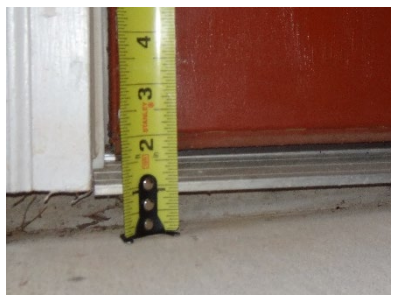
<p><i>Storage door threshold exterior side at Unit 116C.</i></p>	<p>Door thresholds are more than 3/4 inches high at the exterior face and are not beveled (maximum 3/4 inch with bevel allowed).</p> <table><tr><td>Location</td><td>Height (inches)</td></tr><tr><td>Unit 116C, storage</td><td>1-1/2</td></tr></table>	Location	Height (inches)	Unit 116C, storage	1-1/2	<p>Provide beveled transition strip or offer remediation upon request of tenants. If offered on tenant request, a durable-material placard, contrasting black text on white background, in minimum 14-point font, must be placed on the side of the patio door stating: “A BEVEL TO ASSIST PERSONS WITH DISABILITIES FOR THIS THRESHOLD IS AVAILABLE UPON REQUEST. CONTACT MANAGEMENT.”</p>
Location	Height (inches)						
Unit 116C, storage	1-1/2

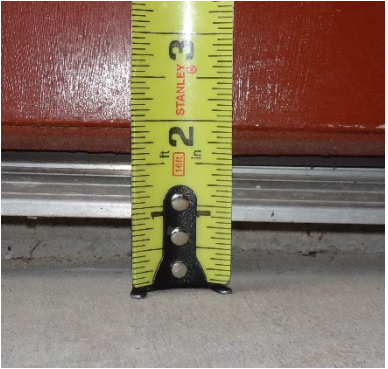
<p><i>Storage door threshold exterior side at Unit 104B.</i></p>	<p>Door thresholds are more than 3/4 inches high at the exterior face and are not beveled (maximum 3/4 inch with bevel allowed).</p> <p>Location Unit 104B, storage</p> <p>Height (inches) 1-1/2</p>	<p>At storage doors:</p> <p>Provide beveled transition strip or offer remediation upon request of tenants. If offered on tenant request, a durable-material placard, contrasting black text on white background, in minimum 14-point font, must be placed on the side of the patio door stating: “A BEVEL TO ASSIST PERSONS WITH DISABILITIES FOR THIS THRESHOLD IS AVAILABLE UPON REQUEST. CONTACT MANAGEMENT.”</p>
-----------	---	--	--

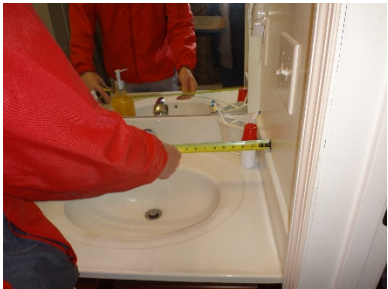
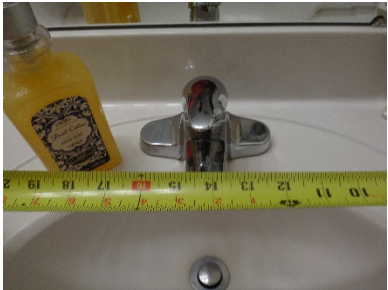
<p><i>Lavatory in Unit 104B.</i></p>

<p><i>Dimension from side wall to centerline of lavatory.</i></p>	<p>The lavatory centerlines are less than 24 inches to the side wall (minimum 24 inches required) and the cabinets are not removable.</p> <table><tr><th><u>Location</u></th><th><u>Distance (inches)</u></th></tr><tr><td>Unit 104B bathroom.</td><td>14-1/4</td></tr></table>	<u>Location</u>	<u>Distance (inches)</u>	Unit 104B bathroom.	14-1/4	<p>Install removable base cabinet at lavatory.</p> <p>Attach a durable-material placard stating: “THIS CABINET IS REMOVABLE FOR PERSONS WITH DISABILITIES. CONTACT MANAGEMENT.”</p>
<u>Location</u>	<u>Distance (inches)</u>						
Unit 104B bathroom.	14-1/4
