APPENDIX G
RETROFIT PLAN FOR MANOR RIDGE APARTMENTS

Manor Ridge Apartments Retrofit Plan – 1

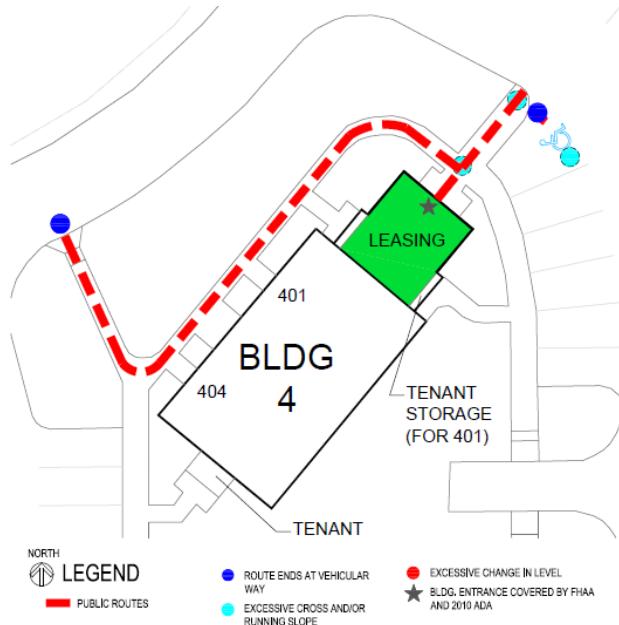
Lack of Accessible Route			
1

<p><i>View looking west from north of Building 8.</i></p>	<p>There is no accessible route between pedestrian site arrival points and leasing office; existing route ends at vehicular way (accessible route required).</p>	<p>Provide new sidewalk and curb ramps from Earns Rd. to the existing walk in front of the leasing office building (see Accessible Route Diagram).</p>

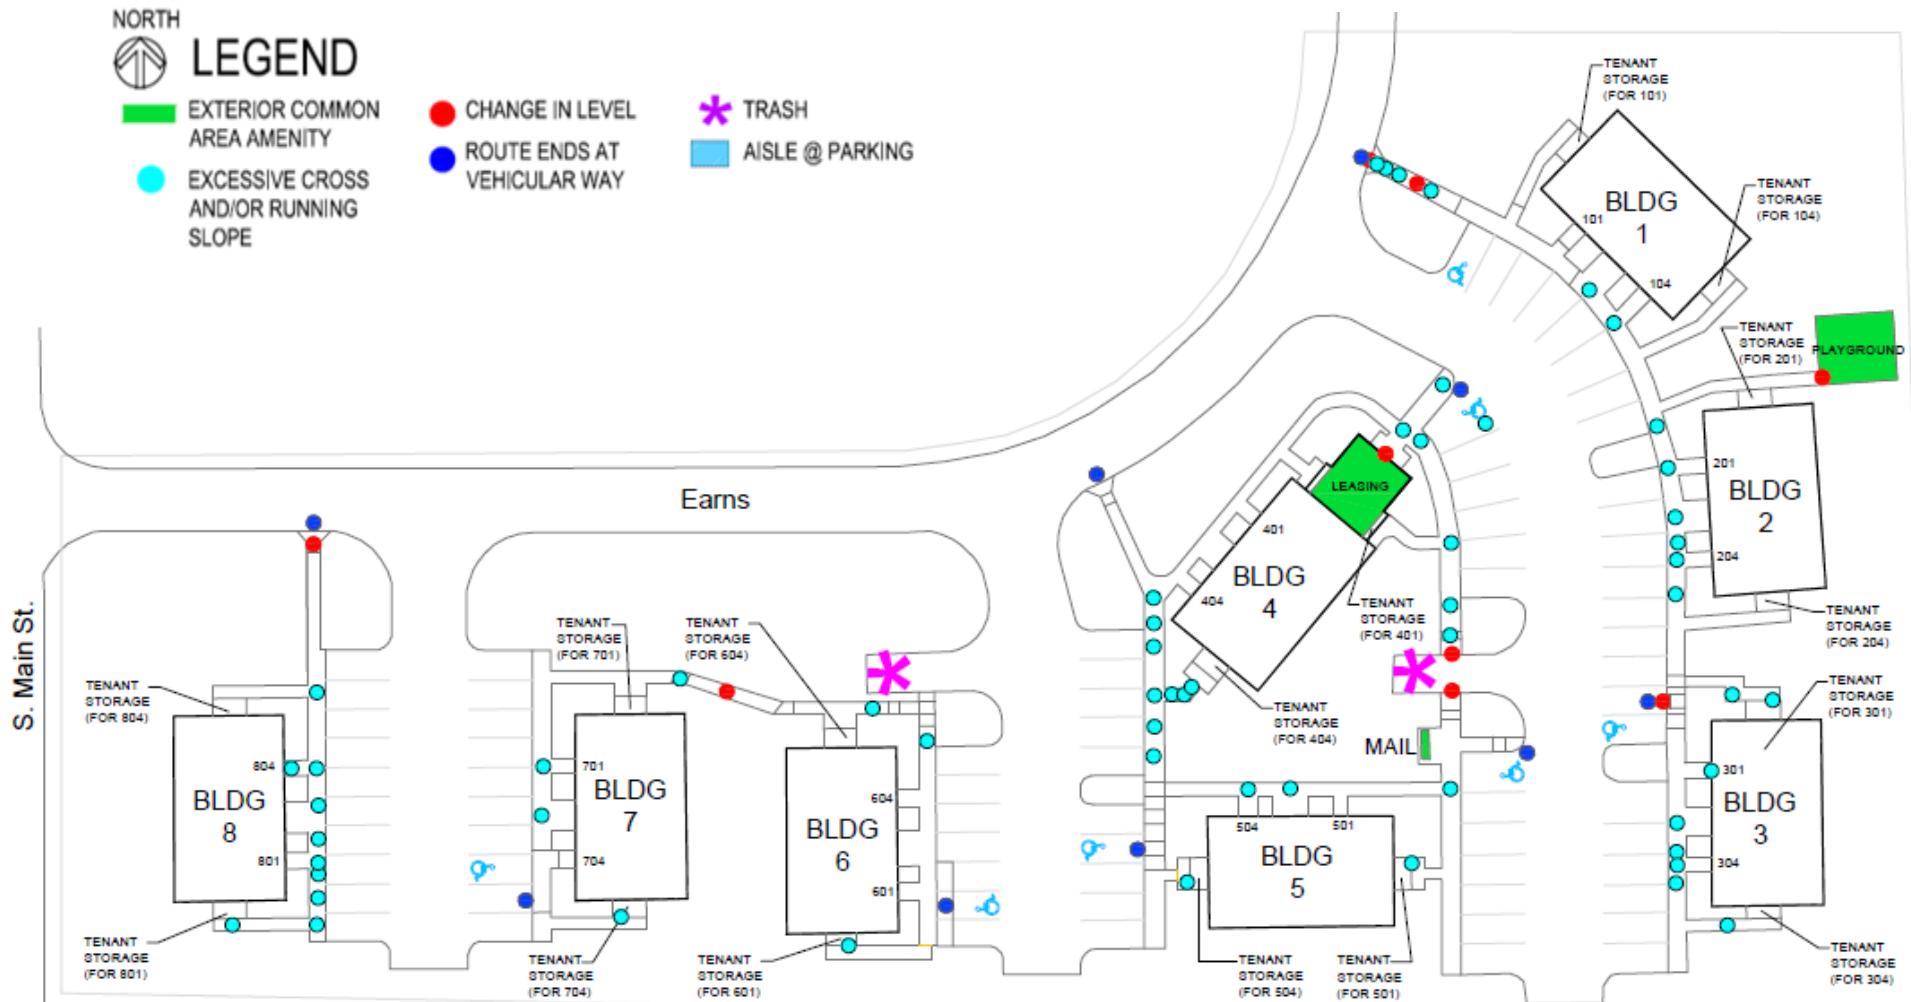
Inaccessible Features at Common Use Routes

Lack of Accessible Route/Inaccessible Width			
9	<i>See map diagrams.</i>	<p>There is no accessible route from covered dwelling units to common area buildings, site arrival points, leasing office, and exterior common areas and amenities (routes required).</p>	<p>Replace concrete as required to retrofit sections with excessive cross slope. Repave/overlay asphalt at parking spaces and access aisles. Restripe parking spaces and access aisles.</p>
10

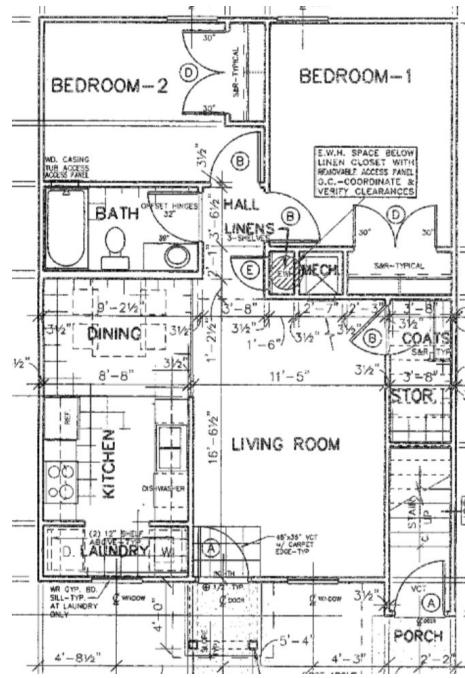
Unit Plan. (PENDERGRAPH03205).

Surveyed Units 101 and 601 – Typical for 6 total units

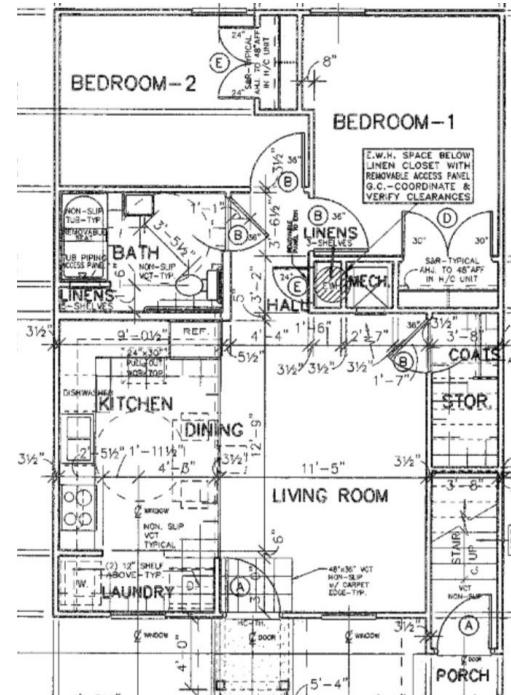
Unit Plan. (PENDERGRAPH03205).

Surveyed Unit 501 – Typical for 2 total units

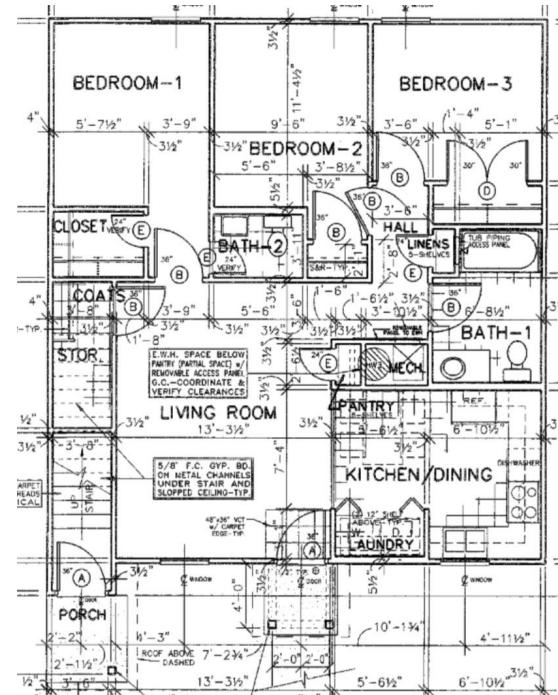
Unit Plan. (PENDERGRAPH03205).

Surveyed Units 304 and 704 – Typical for 8 total units

31		Door thresholds are 1-3/8 inches to 1-1/2 inches high at the interior face and are not beveled (maximum 3/4 inch with bevel allowed). <i>Entrance door threshold interior side at Unit 304.</i>	Provide beveled transition strips.
----	--	--	------------------------------------
