APPENDIX H

RETROFIT PLAN FOR MILLERS RIDGE APARTMENTS

Millers Ridge Apartments Retrofit Plan – 1

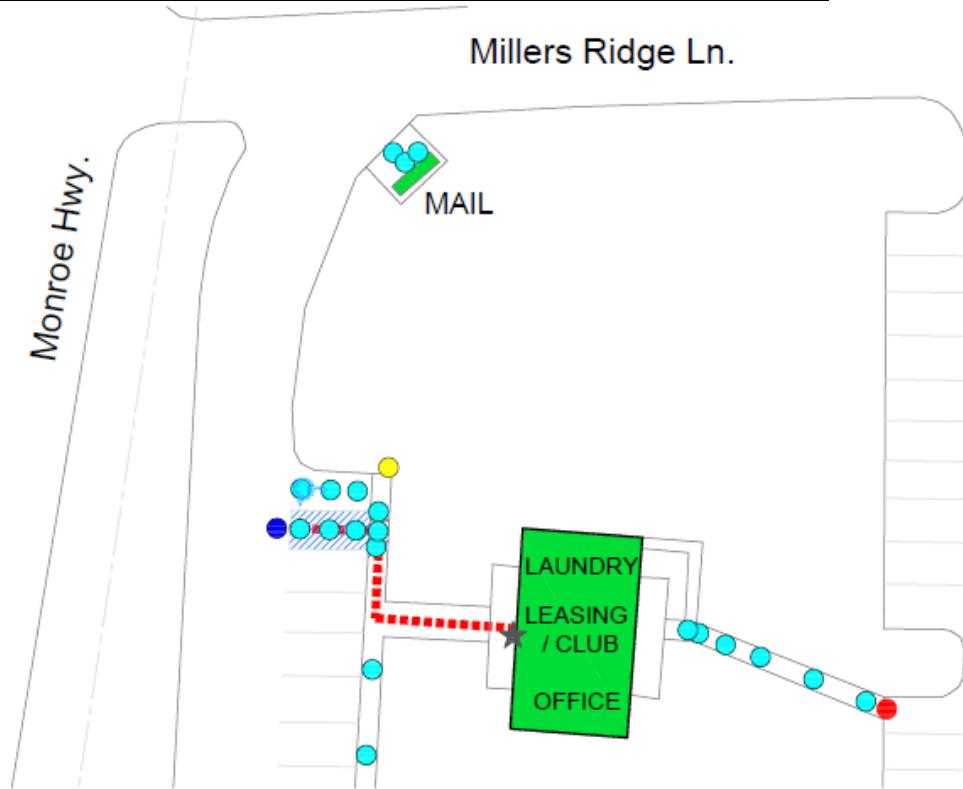
Millers Ridge: Route to Leasing Office from Site Arrival Points

Note: while inaccessible features are shown at 2 routes, retrofits are required to provide only one route to the leasing/clubhouse from pedestrian points of arrival, vehicular points of arrival and all covered dwelling units. If all required routes are provided as is proposed in the Accessible Route Diagram, the walk east of leasing can remain as-is. See Accessible Route Diagram on page 2.

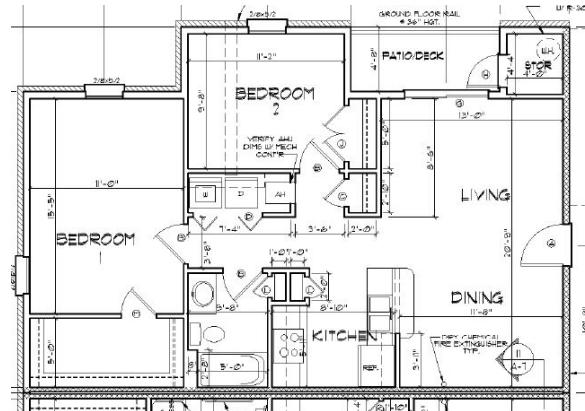
Unit Plan. (PENDERGRAPH00065).

<p>Replace range or add outlets on side walls at each side of the counters. New outlets on side walls to be maximum 10 inches back from the front face of the range.</p>	<u>Location</u>	<u>Depth (inches)</u>	Unit 1005	26-7/8	Unit 3004	27 +/-
<u>Location</u>	<u>Depth (inches)</u>							
Unit 1005	26-7/8							
Unit 3004	27 +/-

<p><i>Bathtub/shower surround in Unit 1005.</i></p>	<p>The shape of the bathtub surrounds precludes the installation of future grab bars with firm attachment to blocking (ability to install grab bars required).</p>	<p>Replace tub surround or install custom grab bars on request that can be mounted in the required locations at the existing surrounds.</p>
24

The extent of existing blocking in bathrooms cannot be determined without destructive testing. Additional blocking at unit toilets, tubs and showers may be required as part of unit retrofits. Open interior walls at one unit to investigate extent of existing blocking. Once existing conditions are known, extent of new blocking required (if any) will be determined.

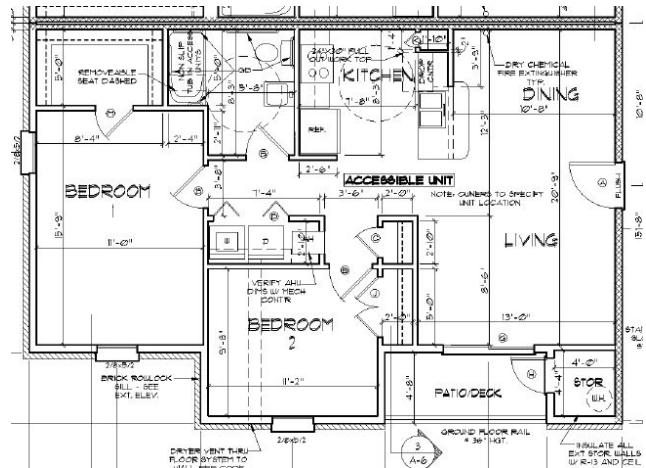
Unit Plan. (PENDERGRAPH0065).

<u>Location</u>	<u>Height (inches)</u>	Unit 1009 entry	7/8	Unit 1009 patio	1-1/8	<p>Unit entry door: Install threshold transition strips at each side of each location or replace threshold.</p> <p>Patio doors: Provide beveled transition strip or offer remediation upon request of tenants. If offered on tenant request, a durable-material placard, contrasting black text on white background, in minimum 14-point font, must be placed on the side of the patio door stating: "A BEVEL TO ASSIST PERSONS</p>
<u>Location</u>	<u>Height (inches)</u>								
Unit 1009 entry	7/8								
Unit 1009 patio	1-1/8

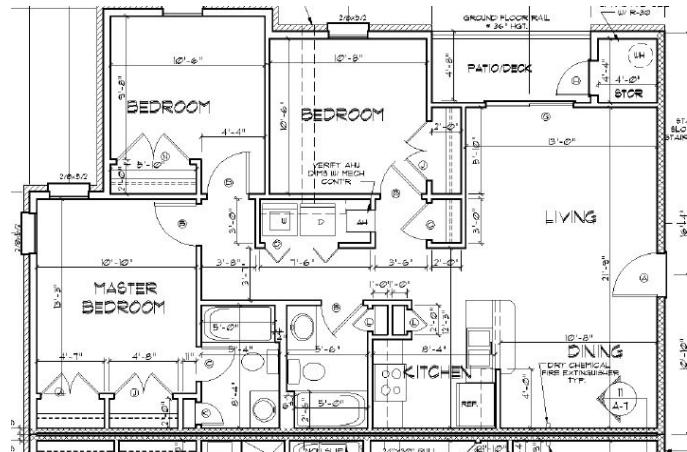
Unit Plan. (PENDERGRAPH00067).

Note: Unit 2005 master bathroom door opens outward.

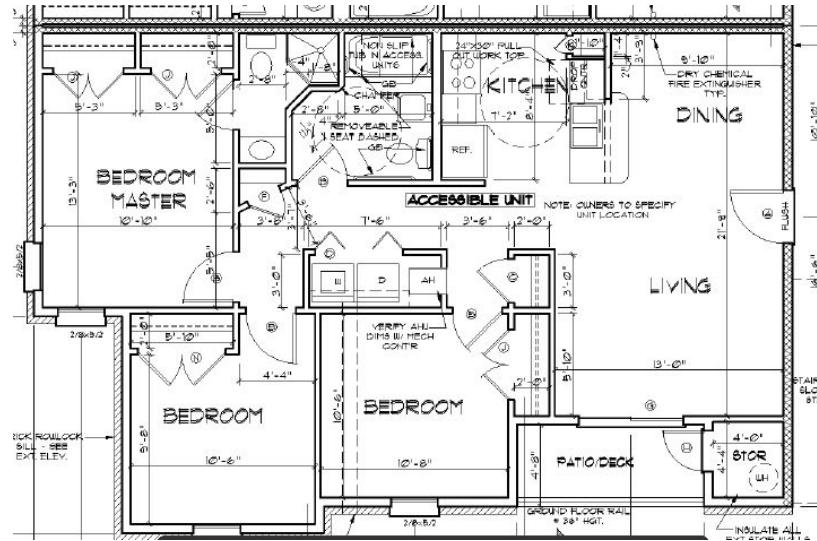
Unit Plan. (PENDERGRAPH00067).

Surveyed Unit 2-09 – Typical for 1 unit only (Note: evaluated with hall Bath as Option B).
