Exhibit 2.2

Marsh Creek Matrix of Required Retrofits to Public and Common Use Areas

MARSH CREEK APARTMENTS: PUBLIC AND COMMON USE AREAS

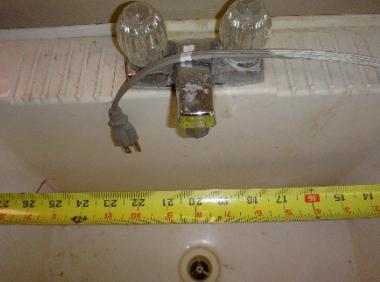
<i>Utility sink in Laundry Room.</i>	<p>The utility sink does not have the minimum clear floor space required for parallel approach. The sink is not centered on a 48- inch wide clear floor space (minimum 24 inches to center of controls required). The centerline is 20 inches from the adjacent equipment.</p>	<p>Remediate to improve the condition.</p>
