IN THE UNITED STATES DISTRICT COURT  
FOR THE EASTERN DISTRICT OF NORTH CAROLINA  
WESTERN DIVISION  
No. 5:21-cv-00395-M

**INDEX OF CONSENT ORDER EXHIBITS**

Milburnie Road Matrix of Required Retrofits to Public and Common Use Areas.

# MILBURNIE ROAD APARTMENTS: PUBLIC AND COMMON USE AREAS

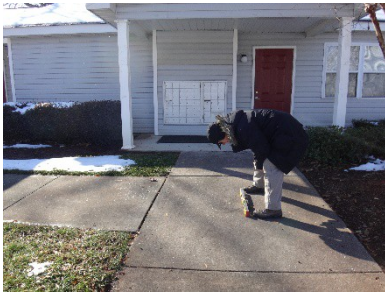
<p><i>Measuring cross slope at turn to mail area.</i></p>	<p>Cross slopes of the routes/sidewalks are more than 2% (maximum 2% allowed).</p> <p>Location</p> <p>Southeast of Building 4                      7.2% (at curb ramp at Gibney Dr.)</p> <p>East of Building 4                      4.0% (at intersection of Gibney &amp; Sawpit)</p> <p>East of Building 4                      3.9% (route to leasing office)</p> <p>East of Building 4                      4.5% (route to leasing office)</p>	Modify 3.9%, 4.0%, 4.5%, and 7.2% cross slopes to comply with ANSI 4.3.7.

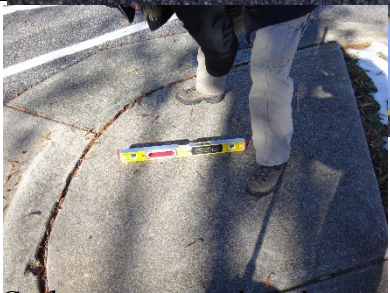
<p><i>Curb ramp cross slope location.</i></p>

<p><i>Cross slope.</i></p>	The cross slope of the curb ramp northeast of Building 4 is 5.9% (maximum 2.0% allowed).	Modify 5.9% cross slope of curb ramp to comply with ANSI 4.7.2 and 4.8.2.
	<b>Inaccessible Threshold</b>

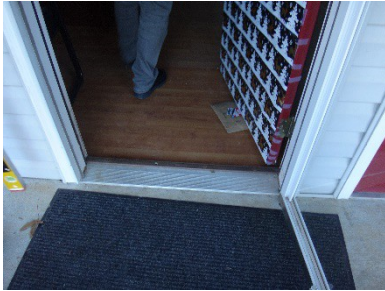
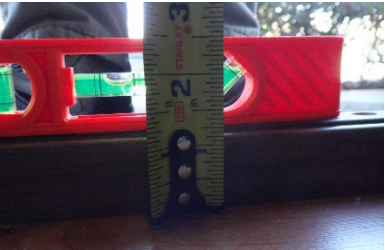
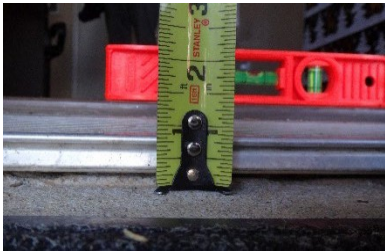
Numbers	Photos	Deficiency	Required Retrofit
6	<p><i>Leasing office door threshold -- Picture 1. Interior threshold -- Picture 2. Exterior threshold -- Picture 3.</i></p>

<p>The leasing/management office door threshold is 1- 1/4 inches high inside and 1- 3/8 inches high at the exterior (maximum 1/2-inch height allowed; maximum 1/4-inch change in level without a bevel allowed.)</p>	<p>Replace threshold to comply with ANSI 4.13.8 and 4.5.2.</p>
	<b>Protruding Objects</b>

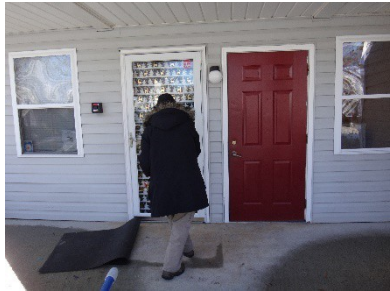
<p><i>Light fixture by door.</i></p>	The light fixture at the doors to the Leasing Office and to the Laundry Room project approximately 7-1/4 inches into the circulation path (maximum 4 inches allowed). The same light fixture is found at the dwelling unit entries and exterior routes.	Modify light fixture to comply with ANSI 4.4.1.
<b><u>Routes from Site Arrival Points to Common Areas and Covered Dwelling Units</u></b>			
<b><u>Inaccessible Features – Milburnie Road Apts.</u></b>			
<b>B. Inaccessible Features at Common Area Routes</b>			
	<b>Inaccessible Features at Routes</b>

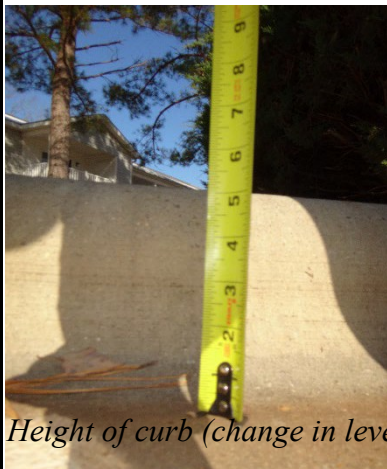
<p><i>Height of curb (change in level).</i></p></div>	<p>The route has changes in level greater than 1/2 inch (maximum 1/2 inch with bevel allowed).</p>

Location	Height (inches)	North of Building 2 (sidewalk to Building 2)	5/8	South of Building 3 (curb at trash area west of Building 3)	5	South of Building 3 (sidewalk to Building 3)	7/8	<p>Modify 5/8", 5", and 7/8" to comply with ANSI 4.5.2. Install striping at three crosswalk locations. Note that the accessible route plan requires an accessible route to the dumpster on the SW side of Building 3, so the existing curb ramp must be fixed.</p>
Location	Height (inches)										
North of Building 2 (sidewalk to Building 2)	5/8										
South of Building 3 (curb at trash area west of Building 3)	5										
South of Building 3 (sidewalk to Building 3)	7/8

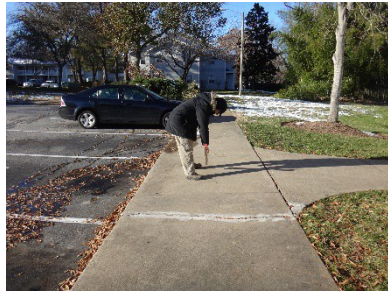
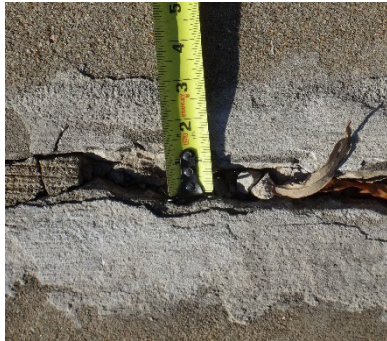
<p><i>Location west of Building 5.</i></p>

<p><i>Gap width.</i></p>	<p>Gaps in the pavement are wider than 1/2 inch (maximum 1/2 inch allowed).</p>

<table><tr><th><u>Location</u></th><th><u>Width (inches)</u></th></tr><tr><td>West of Building 5 (cracked concrete sidewalk)</td><td>3/4</td></tr><tr><td>West of Building 7 (cracked concrete sidewalk)</td><td>7/8</td></tr><tr><td>North of Building 7 (cracked concrete sidewalk)</td><td>&gt;1/2</td></tr></table>

<u>Location</u>	<u>Width (inches)</u>	West of Building 5 (cracked concrete sidewalk)	3/4	West of Building 7 (cracked concrete sidewalk)	7/8	North of Building 7 (cracked concrete sidewalk)	>1/2	<p>Modify all gaps to comply with ANSI 4.5.4.</p>
<u>Location</u>	<u>Width (inches)</u>										
West of Building 5 (cracked concrete sidewalk)	3/4										
West of Building 7 (cracked concrete sidewalk)	7/8										
North of Building 7 (cracked concrete sidewalk)	>1/2

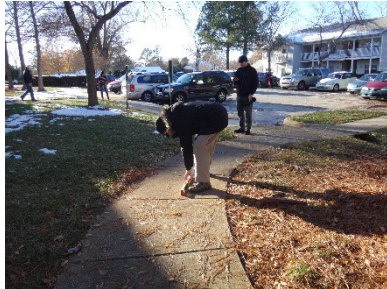
<p><i>Route southwest of Building 1 to Building 5.</i></p>

Location	Slope	Southwest of Building 1	3.8%	Northeast of Building 2	3.6%	North of Building 2	4.2%	North of Building 2	4.0%	South of Building 3	3.7%	(west of walk to Building 3)		South of Building 3	3.5%	(at walk to Building 3)		South of Building 3	3.5%	(south end of walk to Building 3)		Southwest of Building 5	4.0%	Southwest of Building 5	3.9%	West of Building 5	4.2%	West of Building 5	4.1%	(at walk to Building 5)		Northwest of Building 6	5.9%	Northwest of Building 6	3.7%	North of Building 6	4.6%	Northwest of Building 7	4.3%	Northwest of Building 7	4.4%	Northwest of Building 7	3.9%	Northeast of Building 7	3.6%	<div>Modify cross slopes ranging from 3.5% to 5.9% to comply with ANSI 4.3.7.</div> <div>Install striping at three crosswalk locations.</div>
Location	Slope																																																
Southwest of Building 1	3.8%																																																
Northeast of Building 2	3.6%																																																
North of Building 2	4.2%																																																
North of Building 2	4.0%																																																
South of Building 3	3.7%																																																
(west of walk to Building 3)																																																	
South of Building 3	3.5%																																																
(at walk to Building 3)																																																	
South of Building 3	3.5%																																																
(south end of walk to Building 3)																																																	
Southwest of Building 5	4.0%																																																
Southwest of Building 5	3.9%																																																
West of Building 5	4.2%																																																
West of Building 5	4.1%																																																
(at walk to Building 5)																																																	
Northwest of Building 6	5.9%																																																
Northwest of Building 6	3.7%																																																
North of Building 6	4.6%																																																
Northwest of Building 7	4.3%																																																
Northwest of Building 7	4.4%																																																
Northwest of Building 7	3.9%																																																
Northeast of Building 7	3.6%

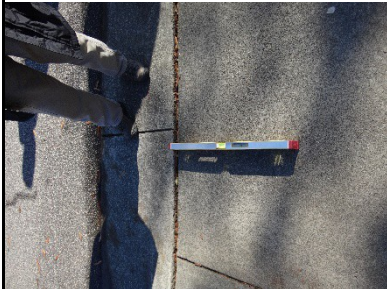
<p><i>Curb ramp SE of Bldg. 4</i></p>

Location	Slope	Southeast of Building 4 (middle of curb ramp)	16.8%	Southeast of Building 4 (bottom of curb ramp)	15.4%	Northeast of Building 4	10.2%	West of Building 7	9.3%	Modify 16.8%, 15.4%, 10.2%, and 9.3% running slopes of curb ramp to comply with ANSI 4.7.2.
Location	Slope												
Southeast of Building 4 (middle of curb ramp)	16.8%												
Southeast of Building 4 (bottom of curb ramp)	15.4%												
Northeast of Building 4	10.2%												
West of Building 7	9.3%

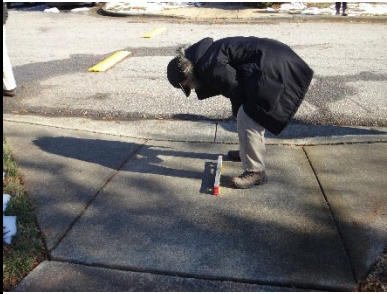
Numbers	Photos	Deficiency	Required Retrofit
12	<p><i>Curb ramp SE of Bldg. 4 -- Picture 1. Cross slope -- Picture 2.</i></p>

<p>Curb ramp cross slopes are more than 2.0% (maximum 2.0% allowed).</p> <p>Location Southeast of Building 4 (middle of curb ramp)</p> <p>Slope 3.4%</p>	<p>Modify 3.4% cross slope of curb ramp to comply with ANSI 4.7.6.</p>
	<p><b>Inaccessible Slopes at Door Maneuvering Spaces</b></p>

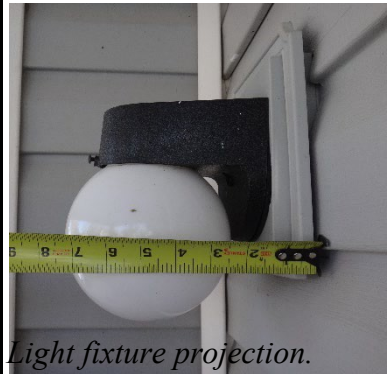
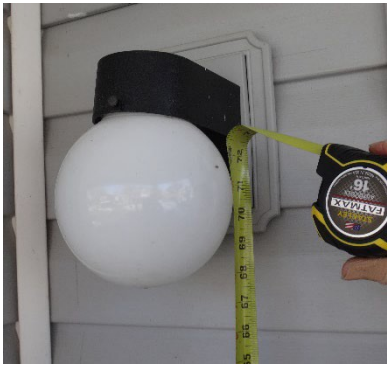
<p><i>Light fixture projection.</i></p></div>	<p>Lights and fire extinguishers project more than 4 inches into the circulation paths (maximum 4 inches allowed).</p>

<p><i>Light fixture height.</i></p>

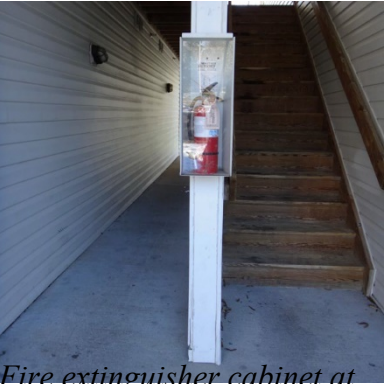
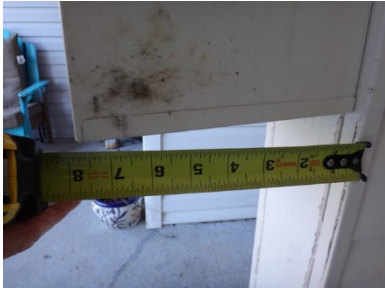
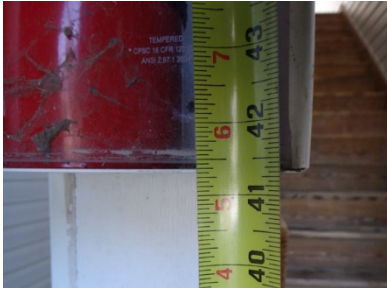
<p><i>Fire extinguisher cabinet at Building 6.</i></p>	Building 3 Breezeway at 103      7 +/- Unit 101, Building 4              7 +/- Unit 102, Building 4              7 +/- Unit 101, Building 5              7 +/- Unit 102, Building 5: Depth of protrusion              7 Height of leading edge          69-1/2 Unit 103, Building 5              7 +/- Unit 104, Building 5              7 +/- Building 5 Breezeway front      7 +/- Unit 101, Building 6              7 +/- Unit 102, Building 6              7 +/- Unit 103, Building 6              7 +/- Unit 104, Building 6              7 +/-

<p><i>Fire extinguisher cabinet depth.</i></p>

<p><i>Fire extinguisher height (to bottom of cabinet).</i></p>	<p>Building 6 Breezeway rear:</p> <p>Depth of protrusion 5-1/4</p> <p>Height of leading edge 69-1/4</p> <p>Unit 101, Building 7 7 +/-</p> <p>Unit 102, Building 7 7 +/-</p> <p>Unit 103, Building 7 7 +/-</p> <p>Unit 104, Building 7 7 +/-</p> <p>Building 7 Breezeway font 5 +/-</p> <p>Building 7 Breezeway rear:</p> <p>Depth of protrusion 7-1/4</p> <p>Height of leading edge 69-3/4</p> <p>Building 7 behind stair 7 +/-</p> <p>Fire Extinguishers Distance</p> <p>Location (inches)</p> <p>Building 1 Breezeway:</p> <p>Depth of protrusion 6-3/4</p> <p>Height of leading edge 41-1/4</p> <p>Building 2 behind stair:</p> <p>Depth of protrusion 6-5/8</p> <p>Height of leading edge 42-7/8</p> <p>Building 2 Breezeway rear 6-1/4 +/-</p> <p>Building 3 Breezeway:</p> <p>Depth of protrusion 6-1/4</p>

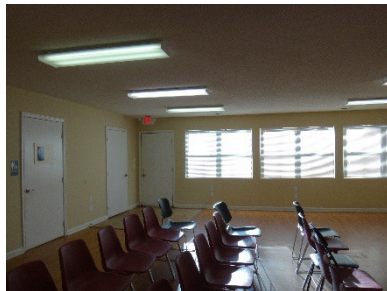
<p>Clear space at the recycling center clear floor space has a cross slope of 3.8% (maximum 2% allowed).</p> <table><tr><th>Location</th><th>Slope</th></tr><tr><td>Southwest of Building 3</td><td>3.8%</td></tr></table>	Location	Slope	Southwest of Building 3	3.8%	<p>Modify 3.8% cross slope to comply with ANSI 4.3.7.</p>		
Location	Slope								
Southwest of Building 3	3.8%								
17	<p><i>Maneuvering clearance at meeting room rear exit (door on the far wall adjacent to the windows).</i></p>

<p>The meeting room door maneuvering clearances are less than 18 inches on the pull side (minimum 18 inches required).</p> <table><tr><th>Location</th><th>Distance (inches)</th></tr><tr><td>Meeting Room rear exit</td><td>&lt;18</td></tr><tr><td>Men's Restroom</td><td>12</td></tr></table>	Location	Distance (inches)	Meeting Room rear exit	<18	Men's Restroom	12	<p>At rear exit, modify by mirroring the door hinges to the opposite side to provide 18" on pull side in order to comply with ANSI 4.13.6.</p> <p>At men's restroom, relocate fire extinguisher.</p>

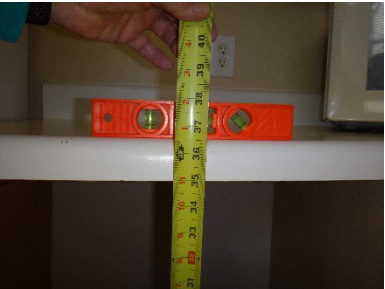
<p data-bbox="300 1291 562 1323"><i>Work surface height.</i></p>	<p data-bbox="768 954 1379 1096">The top of the community room kitchen work surface and the sink rim/counter are both 36-1/2 inches above the floor (maximum 34 inches allowed at full kitchen with range).</p>	<p data-bbox="1388 954 1713 1019">Modify kitchen counter to comply with ANSI 4.30.4.</p>

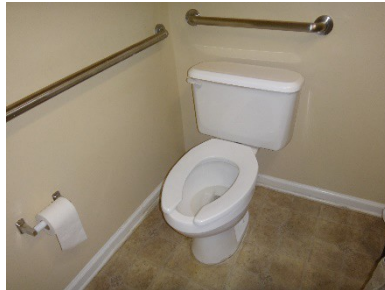
The men's restroom flush control is located on the side of the toilet opposite the side of approach (not allowed).	Modify flush control to comply with ANSI 4.16.5.

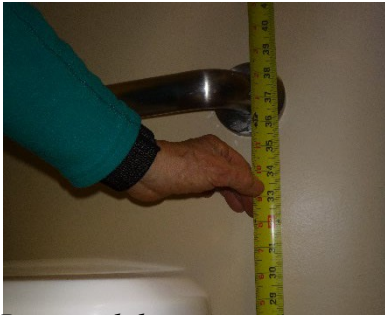
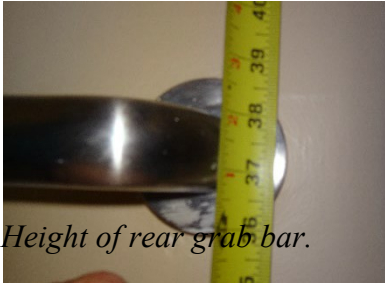
<p><i>Rear grab bar at men's restroom.</i></p>

<p><i>Height of rear grab bar.</i></p>	<p>Toilet grab bars are more than 36 inches above the floor (maximum 36 inches allowed by ADA, maximum 36-3/4 allowed by ANSI 1986).</p> <p>Grab bar Men's rear wall</p> <p>Height (inches) 37-7/8</p>	<p>Fix 37 7/8" to comply with ANSI 4.16.4.</p>

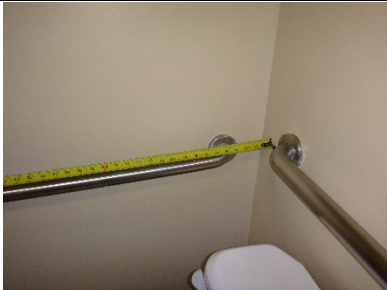
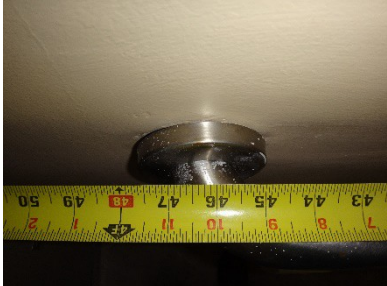
<p><i>Side grab bar in men's restroom.</i></p>

<p><i>Dimension of side grab bar extension.</i></p>	<p>The men's restroom side grab bar at the toilet extends 47 inches from the rear wall (minimum 54 inches required).</p>	<p>Relocate grab bar to comply with ANSI 4.17.6.</p>
25

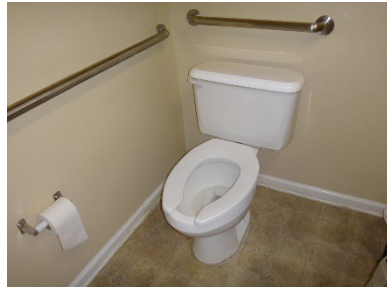
<p><i>Rear grab bar in men's restroom.</i></p>	<p>The rear wall grab bars in both the men's and women's restrooms are 24 inches long (minimum 36 inches required).</p>	<p>Modify flush control to comply with ANSI 4.16.5.</p>

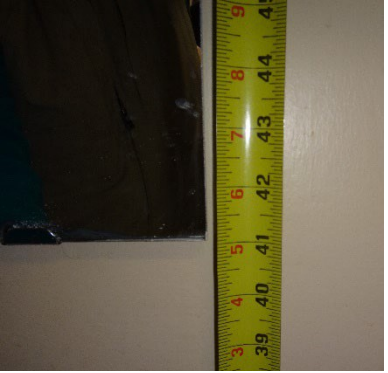
<p><i>Height of mirror above floor in men's restroom.</i></p>	<p>The reflective mirror surfaces are more than 40 inches above the floor (maximum 40 inches allowed).</p> <p>Location Women's restroom</p> <p>Height (inches) 41-7/8</p>	<p>Fix 41 7/8" to comply with ANSI 4.19.6.</p>

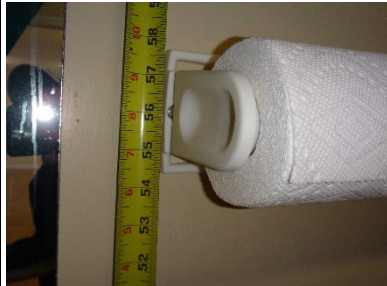
<p><i>Height of paper towel.</i></p></div>	<p>The paper towel dispensers are more than 48 inches above the floor (maximum 48 inches allowed).</p>

Height	<u>Location</u>	<u>(inches)</u>	Men's restroom	58	Women's restroom	60	Relocate paper towel dispenser to comply with ANSI 4.25.3.
	Height										
<u>Location</u>	<u>(inches)</u>										
Men's restroom	58										
Women's restroom	60										
	<b>Additional Information Based on 2010 ADA</b>

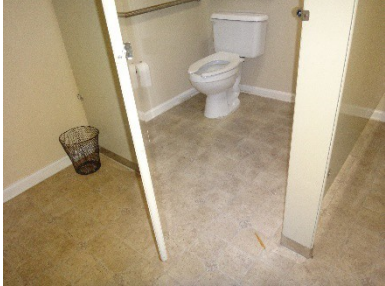
Numbers	Photos	Deficiency	Required Retrofit
	<p data-bbox="300 219 705 293"><i>Men's room stall door standing ajar.</i></p>

<p data-bbox="768 219 1379 289">Both the men's and women's accessible toilet stall doors do not self-close (self-closing required).</p>	<p data-bbox="1388 219 1713 321">Modify stall door to comply with ADA 604.8.1.2.</p>

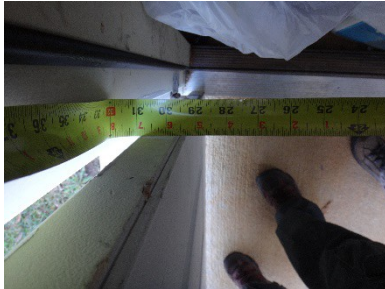
<p><i>Clear opening at storage closet door.</i></p>	<p>Doors at patios and storage closets have clear openings less than 31-5/8 inches wide (minimum 31-5/8 inch required).</p>

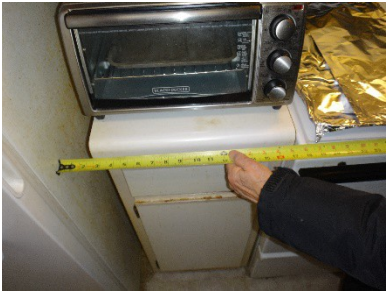
<p><i>Clear floor space at counter and outlet obstructed by adjacent refrigerator and range.</i></p>	The outlets above kitchen countertops lack the required clear floor space for approach (at least 1 outlet in each counter area must have clear floor space for approach).	Install power strip and position to eliminate any reach range issues.
<b>UNIT TYPE: 2 Bedroom, 1 Bathroom – (Accessible)</b> Surveyed Unit 101, Building 1 – Typical for 2 total units

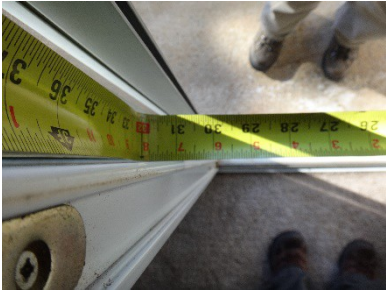
<p><i>Clear patio door opening.</i></p>	Patio and storage closet door clear opening widths are less than 31-5/8 inches (minimum 31-5/8 inch required).	For sliding door, trim door stop to provide 31 5/8" to comply with Requirement 3(2). For storage door, modify door on-request to comply with Requirement 3(2).
36

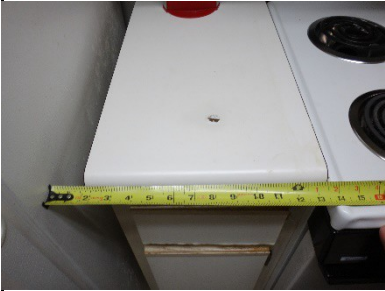
<p><i>Clear floor space obstructed by adjacent refrigerator and range. Unit 101, Building 1.</i></p>	The outlets above kitchen countertops lack required clear floor space for approach (at least 1 outlet in each counter area must have clear floor space for approach).	Install power strip within reach range requirements.

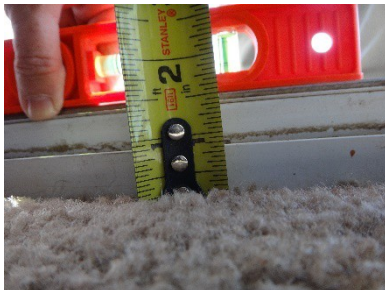
</div> <p><i>Patio door threshold at Unit 103, Building 2.</i></p>	<p>Door thresholds are more than 3/4 inches high at the interior face and are not beveled (maximum 3/4 inch with bevel allowed).</p> <table><thead><tr><th>Location</th><th>Height (inches)</th></tr></thead><tbody><tr><td>Unit 102, Building 3 Patio interior side</td><td>1-1/2</td></tr><tr><td>Unit 104, Building 3 Entry interior side</td><td>1-3/8</td></tr><tr><td>Unit 104, Building 3 Patio interior side</td><td>1-1/4</td></tr></tbody></table>	Location	Height (inches)	Unit 102, Building 3 Patio interior side	1-1/2	Unit 104, Building 3 Entry interior side	1-3/8	Unit 104, Building 3 Patio interior side	1-1/4	<p>Install a bevel at 1:2 to comply with Requirement 5.</p>
Location	Height (inches)										
Unit 102, Building 3 Patio interior side	1-1/2										
Unit 104, Building 3 Entry interior side	1-3/8

Unit 104, Building 3 Patio interior side	1-1/4										
39	<div>

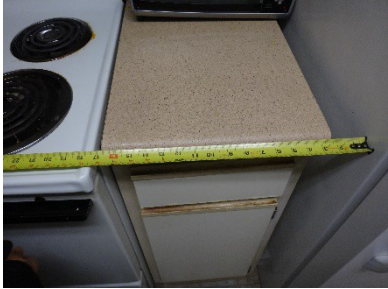
<p><i>Clear floor space obstructed by adjacent refrigerator and range. Unit 102, Building 3.</i></p>	The outlets above kitchen countertops lack required clear floor space for approach (at least 1 outlet in each counter area must have clear floor space for approach).	Install power strip within reach range requirements.
42	<p><i>Vanity base in Unit 104, Building 3.</i></p>

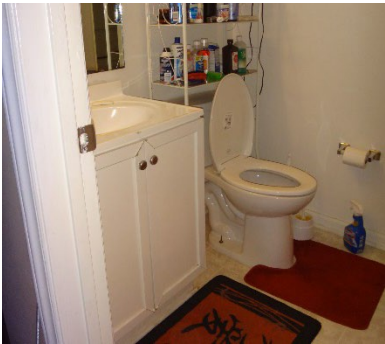
Lavatory centerlines are 13-1/4 inches to the side wall (minimum 24 inches required for parallel approach) and the cabinets are not removable.	Ensure that one bathroom in each unit is a fully compliant Spec-B layout.

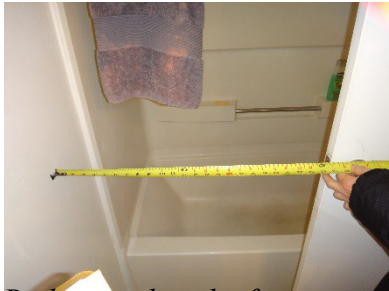
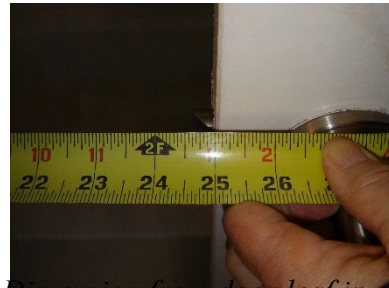
<p><i>Bathroom door leaf in open position at Unit 102, Bldg. 3.</i></p>

<p><i>Dimension from door leaf in open position to rear wall.</i></p>	<p>Clear floor space in the master bathroom is less than 24-7/8 inches to 25 inches long (minimum 48 inches clear of the door swing required).</p>	<p>In the Master Bath, reverse the swing of door into bedroom to provide a clear floor space to comply with Requirement 7(2)(b)(i)</p>
<p><b>UNIT TYPE: 3 Bedroom, 2 Bathroom – (Accessible)</b>            Surveyed Unit 101, Building 2 – Typical for 2 total units</p>

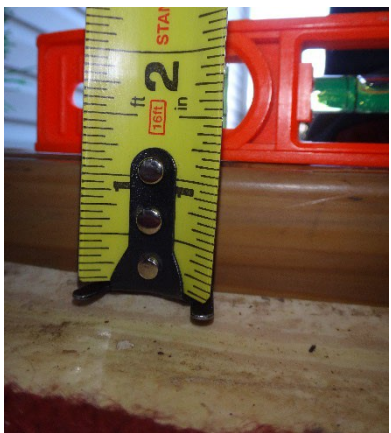
<p><i>Entry door threshold interior side at Unit 101, Building 2.</i></p>	<p>Door thresholds are more than 3/4 inches high at the interior face and are not beveled (maximum 3/4 inch with bevel allowed).</p> <p><u>Location</u></p>

<table><tr><td>Unit 101, Building 2</td><td>1-1/8</td></tr></table>

Unit 101, Building 2	1-1/8	Entry interior side		Unit 101, Building 2	1-1/8	Patio interior side		Unit 101, Building 2	3/4	Storage exterior side		<p>Install a bevel at 1:2 on the interior side of the sliding door. Accept proposed fix for entry door and on-request for storage door.</p>
Unit 101, Building 2	1-1/8														
Entry interior side															
Unit 101, Building 2	1-1/8														
Patio interior side															
Unit 101, Building 2	3/4														
Storage exterior side

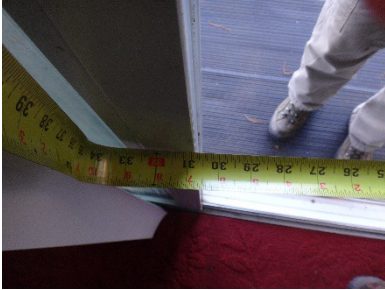
<p><i>Clear patio door opening.</i></p>	Clear openings at patio and storage closet doors are less than 31-5/8 inches wide (minimum 31-5/8 inch required).	For sliding door, trim door stop to provide 31 5/8" minimum clear opening to comply with Requirement 3(2). For storage door, modify door on-request to comply with Requirement 3(2).
46a.		Extent of blocking in bathrooms cannot be determined without destructive testing.	Provide affidavits to confirm that reinforcement is installed to comply with Requirement 6.
47

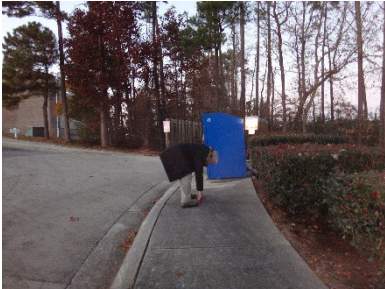
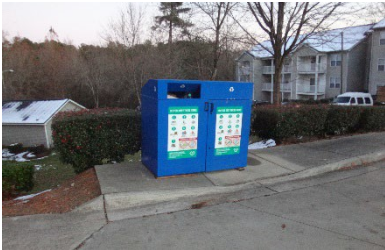
</div> <p><i>Route to leasing office.</i></p>	The curb ramp and sidewalk leading to the leasing office is blocked by recycling can and the width is not accessible (minimum 36 inches required).	Add a lease addendum in which property management will deposit recycling in container upon resident request.						
3	<div>

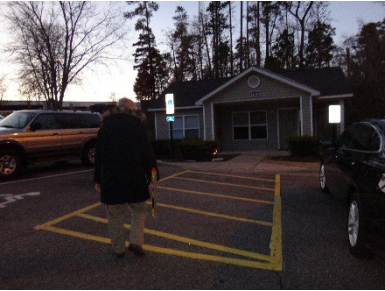
</div> <p><i>Parking space &amp; cross slope.</i></p>	<p>The designated parking space access aisle at the leasing office has a cross slope greater than 2% (maximum 2% allowed).</p>

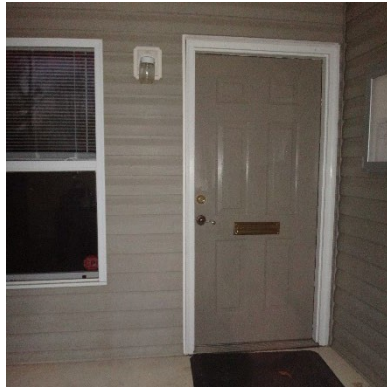
</div> <p><i>Light fixture at entrance to leasing office.</i></p>	<p>The light fixture at entrance to leasing office protrudes approximately 5 inches into the circulation path (maximum 4 inches allowed).</p>	<p>Modify protruding objects that project more than 5" into the circulation path to comply with ANSI 4.4.1.</p>

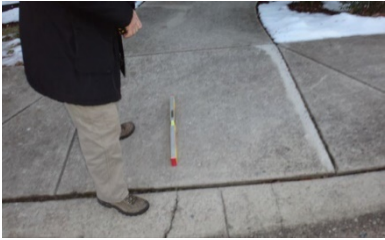
<p><i>Ramp north of Building 1 (shows level measuring running slope). 5.3% is cross slope reading.</i></p>	The cross slope of the curb ramp north of Building 1 is 5.3% (maximum 2.0% allowed).	Install a new sidewalk to bypass this curb ramp to connect to walkway toward accessible parking space on the south side of the building or replace curb ramp with new sidewalk to comply with ANSI.
	<b>Inaccessible Ramp Features</b>

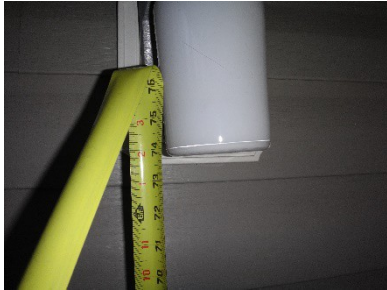
<p>Lights and fire extinguisher cabinets protrude approximately 7 inches into the circulation path (maximum 4 inches allowed where the bottom of the object is more than 27 inches and less than 80 inches above the adjacent walking surface).</p> <p><u>Locations:</u>  West breezeway fire ext. cabinet  East breezeway fire ext. cabinet  East breezeway passage light fixture  West breezeway passage light fixture  Light fixture at Unit 101 entry  Light fixture at Unit 102 entry  Light fixture at Unit 103 entry  Light fixture at Unit 104 entry  Light fixture at Unit 105 entry  Light fixture at Unit 106 entry  Light fixture at Unit 107 entry  Light fixture at Unit 108 entry</p>	<p>Modify protruding objects that project more than 5" into the circulation path to comply with ANSI 4.4.1.</p>

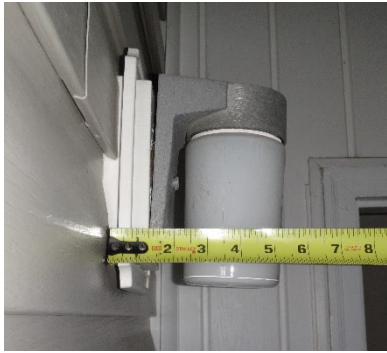
<p><i>Light fixture at entry to Unit 108 (typical).</i></p>

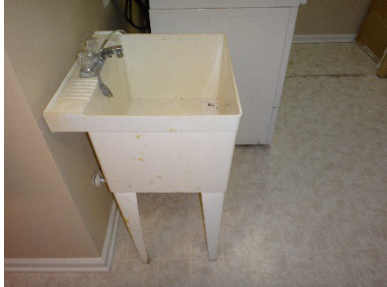
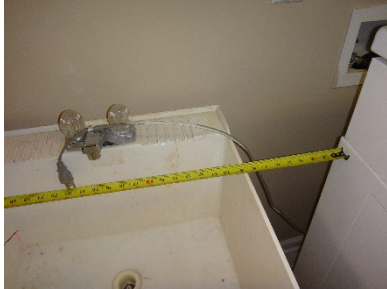
<p><i>Utility sink in Laundry Room.</i></p>	The utility sink does not have the minimum clear floor space required for parallel approach. The sink is not centered on a 48- inch wide clear floor space (minimum 24 inches to center of controls required). The centerline is 20 inches from the adjacent equipment.	Remediate to improve the condition.

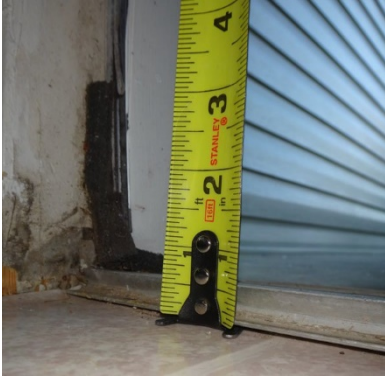
<p><i>Unit entry door threshold.</i></p>	Primary unit entry door thresholds are 5/8 high and are not beveled at the interior side (maximum 1/4-inch change in level without bevel allowed).	Modify door thresholds to comply with Requirement 4(4).
21

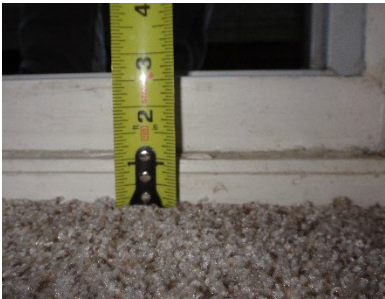
<p><i>Patio door threshold interior side at Unit 105.</i></p>	Patio door threshold assemblies are 2-5/8 inches high and have changes in level greater than 1/4 inch that are not beveled (maximum 3/4-inch height allowed; maximum 1/4-inch change in level without bevel allowed).	Modify door thresholds upon resident request by installing a bevel on the interior side at a ratio of 1:2 to comply with Requirement 4(4).

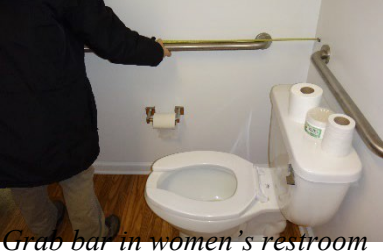
Numbers	Photos	Deficiency	Required Retrofit
5

The side wall grab bar at the women's restroom extends 51-1/4 inches from the rear wall (minimum 54 inches required).	Relocate grab bar to comply with ANSI 4.17.6.

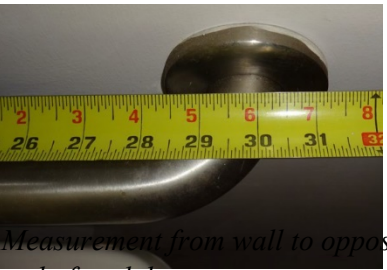
<p><i>Measurement from wall to opposite end of grab bar</i></p>	<p>The rear wall grab bars in the Community Room restrooms are 24 inches long (minimum 36 inches required).</p>

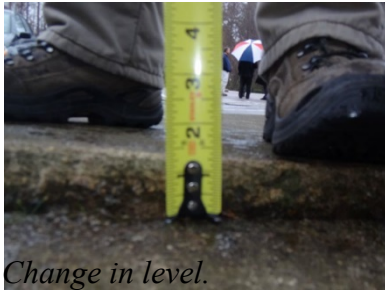
Numbers	Photos	Deficiency	Required Retrofit								
10	<div>

<p><i>Change in level.</i></p></div>	<div>The route has change in level greater than 1/2 inch (maximum 1/2 inch with bevel allowed).</div>

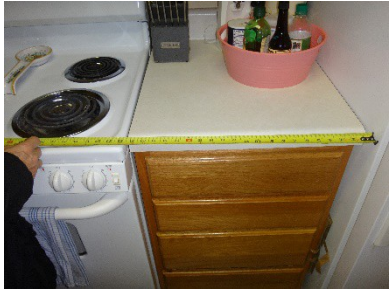
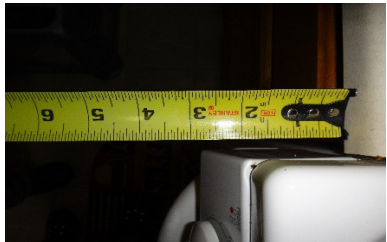
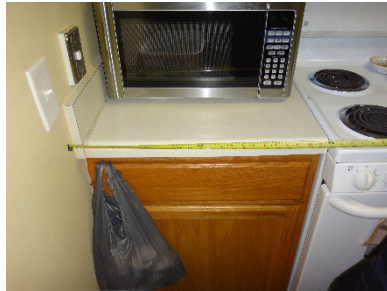
Numbers	Photos	Deficiency	Required Retrofit
21

<p><i>Clear floor space obstructed by adjacent refrigerator and range in Unit 2051-102.</i></p>	The outlets above kitchen countertops in 2 areas (both sides of the range) lack the required clear floor space for approach (at least 1 outlet in each counter area must have clear floor space for approach).	Subject to tolerances contained in the agreed-upon remediation protocols, modify existing outlet or install a GFI-rated, molded, multi-plug outlet with commercial grade components to bring outlet into compliance with Requirement #5. Any such outlet must be approved by the United States prior to installation.

<p><i>Measurement of clear floor space width.</i></p>

<p><i>Range extension from countertop.</i></p>

<p><i>Clear floor space obstructed by range in Unit 2051-102.</i></p>

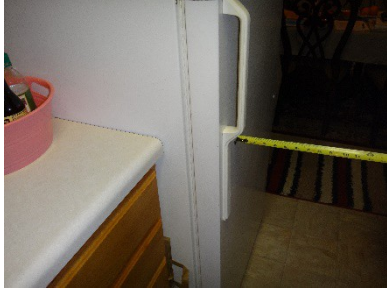
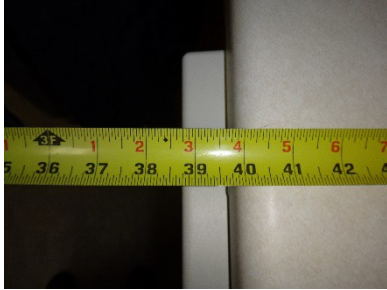
<p><i>Placement of tape between refrigerator and dishwasher in Unit 2051-102.</i></p>	The clearance between kitchen elements (face of refrigerator to face of dishwasher) is 38-3/4 inches (minimum 40 inches required).	Remediate upon resident request.

<p data-bbox="279 690 569 716"><i>Measurement of clearance.</i></p>		
23

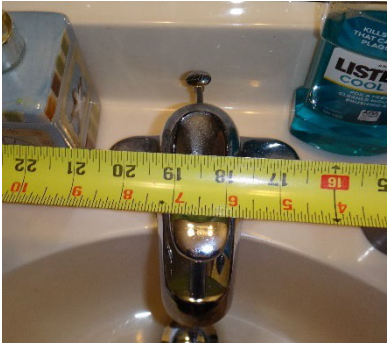
<p data-bbox="279 1084 730 1198"><i>Dimension from side wall to centerline of lavatory in Unit 2051-102.</i></p>	<p data-bbox="737 721 1339 829">The lavatory centerlines are 18-1/2 inches to the side wall (minimum 24 inches required) and the cabinets are not removable.</p>	<p data-bbox="1346 721 1652 906">Install removable base cabinet to provide clear floor space to comply with Requirement 7(2)(a)(ii).</p>

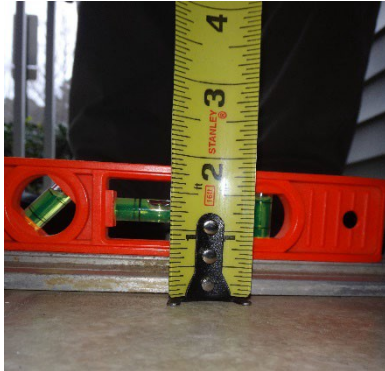
Numbers	Photos	Deficiency	Required Retrofit				
24

<p><i>Entrance door threshold interior side in Unit 2010- 104.</i></p>	Door thresholds are 5/8 inch high at the interior face and are not beveled (maximum 1/4 inch without bevel allowed).	Modify door thresholds to comply with Requirement 4(4).				
25

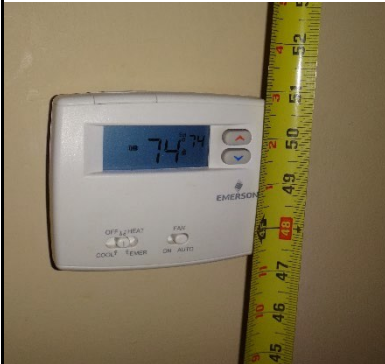
<p><i>Thermostat in Unit 2010-105.</i></p>	<p>The thermostat top controls are more than 48 inches above the floor (maximum 48 inches allowed).</p> <table><thead><tr><th><u>Location</u></th><th><u>Height (inches)</u></th></tr></thead><tbody><tr><td>Unit 2010-105</td><td>50-1/8</td></tr></tbody></table>	<u>Location</u>	<u>Height (inches)</u>	Unit 2010-105	50-1/8	Accept proposed fix. Modify thermostat at 50 1/2" to comply with Requirement 5.
<u>Location</u>	<u>Height (inches)</u>						
Unit 2010-105	50-1/8

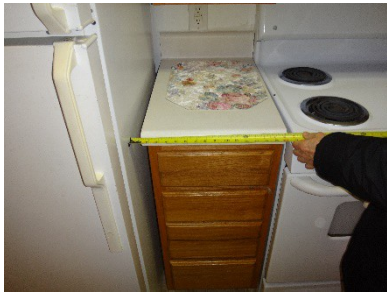
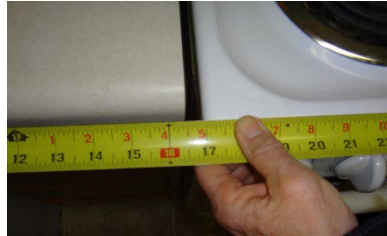
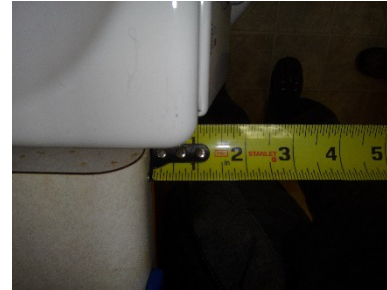
Numbers	Photos	Deficiency	Required Retrofit
26

<p><i>Clear floor space obstructed by adjacent refrigerator and range in Unit 2010-104</i></p>

<p><i>Measurement of clear floor space width.</i></p>

<p><i>Projection of range beyond</i></p>	<p>The outlet above one area of kitchen countertop lacks the required clear floor space for approach (at least 1 outlet in each counter area must have clear floor space for approach). Both the refrigerator and range are greater than 25 inches deep.</p>	<p>Subject to tolerances contained in the agreed-upon remediation protocols, modify existing outlet or install a GFI-rated, molded, multi-plug outlet with commercial grade components to bring outlet into compliance with Requirement #5. Any such outlet must be approved by the United States prior to installation.</p>

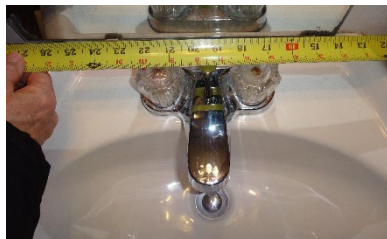
<p><i>Measurement from bathtub to lavatory centerline in Unit 2010-104.</i></p>	<p>The lavatory centerlines are less than 24 inches to the side wall (minimum 24 inches required) and knee space is not provided.</p>

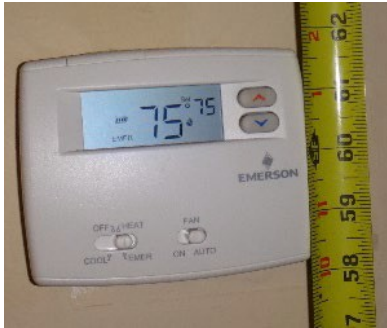
Numbers	Photos	Deficiency	Required Retrofit
30

<p><i>Thermostat in Unit 2020-101.</i></p>	The thermostat top controls are 61 inches above the floor (maximum 48 inches allowed).	Modify thermostat to comply with Requirement 5.
31		Extent of blocking in bathrooms cannot be determined without destructive testing.	Provide affidavits to confirm that reinforcement is installed to comply with Requirement 6.

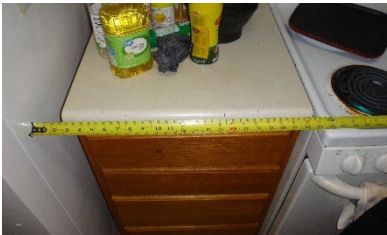
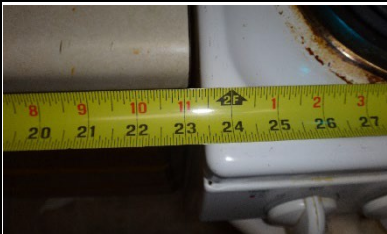
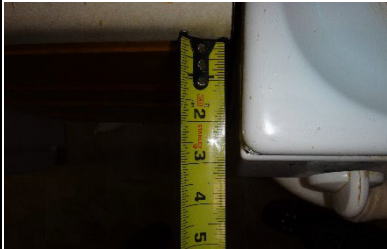
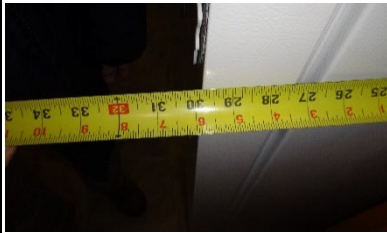
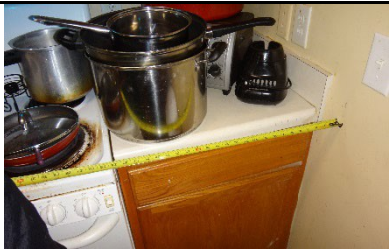
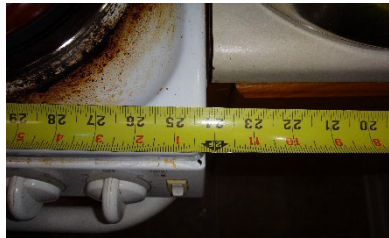
<p><i>Clear floor space obstructed by adjacent refrigerator and range in Unit 2020-101.</i></p>	The outlets above kitchen countertops in 2 areas (both sides of the range) lack the required clear floor space for approach (at least 1 outlet in each counter area must have clear floor space for approach).	Subject to tolerances contained in the agreed-upon remediation protocols, modify existing outlet or install a GFI-rated, molded, multi-plug outlet with commercial grade components to bring outlet into compliance with Requirement #5.

<p><i>Measurement of clear floor space width.</i></p>

<p><i>Range extension from countertop.</i></p>

<p><i>Refrigerator depth.</i></p>		<p>Any such outlet must be approved by the United States prior to installation.</p>

<p><i>Clear floor space obstructed by range in Unit 2020-101.</i></p>

<p><i>Measurement of clear floor space width.</i></p>		
34

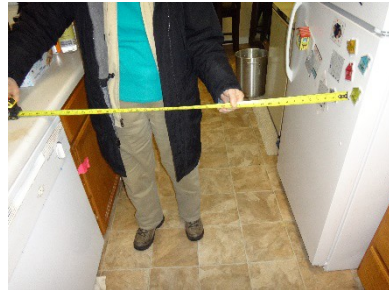
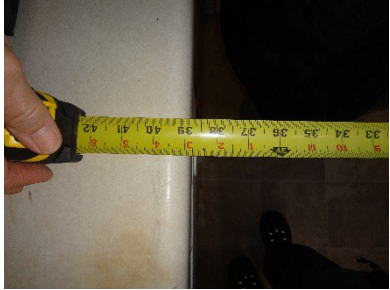
<p><i>Placement of tape between refrigerator and countertop in Unit 2020-101.</i></p>	The clearances between the refrigerator to the opposing countertop are 38-3/4 inches (minimum 40 inches required).	Remediate upon resident request.

<p data-bbox="275 678 625 709"><i>Measurement of clearance.</i></p>

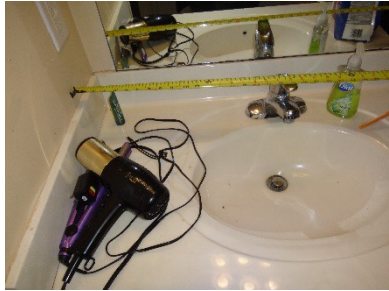
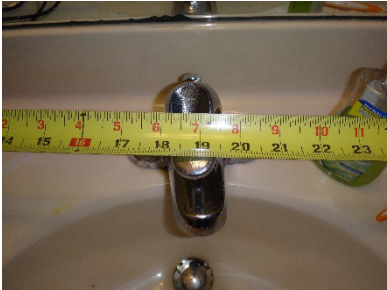
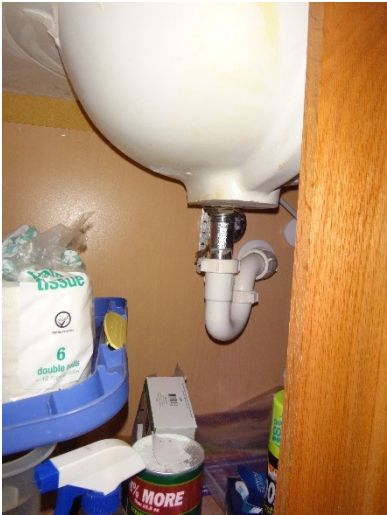
Numbers	Photos	Deficiency	Required Retrofit
35

<p><i>Lavatory in Unit 2020-101 hall bathroom.</i></p>

<p><i>Measurement from side wall to lavatory centerline.</i></p>	<p>The lavatory centerlines are less than 24 inches to the side wall (minimum 24 inches required) and the cabinets are not removable.</p>	<p>Install removable base cabinet to provide clear floor space to comply with Requirement 7(2)(a)(ii).</p>

<p data-bbox="279 922 499 953"><i>Interior of vanity.</i></p>

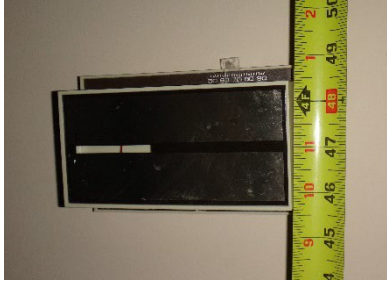
Numbers	Photos	Deficiency	Required Retrofit
36

<p><i>Thermostat in Unit 2051-108</i></p>	The thermostat top controls are 48-7/8 inches above the floor (maximum 48 inches allowed).	Modify door thresholds to comply with Requirement 4(4).
36a.		Extent of blocking in bathrooms cannot be determined without destructive testing.	Provide affidavits to confirm that reinforcement is installed to comply with Requirement 6.

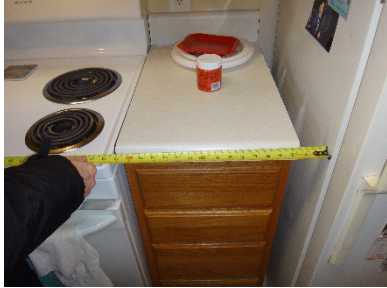
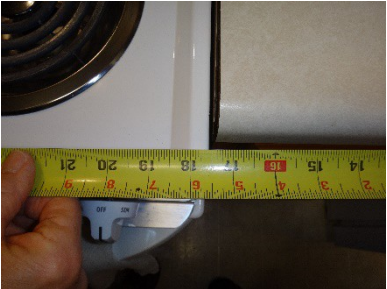
Numbers	Photos	Deficiency	Required Retrofit
37

<p><i>Clear floor space obstructed by adjacent refrigerator and range in Unit 2010-101.</i></p>

<p><i>Measurement of clear floor space width.</i></p>	<p>The outlets above kitchen countertops in 1 area lack the required clear floor space for approach (at least 1 outlet in each counter area must have clear floor space for approach).</p>	<p>Subject to tolerances contained in the agreed-upon remediation protocols, modify existing outlet or install a GFI-rated, molded, multi-plug outlet with commercial grade components to bring outlet into compliance with Requirement #5. Any such outlet must be approved by the United States prior to installation.</p>

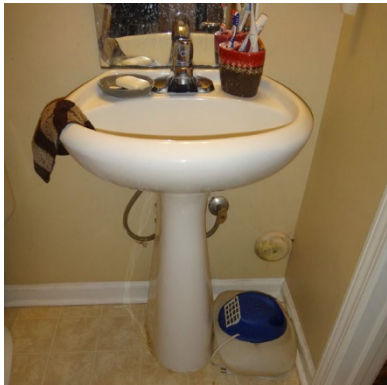
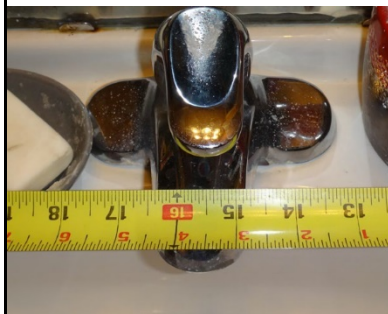
Numbers	Photos	Deficiency	Required Retrofit										
38	<div>

<p><i>Pedestal sink in Unit 2010- 101 master bathroom.</i></p></div> <div>

<p><i>Measurement from side wall to centerline of lavatory in Unit 2010-101 master bathroom.</i></p></div>	<p>The lavatory centerlines are less than 24 inches to the side wall (minimum 24 inches required) and knee space is not provided.</p>

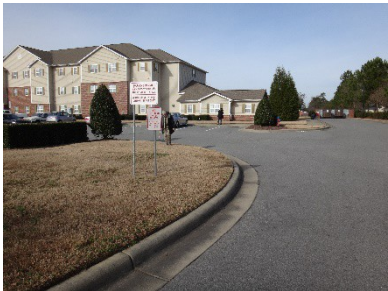
Numbers	Lack of Accessible Route	Deficiency	Required Retrofit
1

<p><i>Route along drive lane.</i></p>	There is no accessible route between pedestrian site arrival points and leasing office.	Install accessible sidewalk to Rollinwood Drive to the South.
	<b>Inaccessible Parking Features</b>		
2

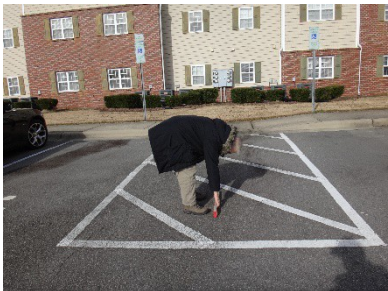
<p><i>Parking aisle location.</i></p>	Designated parking access aisle at leasing has a running slope greater than 2.0% (maximum 2% allowed).	Modify 3.9% running slope to comply with ADA 4.6.2.

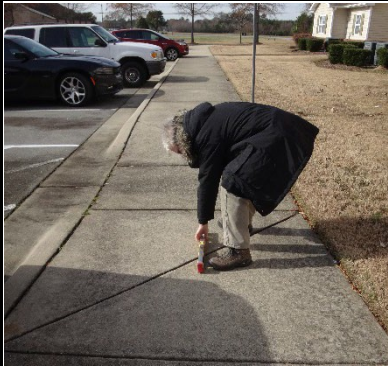
</div> <p><i>Curb ramp south of Building.</i></p> <div>

</div> <p><i>Running slope at curb ramp.</i></p>	<p>The running slope of the ramp leading to the leasing office is more than 8.3% (maximum 8.3% allowed).</p> <table><tr><td><u>Location</u></td><td><u>Slopes</u></td></tr><tr><td>South of Building (southwest of public entrance)</td><td>9.2%</td></tr></table>	<u>Location</u>	<u>Slopes</u>	South of Building (southwest of public entrance)	9.2%	<p>Modify 9.2% running slopes of curb ramp to comply with ANSI 4.7.2.</p>
<u>Location</u>	<u>Slopes</u>						
South of Building (southwest of public entrance)	9.2%						
	Inaccessible Door Features

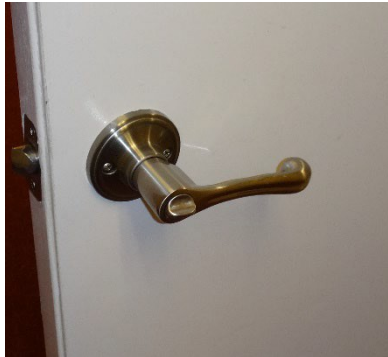
</div> <p><i>Hardware at unisex restroom door.</i></p>	The unisex restroom (closest to the management offices) door has hardware which requires tight grasping, pinching, or twisting of the wrist (not allowed).	Replace door hardware to comply with ANSI 4.13.9.										
Protruding Objects													
6	<div>

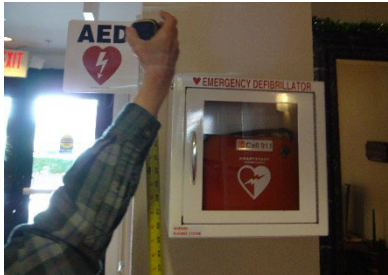
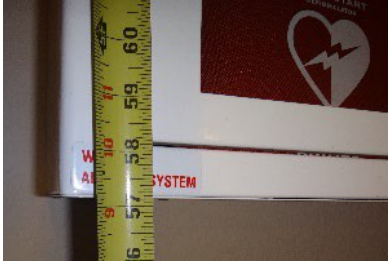
</div> <p><i>AED box in First Floor corridor.</i></p>	<p>The objects protrude more than 4 inches into the circulation path (maximum 4 inches allowed).</p> <p>Protrusion</p>

Location	(inches)	Corridor 1st Floor AED Box	7	Height of leading edge	57-1/8	1st Floor Drinking Fountain	19	Height of leading edge	32-1/4	Modify protruding objects that project more than 5" into the circulation path to comply with ANSI 4.4.1.
Location	(inches)												
Corridor 1st Floor AED Box	7												
Height of leading edge	57-1/8												
1st Floor Drinking Fountain	19												
Height of leading edge	32-1/4

<p><i>AED box height.</i></p>

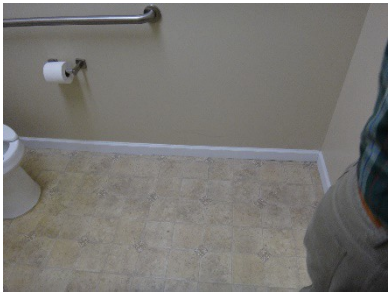
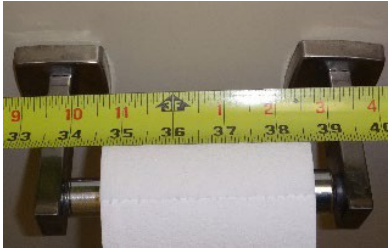
<p><i>Toilet in unisex restroom</i></p>	The leading edge of the toilet paper dispenser is 39-1/2 inches from the rear wall (maximum 36 inches allowed).	Modify toilet paper dispenser to comply with ANSI 4.16.6.

<p><i>Dimension from rear wall to toilet paper dispenser.</i></p>		
8

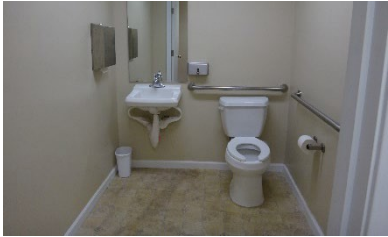
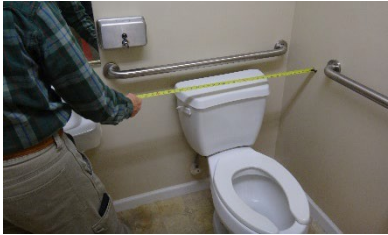
<p><i>Toilet in public unisex restroom.</i></p>

<p><i>Width from side wall to lavatory in public unisex restroom.</i></p>	The toilet clearance is 42 inches wide (minimum 48 inch width by 66 inch depth required).	Modify toilet clearance to comply with ANSI 4.16.2.

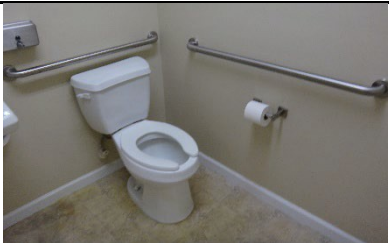
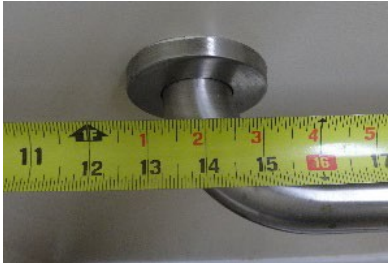
<p><i>Grab bar in unisex restroom.</i></p>

<p><i>Dimension of side grab bar from rear wall</i></p>	The side wall grab bar starts 13-7/8 inches from the rear wall (maximum 12 inches allowed).	Relocate grab bar to comply with ANSI 4.17.6.
	<b>Additional Information Based on ADAAG</b>

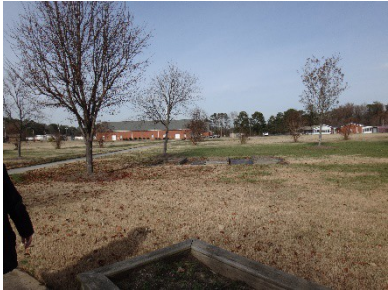
<p><i>No route to garden.</i></p>	There is no accessible route to the garden area.	Modify to comply with Requirement 2.
	<b>Inaccessible Changes in Level</b>		
12

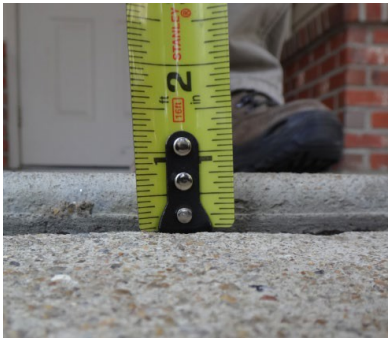
<p><i>Change in level at east entrance.</i></p>	Outside the east entry, at the edge of the stoop, there a change in level that is 3/4 inches high and is not beveled (maximum 1/4 inch allowed without bevel).	Modify level change to comply with ANSI 4.5.2.
	<b>Inaccessible Slopes</b>

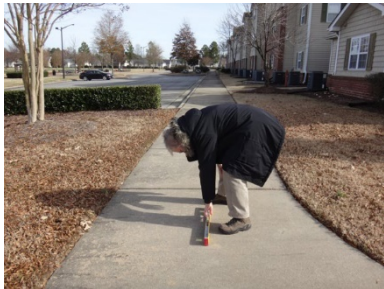
</div> <p><i>Northwest of building at west driveway.</i></p> <div>

<p>A maximum 2% cross slope is allowed at an accessible route. (Guidelines Requirement 1; Guidelines Requirement 2 Chart; ANSI 1986 4.3.7).</p>	Location	Slope	Northwest of Building	3.9%	Northwest of Building	3.3%	Northwest of Building	3.5%	Northwest of Building	3.9%	Northwest of Building	3.4%	Northeast of Building	3.4%	<p>Modify 3.3%, 3.9%, 3.5%, 3.9%, 3.4%, 3.4% cross slopes to comply with ANSI 4.3.7.</p>
Location	Slope																
Northwest of Building	3.9%																
Northwest of Building	3.3%																
Northwest of Building	3.5%																
Northwest of Building	3.9%																
Northwest of Building	3.4%																
Northeast of Building	3.4%

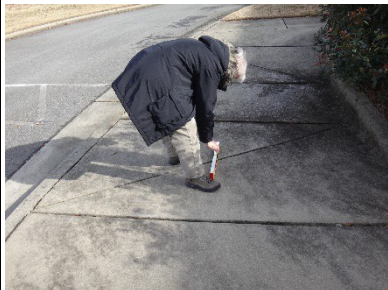
</div> <p><i>Curb ramp measurement location.</i></p> <div>

</div> <p><i>Running slope</i></p>	Running slope of the curb ramp north of the building is 10.1% (maximum 8.3% allowed).	Modify curb ramp to comply with ANSI 4.7.2.										
15	<div>

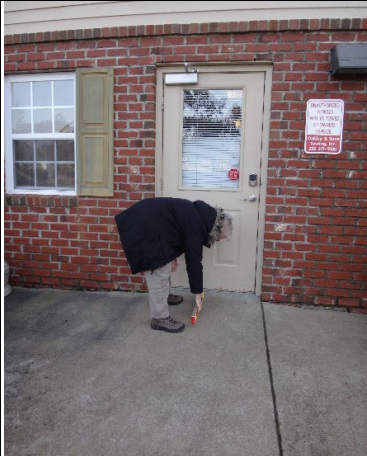
</div> <p><i>North entrance door.</i></p>	<p>Common door maneuvering clearances are sloped greater than 2.0% (maximum 2% allowed).</p>

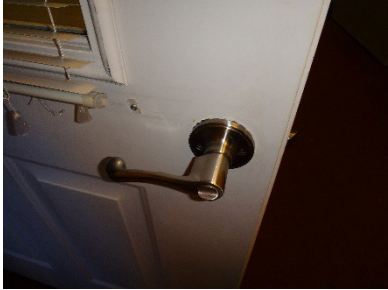
<p><i>Hardware at community room door.</i></p>	<p>The doors have hardware which requires tight grasping, pinching, or twisting of the wrist (not allowed) to operate either the latch or the lock.</p> <p>This is a typical hardware feature throughout building common areas (not an exhaustive list).</p> <p><u>Location</u>  Third Floor Community Room  Third Floor Library  First Floor Unisex Restroom 2</p>	<p>Replace hardware to comply with 4.13.9.</p>
	<b>Protruding Objects</b>

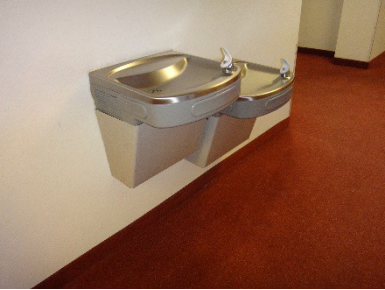
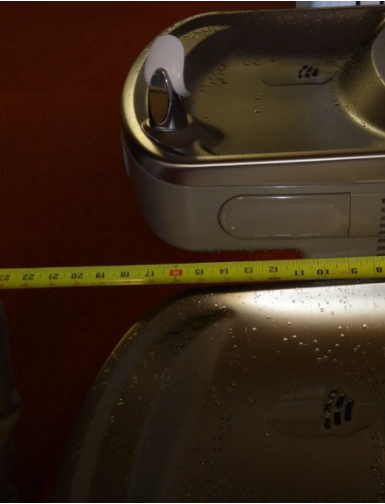
<p><i>Drinking fountain in third floor corridor.</i></p>

<p><i>Height of bottom edge.</i></p>	<p>Drinking fountain protrudes approximately 19 inches into the circulation path (maximum 4 inches allowed).</p> <p><u>Location</u>  Second Floor Corridor  Height of leading edge                      32-3/8  Third Floor Corridor  Height of leading edge                      32-3/4</p>	<p>Modify protruding objects that project more than 5" into the circulation path to comply with ANSI 4.4.1.</p>

<p><i>Projection from the wall.</i></p>

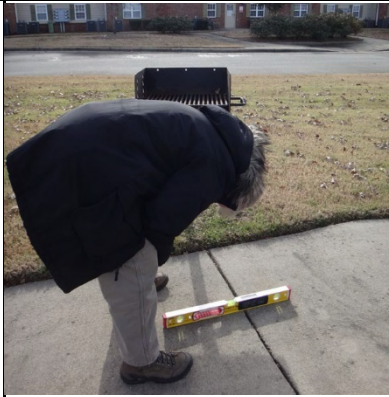
<p><i>Grill at common area</i></p>

<p><i>Cross slope at grill.</i></p>	Clear floor space at the grill northeast of the building slopes 3.5% (maximum 2% allowed).	Modify 3.5% slope to comply with ANSI 4.3.7.
19

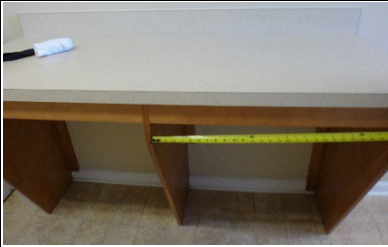
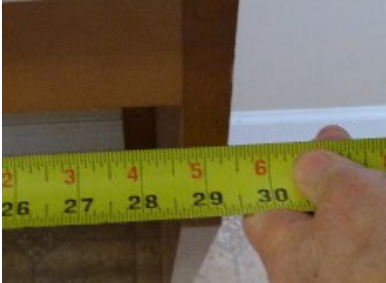
<p><i>Knee space at work surface in Laundry Room</i></p>	The clear width of the knee space at the laundry work surface is 28-5/8 inches (minimum 30 inches clear width required).	Modify knee space to comply with ANSI 4.30.3.

<p><i>Width of knee space.</i></p>		
20

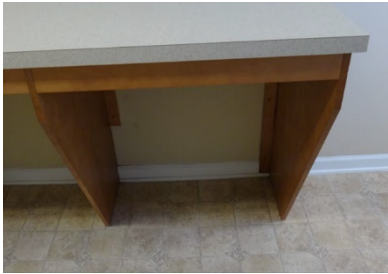
<p><i>Laundry room work space</i></p>

<p><i>Counter height.</i></p>	Countertop at laundry work surface is 36-1/4 inches above the floor (maximum 34 inches allowed).	Modify countertop to comply with ANSI 4.30.4

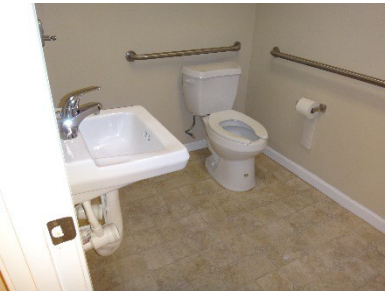
<p><i>Single user restroom.</i></p>

<p><i>Centerline of toilet.</i></p>	The toilet centerline at one third floor single user restroom is 19 inches from the side wall (maximum 18 inches allowed).	Modify toilet by installing offset toilet flange to comply with ANSI 4.16.2.
23
