IN THE UNITED STATES DISTRICT COURT  
FOR THE EASTERN DISTRICT OF NORTH CAROLINA  
WESTERN DIVISION  
No. 5:21-cv-00395-M

**INDEX OF CONSENT ORDER EXHIBITS**

Milburnie Road Matrix of Required Retrofits to Public and Common Use Areas.

# MILBURNIE ROAD APARTMENTS: PUBLIC AND COMMON USE AREAS

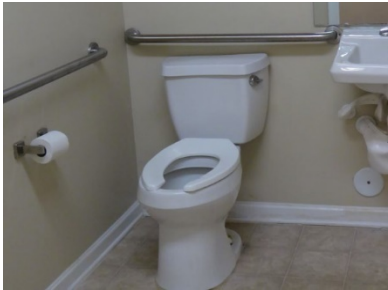
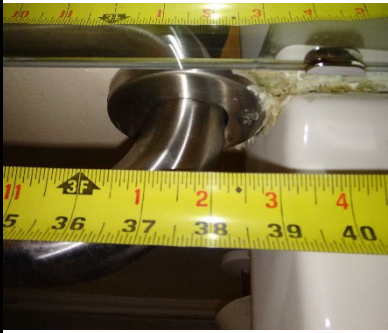
<p><i>Single user restroom.</i></p>	The rear wall grab bars extends 20 inches from the toilet centerline (minimum 24 inches required). The extension from the sidewall is 37-1/2 inches (minimum 42 inches required).	Relocate grab bar to comply with ANSI 4.17.6.

<p><i>Grab bar extension from side wall.</i></p>

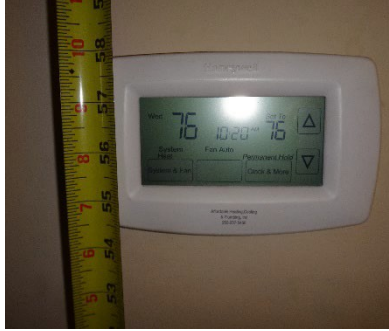
<p><i>Thermostat in Unit 167.</i></p>	Thermostat top controls are 57 inches above the floor (maximum 48 inches allowed).	Modify thermostat to comply with Requirement 5.

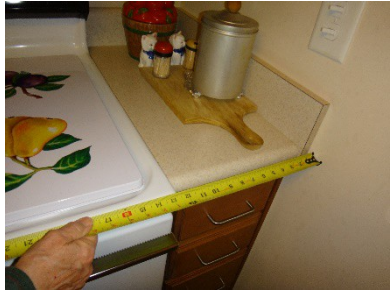
<p><i>Clear floor space obstructed by adjacent range. Unit 167.</i></p>

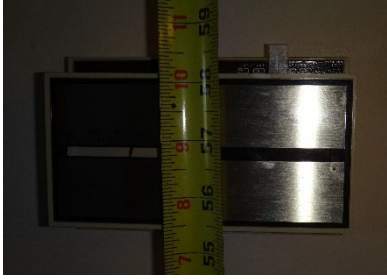
<p><i>Thermostat in Unit 254.</i></p>	Thermostat top controls are 58-5/8 inches above the floor (maximum 48 inches allowed).	Modify thermostat to comply with Requirement 5.

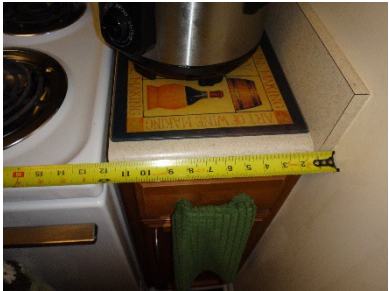
<p><i>Clear floor space obstructed by adjacent range.</i></p>

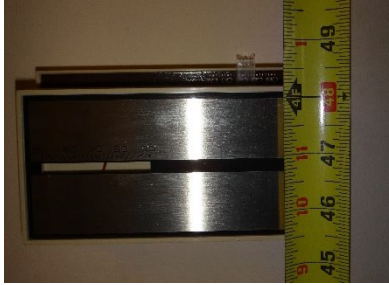
<p><i>Thermostat in Unit 225.</i></p>	<p>Thermostat top controls are 48-3/4 inches above the floor (maximum 48 inches allowed).</p> <p>(Guidelines, Requirement 5; ANSI 1986 4.25.3; ANSI 1986 Figure 5(a)).</p>	<p>Modify thermostat to comply with Requirement 5.</p>

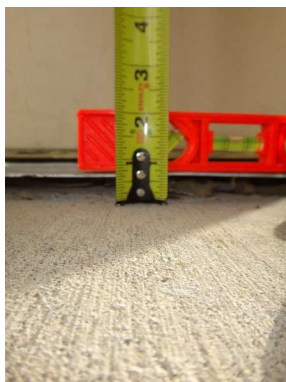
</div> <p><i>Unit 4141-104 entrance door.</i></p>	<p>Entrance door thresholds are more than 1/4 inches high and are not beveled (maximum 1/4-inch height allowed without bevel).</p>

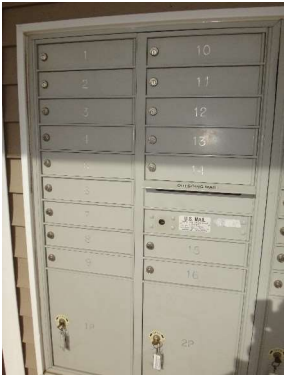
<p>Mail center at Building 1.</p></div><div>

<p>Typical mailbox frame.</p></div><div>

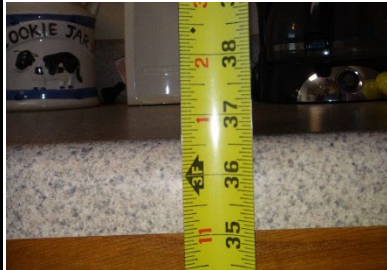
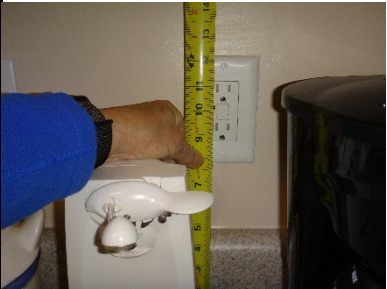
<p><i>Height of kitchen countertop in Unit 4137-102.</i></p>

<p><i>Outlet over countertop in Unit 4137-102.</i></p></div>	<p>Kitchen and bathroom outlets over counters are more than 46 inches above the floor (maximum 46 inches allowed).</p>

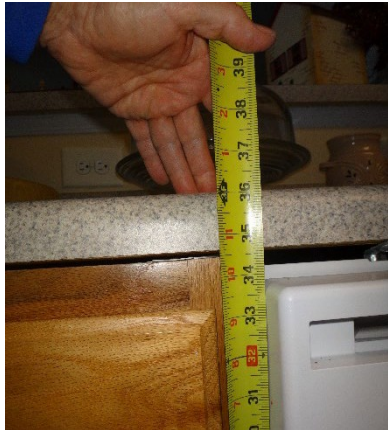
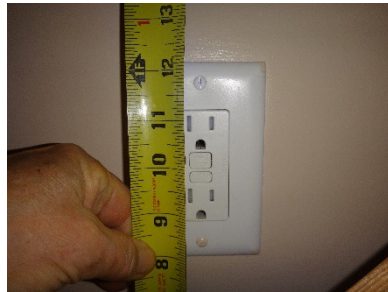
<p><i>Height of kitchen countertop in Unit 4137-104.</i></p>

<p><i>Outlet over countertop in Unit 4137-104</i></p></div>	<p>Outlets over counters are more than 46 inches above the floor (maximum 46 inches allowed).</p>

Height	<u>Location</u>	<u>(inches)</u>	Unit 4129-101 hall bath	47-1/4	<p>In accordance with agreed-upon tolerances, modify existing outlet or install a GFI-rated, molded, multi-plug outlet with commercial grade components to bring outlet into compliance with Requirement #5. Any such outlet must be approved by the United States prior to installation.</p>
	Height								
<u>Location</u>	<u>(inches)</u>								
Unit 4129-101 hall bath	47-1/4

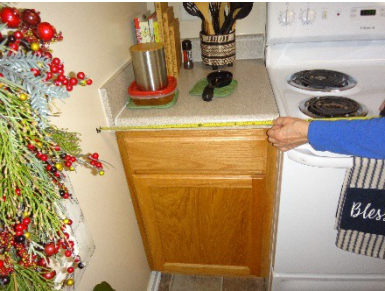
<p><i>Counter area left of range in Unit 4137-104.</i></p>

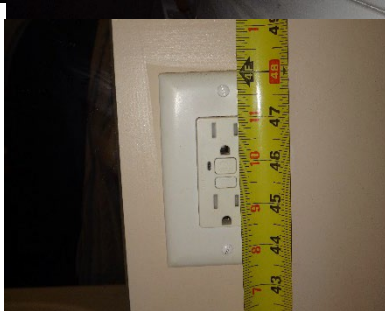
<p><i>Outlet over countertop in Unit 101, Building 4.</i></p>	<p>Outlets over obstructions are more than 46 inches above the floor (maximum 46 inches allowed).</p> <table> <tr> <th>Location</th> <th>Height (inches)</th> </tr> <tr> <td>Unit 4125-101 hall bath</td> <td>47-1/4</td> </tr> </table>	Location	Height (inches)	Unit 4125-101 hall bath	47-1/4	<p>In accordance with agreed-upon tolerances, modify existing outlet or install a GFI-rated, molded, multi-plug outlet with commercial grade components to bring outlet into compliance with Requirement #5. Any such outlet must be approved by the United States prior to installation.</p>
Location	Height (inches)						
Unit 4125-101 hall bath	47-1/4

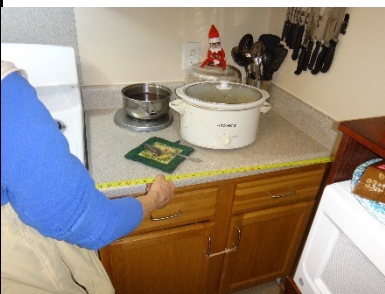
<p data-bbox="281 545 709 610"><i>Counter area right of range in Unit 4133-101.</i></p> <p data-bbox="281 902 653 935"><i>Measurement of counter width.</i></p> <p data-bbox="281 1243 678 1276"><i>Range extension from countertop</i></p>	<p>Outlets above kitchen countertops lack the required clear floor space for approach (at least 1 outlet in each counter area must have clear floor space for approach).</p>	<p>In accordance with agreed-upon tolerances, modify existing outlet or install a GFI-rated, molded, multi-plug outlet with commercial grade components to bring outlet into compliance with Requirement #5. Any such outlet must be approved by the United States prior to installation.</p>

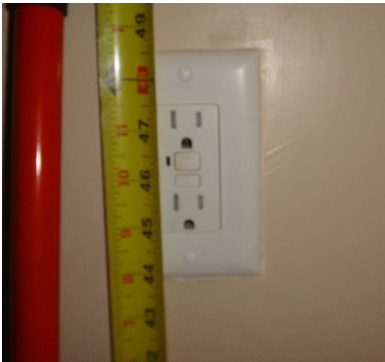
</div> <p><i>Outlet over vanity in Unit 4121-104.</i></p>	<p>Outlets over obstructions are more than 46 inches above the floor (maximum 46 inches allowed).</p>

Height	<u>Location</u>	<u>(inches)</u>	Unit 4121-104 hall bath	47-3/8	<p>In accordance with agreed-upon tolerances, modify existing outlet or install a GFI-rated, molded, multi-plug outlet with commercial grade components to bring outlet into compliance with Requirement #5. Any such outlet must be approved by the United States prior to installation.</p>
	Height								
<u>Location</u>	<u>(inches)</u>								
Unit 4121-104 hall bath	47-3/8								
26	<div>

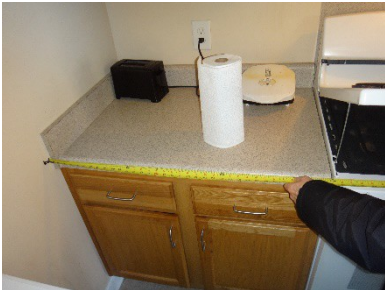
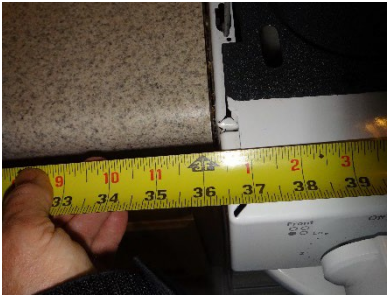
</div> <p><i>Counter area left of range in Unit 4121-104.</i></p>	<p>Outlet above kitchen countertop lacks the required clear floor space for approach (at least 1 outlet in each counter area must have clear floor space for approach).</p>	<p>In accordance with agreed-upon tolerances, modify existing outlet or install a GFI-rated, molded, multi-plug outlet with commercial grade components to bring outlet into compliance with Requirement #5. Any such outlet must be approved by the United States prior to installation.</p>

<p><i>Measurement of counter width.</i></p>

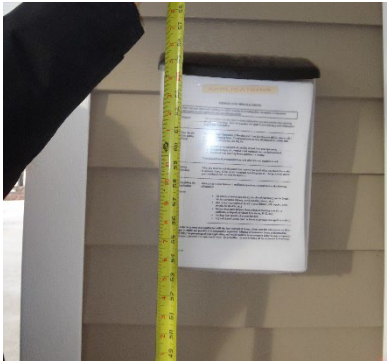
<p><i>Brochure holder.</i></p>	The brochure holder is 55-1/2 inches above the floor (maximum 54 inches allowed).	Relocate brochure holder to comply with ANSI 4.2.6.
<b>Inaccessible Restroom Features</b>			
2

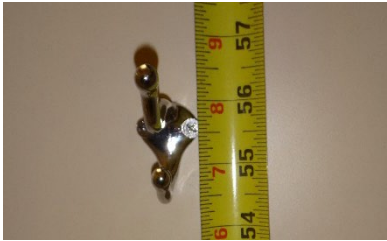
<p><i>Height of coat hook in women's restroom.</i></p>	The women's restroom coat hook is more than 56-1/2 inches above the floor (maximum 54 inches allowed).	Modify coat hook to comply with ANSI 4.2.6.

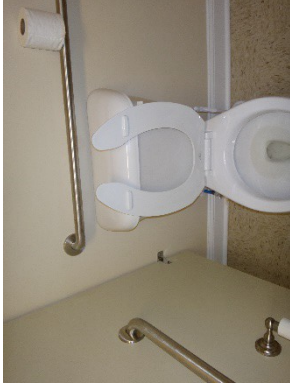
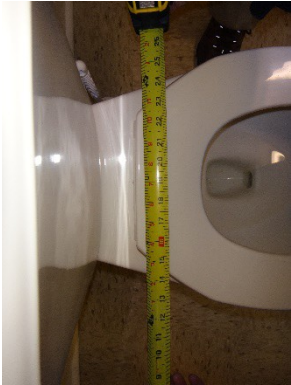
<p><i>Toilet in men's restroom.</i></p>

<p><i>Dimension from wall to toilet centerline.</i></p>	<p>The men's restroom toilet centerline is approximately 19-1/2 inches from the side wall (maximum 18 inches required).</p>	<p>Modify toilet by installing offset toilet flange to comply with ANSI 4.16.2.</p>
4

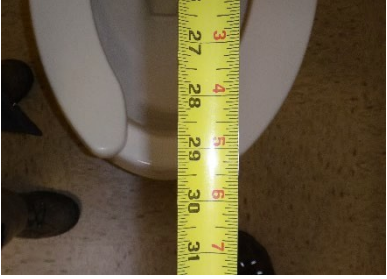
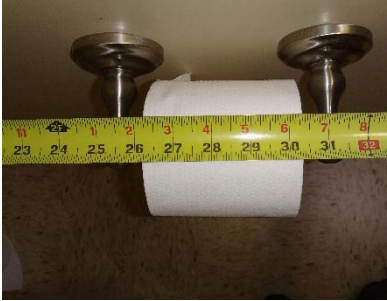
<p><i>Toilet in women's restroom.</i></p>	<p>The toilet paper dispensers are not in front of the nose of the toilets, are less than 7 inches from the nose of the toilet, and are less than 36 inches from the back wall (minimum 7 inches and maximum 9 inches required from nose of toilet).</p>	<p>Modify toilet paper dispenser to comply with ANSI 4.16.6.</p>

<p><i>Dimension from rear wall to nose of toilet.</i></p>

<p><i>Dimension from rear wall to toilet paper dispenser.</i></p>

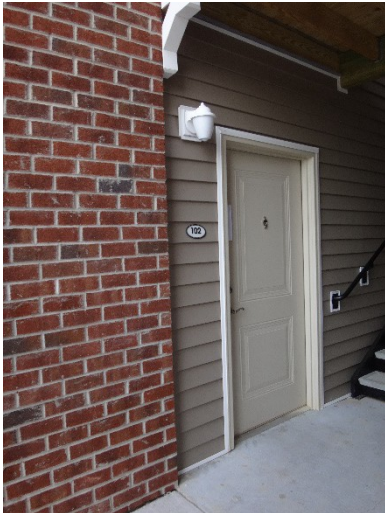
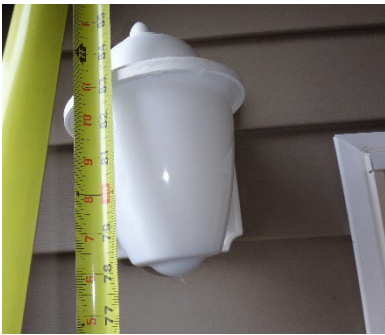
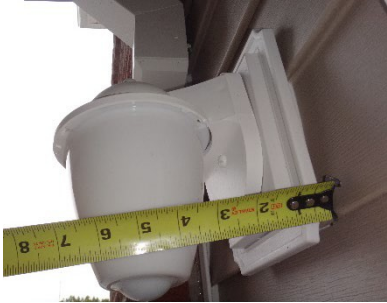
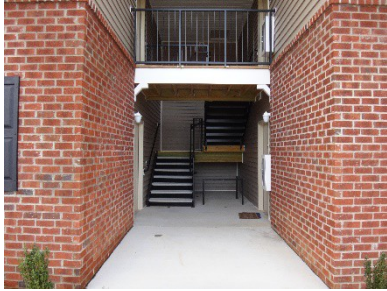
<p><i>Light fixture at unit 102 breezeway.</i></p>

<p><i>Protruding height</i></p></div>	<p>Typical breezeway lights and fire extinguisher cabinets protrude more than 4 inches into the circulation path (maximum 4 inches allowed). Each breezeway has two lights and one fire extinguisher cabinet at the first floor.</p>

<p><i>Protruding depth.</i></p>

<p><i>Typical breezeway</i></p>		
	<b>Other Inaccessible Common Area Features</b>

Breezeway	Protrusion	<u>Location</u>	<u>(inches)</u>	Unit 102 light fixture		Depth of protrusion	6-1/2	Height to bottom	77-3/4	<p>Modify protruding objects that project more than 5" into the circulation path to comply with ANSI 4.4.1.</p>
Breezeway	Protrusion												
<u>Location</u>	<u>(inches)</u>												
Unit 102 light fixture													
Depth of protrusion	6-1/2												
Height to bottom	77-3/4

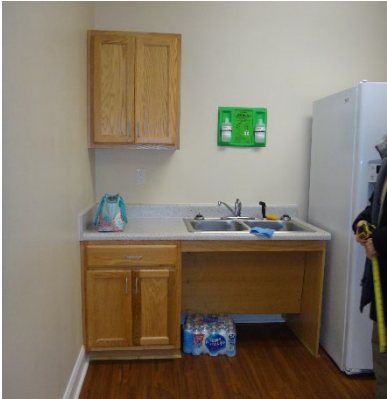
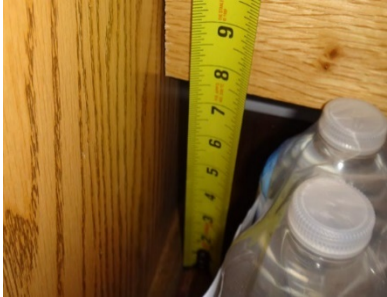
<p><i>Sink at kitchenette.</i></p>

<p><i>Measurement of toe space.</i></p>	Toe space at kitchenette is 7-1/2 inches high (minimum 9 inches required).	Modify toe space to comply with ANSI 4.19.3.

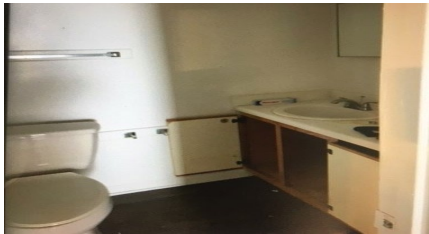
In the hall bathroom, the centerline of the lavatory is less than 24" from adjacent wall; measured at 14 1/2.	Replace lavatory base cabinet and install offset sink such that lavatory is aligned with clear floor space. Include removable cabinet that is no less than 30" wide. Removal of the cabinet must provide finished clear knee space centered on the lavatory and insulated pipes to comply with Requirement (7)(2)(a)(ii).
<p><b>Required retrofits associated with the below line items shall be performed at all two-bedroom first floor units in Buildings 100 and 200 on Tobler Court, and in Buildings 200, 400, 600 and 700 on Wittenberg Way. See Accessible Route Plan &amp; Keyed Notes.</b></p>

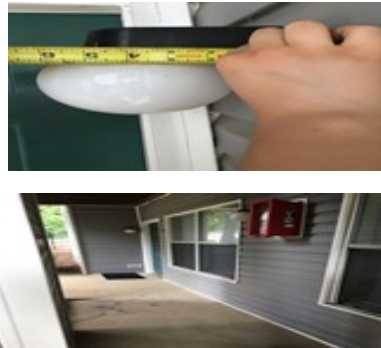
<p>At all ground-floor covered unit entrances, light fixtures protrude more than 4" into the accessible route and are mounted between 27" to less than 80" above the ground level; measured at approximately 6" from adjacent wall.</p>	<p>Relocate the light fixtures to no less than 80" above the ground level or replace with a compliant fixture that will not protrude more than 4" from adjacent wall to comply with ANSI 4.4.1. Alternatively, install cane detection.</p>

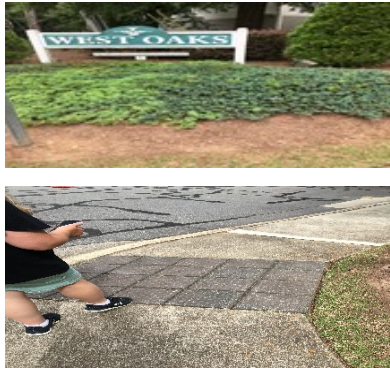
At the entrance to West Oaks at Brewer Street, the curb ramp has cross slopes exceeded 2% maximum.	Modify curb ramp to comply with ANSI 4.7.2 and 4.8.2 contingent upon approval from the City of Raleigh.
9	See Accessible Route Plan and Key Plan.	At between the dumpster pad and Building 2117/unit 101, the in-line curb ramp has cross slopes greater than 2% maximum.	Modify curb ramp to comply with ANSI 4.7.2 and 4.8.2.

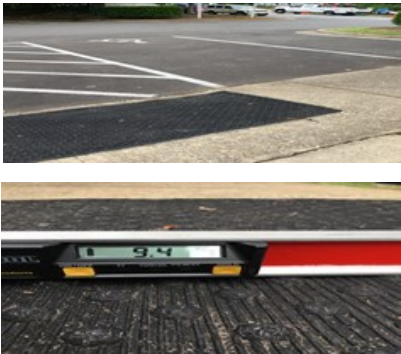
<p>At the Flavion Drive building, the in-line curb ramps have cross slopes greater than 2% maximum at the following two locations: 1. Across from the entry sidewalk to Unit 106; and 2. Across from the entry sidewalk to Unit 101.</p>	<p>Modify curb ramp to comply with ANSI 4.7.2 and 4.8.2.</p>

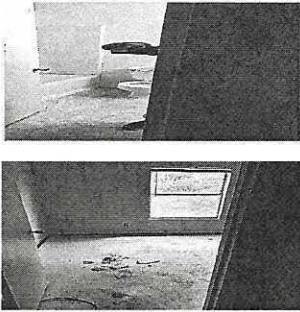
<p>The door clear openings for the bathrooms and Bedrooms 1 and 2 are less than 31 5/8" (minimum 31 5/8" required). See attached plan for measurements.</p>	<p>Widen the bathroom doors and doors to Bedroom 1 and Bedroom 2 to provide 31 5/8" minimum to comply with Requirement 3(2).</p>
	<p>Required retrofits associated with the below line items shall be performed at two three-bedroom first floor units. See Accessible Route Plan.</p>

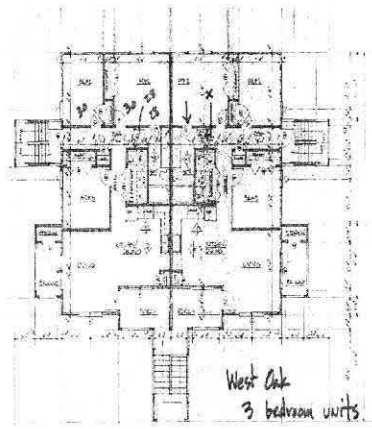
A detailed floor plan of a three-bedroom apartment unit. The plan shows the layout of the bedrooms, bathroom, kitchen, and living areas. Arrows and numbers are used to indicate specific door clearances. A handwritten note at the bottom of the plan reads "West Oaks 3 bedroom units".	The door clear openings for Bedrooms 1, 2, and 3 are less than 31 5/8" (minimum 31 5/8" required). See attached plan for measurements.	Widen the doors to Bedrooms 1, 2, and 3 to provide 31 5/8" minimum to comply with Requirement 3(2).
7	See plan in line item #6 for measurements.	The door clear opening for the hall bathroom is less than 31 5/8" (minimum 31 5/8" required).	Widen the hall bathroom door to provide 31 5/8" minimum to comply with Requirement 3(2).
7a	See plan in line item #6 for measurements.	The clear floor space outside of door swing in the hall bathroom is less than 30"x48".	Reverse the swing of door out into the hallway to provide a clear floor space to comply with Requirement 7(2)(b)(i).
