Hodges Creek Matrix of Required Retrofits to Covered Unit Interiors

## HODGES CREEK APARTMENTS: COVERED UNIT INTERIORS

### D. INACCESSIBLE FEATURES IN COVERED DWELLING UNITS Unit Types by Building:

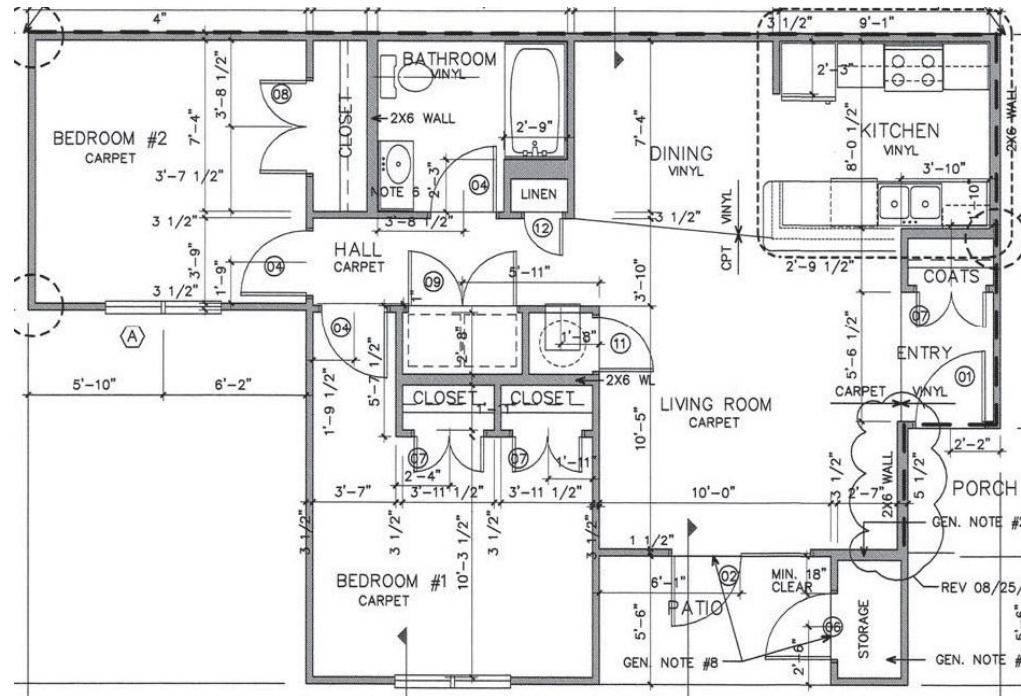
Unit Plan. (A03/01).

Surveyed Unit 2051-102 – Typical for 2 total units

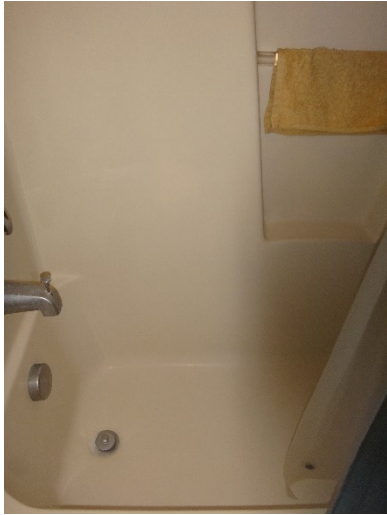
| Numbers | Photos | Deficiency | Required Retrofit |
|---|---|---|---|
| 20 | <p><i>Bathtub/shower surround in Unit 2051-102.</i></p> | The shape of the bathtub surrounds precludes the installation of future grab bars with firm attachment to blocking (ability to install grab bars required). | Remediate upon resident request. |

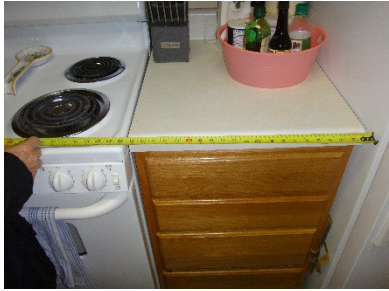
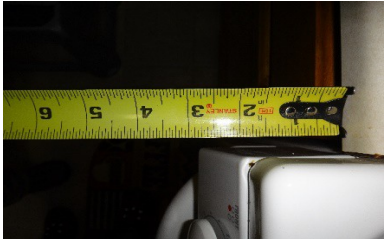
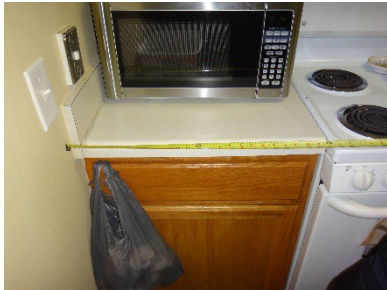
| Numbers | Photos | Deficiency | Required Retrofit |
|---|---|---|---|
| 21 | <p><i>Clear floor space obstructed by adjacent refrigerator and range in Unit 2051-102.</i></p> | The outlets above kitchen countertops in 2 areas (both sides of the range) lack the required clear floor space for approach (at least 1 outlet in each counter area must have clear floor space for approach). | Subject to tolerances contained in the agreed-upon remediation protocols, modify existing outlet or install a GFI-rated, molded, multi-plug outlet with commercial grade components to bring outlet into compliance with Requirement #5. Any such outlet must be approved by the United States prior to installation. |

| Numbers | Photos | Deficiency | Required Retrofit |
|---|---|---|---|
| | <p><i>Measurement of clear floor space width.</i></p> <p><i>Range extension from countertop.</i></p> <p><i>Clear floor space obstructed by range in Unit 2051-102.</i></p> | | |

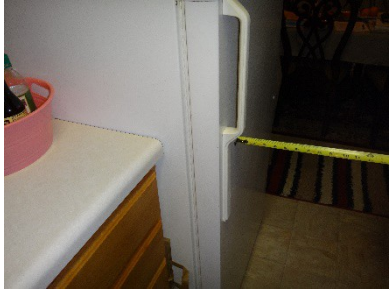
| Numbers | Photos | Deficiency | Required Retrofit |
|---|---|---|---|
| 22 | <p><i>Placement of tape between refrigerator and dishwasher in Unit 2051-102.</i></p> | <p>The clearance between kitchen elements (face of refrigerator to face of dishwasher) is 38-3/4 inches (minimum 40 inches required).</p> | <p>Remediate upon resident request.</p> |

| Numbers | Photos | Deficiency | Required Retrofit |
|---|---|---|---|
| | <p data-bbox="279 690 569 716"><i>Measurement of clearance.</i></p> | | |

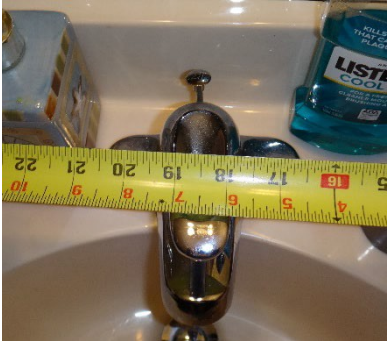
| Numbers | Photos | Deficiency | Required Retrofit |
|---|---|---|---|
| 23 | <p data-bbox="279 1084 730 1198"><i>Dimension from side wall to centerline of lavatory in Unit 2051-102.</i></p> | <p data-bbox="737 721 1339 829">The lavatory centerlines are 18-1/2 inches to the side wall (minimum 24 inches required) and the cabinets are not removable.</p> | <p data-bbox="1346 721 1652 906">Install removable base cabinet to provide clear floor space to comply with Requirement 7(2)(a)(ii).</p> |

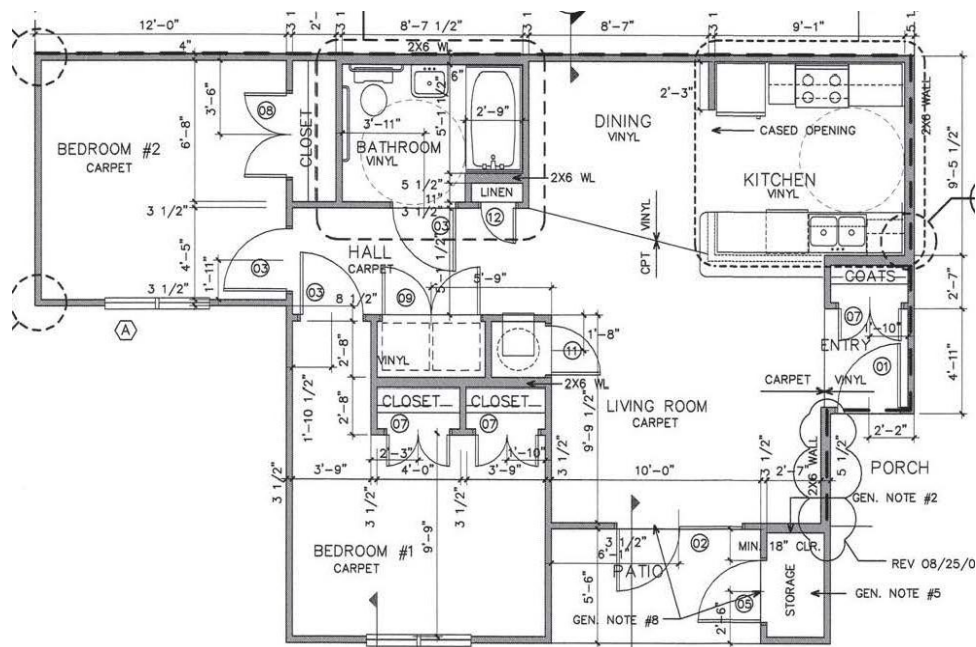
*Unit Plan. (A03/02).*

Surveyed Unit 2010-104, Unit 2010-105, Unit 2010-106, and Unit 2051-103 – Typical for 10 total units

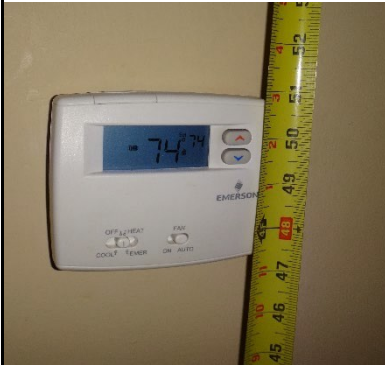
<p><i>Thermostat in Unit 2010-105.</i></p>                            | <p>The thermostat top controls are more than 48 inches above the floor (maximum 48 inches allowed).</p> <table><thead><tr><th><u>Location</u></th><th><u>Height (inches)</u></th></tr></thead><tbody><tr><td>Unit 2010-105</td><td>50-1/8</td></tr></tbody></table> | <u>Location</u>                                         | <u>Height (inches)</u> | Unit 2010-105 | 50-1/8 | Accept proposed fix. Modify thermostat at 50 1/2" to comply with Requirement 5. |
| <u>Location</u> | <u>Height (inches)</u> | | | | | | |
| Unit 2010-105 | 50-1/8 | | | | | | |

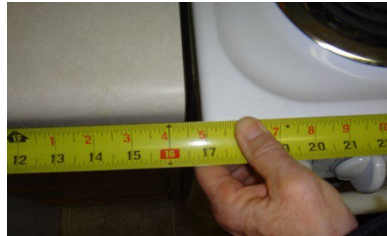
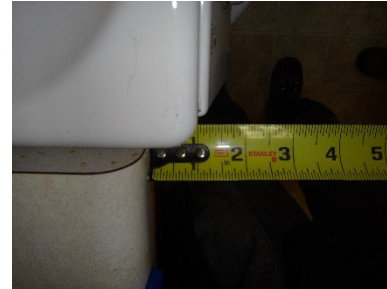
| Numbers | Photos | Deficiency | Required Retrofit |
|---|---|---|---|
| 26 | <p><i>Clear floor space obstructed by adjacent refrigerator and range in Unit 2010-104</i></p> <p><i>Measurement of clear floor space width.</i></p> <p><i>Projection of range beyond</i></p> | <p>The outlet above one area of kitchen countertop lacks the required clear floor space for approach (at least 1 outlet in each counter area must have clear floor space for approach). Both the refrigerator and range are greater than 25 inches deep.</p> | <p>Subject to tolerances contained in the agreed-upon remediation protocols, modify existing outlet or install a GFI-rated, molded, multi-plug outlet with commercial grade components to bring outlet into compliance with Requirement #5. Any such outlet must be approved by the United States prior to installation.</p> |

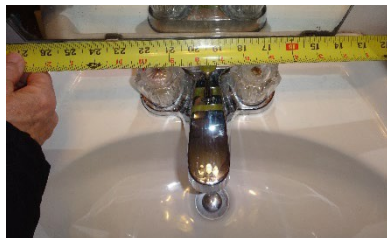
<p><i>Pedestal sink in Unit 2010- 104.</i></p>

<p><i>Measurement from bathtub to lavatory centerline in Unit 2010-104.</i></p> | <p>The lavatory centerlines are less than 24 inches to the side wall (minimum 24 inches required) and knee space is not provided.</p>

<table><tr> <th>Location</th> <th>Distance (inches)</th> </tr><tr> <td>Unit 2010-104 bathroom</td> <td>19-1/2</td> </tr><tr> <td>Unit 2051-103 bathroom</td> <td>18 +/-</td> </tr></table>

| Location | Distance (inches) | Unit 2010-104 bathroom | 19-1/2 | Unit 2051-103 bathroom | 18 +/- | <p>Install removable base cabinet to provide clear floor space to comply with Requirement 7(2)(a)(ii).</p> |
| Location | Distance (inches) | | | | | | | | |
| Unit 2010-104 bathroom | 19-1/2 | | | | | | | | |
| Unit 2051-103 bathroom | 18 +/- | | | | | | | | |

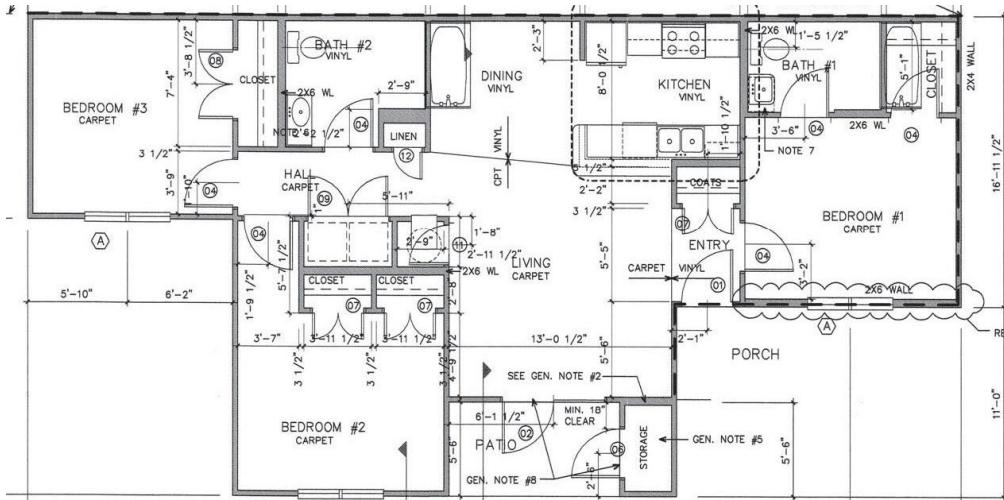
*Unit Plan. (A03/03).*

Surveyed Unit 2020-101 – Typical for 3 total units

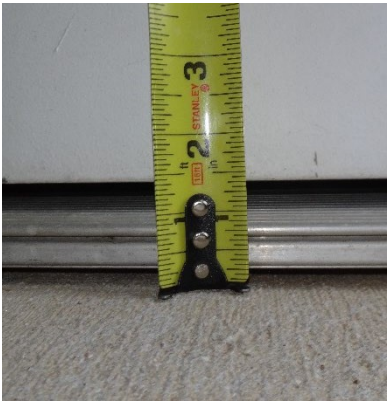
| Numbers | Photos | Deficiency | Required Retrofit |
|---|---|---|---|
| 29 | <p><i>Measurement of storage room threshold at Unit 2020- 101.</i></p> | Door thresholds are 3/4 inch high and are not beveled (maximum 1/4 inch without bevel allowed). | Modify door thresholds to comply with Requirement 4(4). |

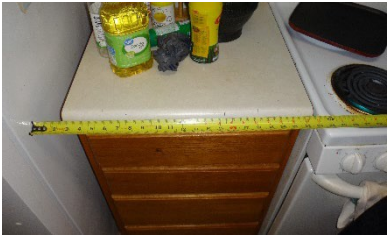
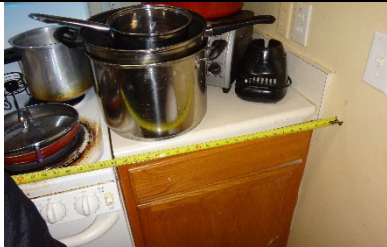
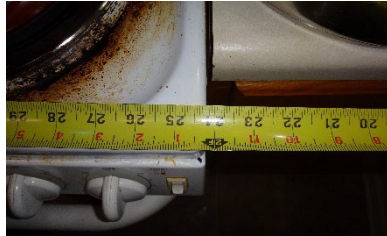
| Numbers | Photos | Deficiency | Required Retrofit |
|---|---|---|---|
| 33 | <p><i>Clear floor space obstructed by adjacent refrigerator and range in Unit 2020-101.</i></p> | The outlets above kitchen countertops in 2 areas (both sides of the range) lack the required clear floor space for approach (at least 1 outlet in each counter area must have clear floor space for approach). | Subject to tolerances contained in the agreed-upon remediation protocols, modify existing outlet or install a GFI-rated, molded, multi-plug outlet with commercial grade components to bring outlet into compliance with Requirement #5. |

| Numbers | Photos | Deficiency | Required Retrofit |
|---|---|---|---|
| | <p><i>Clear floor space obstructed by range in Unit 2020-101.</i></p> <p><i>Measurement of clear floor space width.</i></p> | | |

| Numbers | Photos | Deficiency | Required Retrofit |
|---|---|---|---|
| | <p><i>Measurement of clear floor space width.</i></p> <p><i>Range extension from countertop.</i></p> <p><i>Refrigerator depth.</i></p> | | <p>Any such outlet must be approved by the United States prior to installation.</p> |

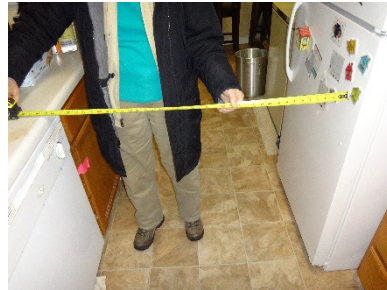
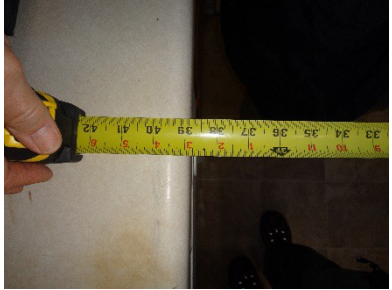
| Numbers | Photos | Deficiency | Required Retrofit |
|---|---|---|---|
| 34 | <p><i>Placement of tape between refrigerator and countertop in Unit 2020-101.</i></p> | The clearances between the refrigerator to the opposing countertop are 38-3/4 inches (minimum 40 inches required). | Remediate upon resident request. |

| Numbers | Photos | Deficiency | Required Retrofit |
|---|---|---|---|
| | <p data-bbox="275 678 625 709"><i>Measurement of clearance.</i></p> | | |

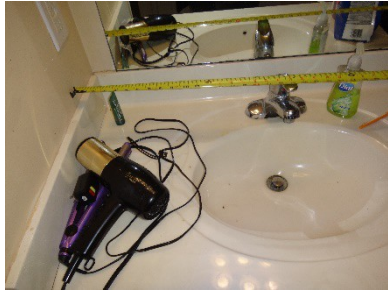
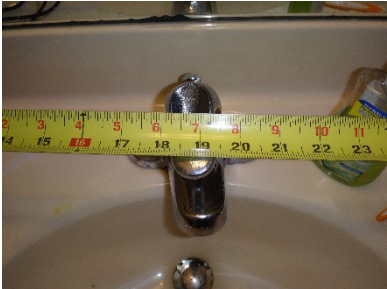
| Numbers | Photos | Deficiency | Required Retrofit |
|---|---|---|---|
| 35 | <p><i>Lavatory in Unit 2020-101 hall bathroom.</i></p> <p><i>Measurement from side wall to lavatory centerline.</i></p> | <p>The lavatory centerlines are less than 24 inches to the side wall (minimum 24 inches required) and the cabinets are not removable.</p> | <p>Install removable base cabinet to provide clear floor space to comply with Requirement 7(2)(a)(ii).</p> |

| Numbers | Photos | Deficiency | Required Retrofit |
|---|---|---|---|
| | <p data-bbox="279 922 499 953"><i>Interior of vanity.</i></p> | | |

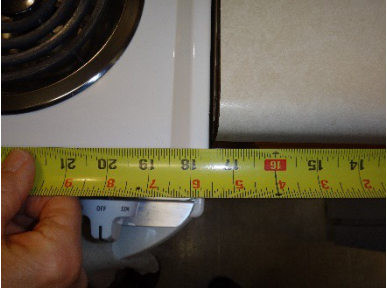
| Numbers | Photos | Deficiency | Required Retrofit |
|---|---|---|---|
| 37 | <p><i>Clear floor space obstructed by adjacent refrigerator and range in Unit 2010-101.</i></p> <p><i>Measurement of clear floor space width.</i></p> | <p>The outlets above kitchen countertops in 1 area lack the required clear floor space for approach (at least 1 outlet in each counter area must have clear floor space for approach).</p> | <p>Subject to tolerances contained in the agreed-upon remediation protocols, modify existing outlet or install a GFI-rated, molded, multi-plug outlet with commercial grade components to bring outlet into compliance with Requirement #5. Any such outlet must be approved by the United States prior to installation.</p> |

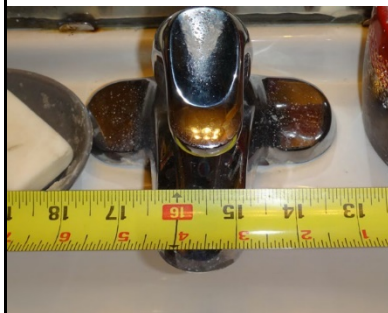
<p><i>Pedestal sink in Unit 2010- 101 master bathroom.</i></p></div> <div>

<p><i>Measurement from side wall to centerline of lavatory in Unit 2010-101 master bathroom.</i></p></div> | <p>The lavatory centerlines are less than 24 inches to the side wall (minimum 24 inches required) and knee space is not provided.</p>

<table><tr><th><u>Location</u></th><th><u>Distance (inches)</u></th></tr><tr><td>Unit 2010-101 hall bath</td><td>21</td></tr><tr><td>Unit 2010-101 master bath</td><td>15-5/8</td></tr><tr><td>Unit 2051-108 hall bath</td><td>19-1/2</td></tr><tr><td>Unit 2051-108 master bath</td><td>15-5/8</td></tr></table>
