UNITED STATES DISTRICT COURT  
FOR THE EASTERN DISTRICT OF NORTH CAROLINA  
WESTERN DIVISION  
No. 5:15-CR-62-H  
No. 5:15-CR-67-H  
No. 5:15-CR-68-H

UNITED STATES OF AMERICA )  
 )  
 v. ) JOINT FACTUAL STATEMENT  
 )  
DUKE ENERGY BUSINESS SERVICES LLC )  
DUKE ENERGY CAROLINAS, LLC )  
DUKE ENERGY PROGRESS, INC. )

### Dan River Steam Station - Middle District of North Carolina

Cape Fear Steam Electric Plant -  
Middle District of North Carolina

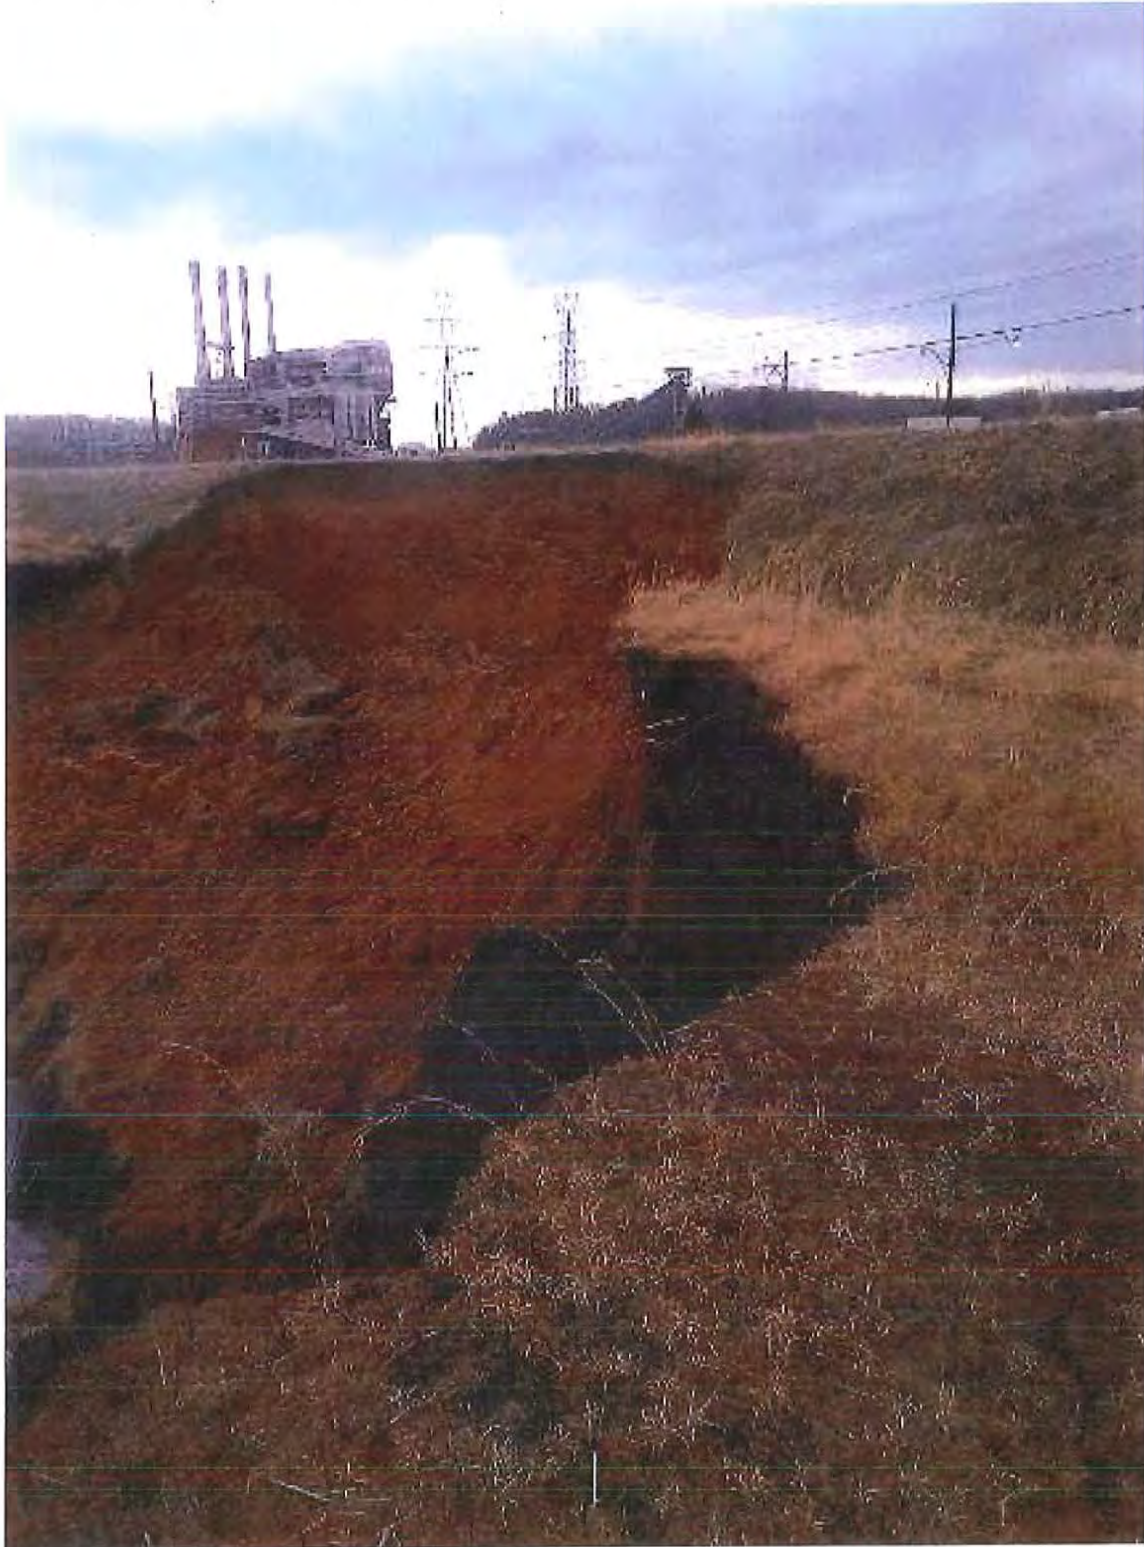
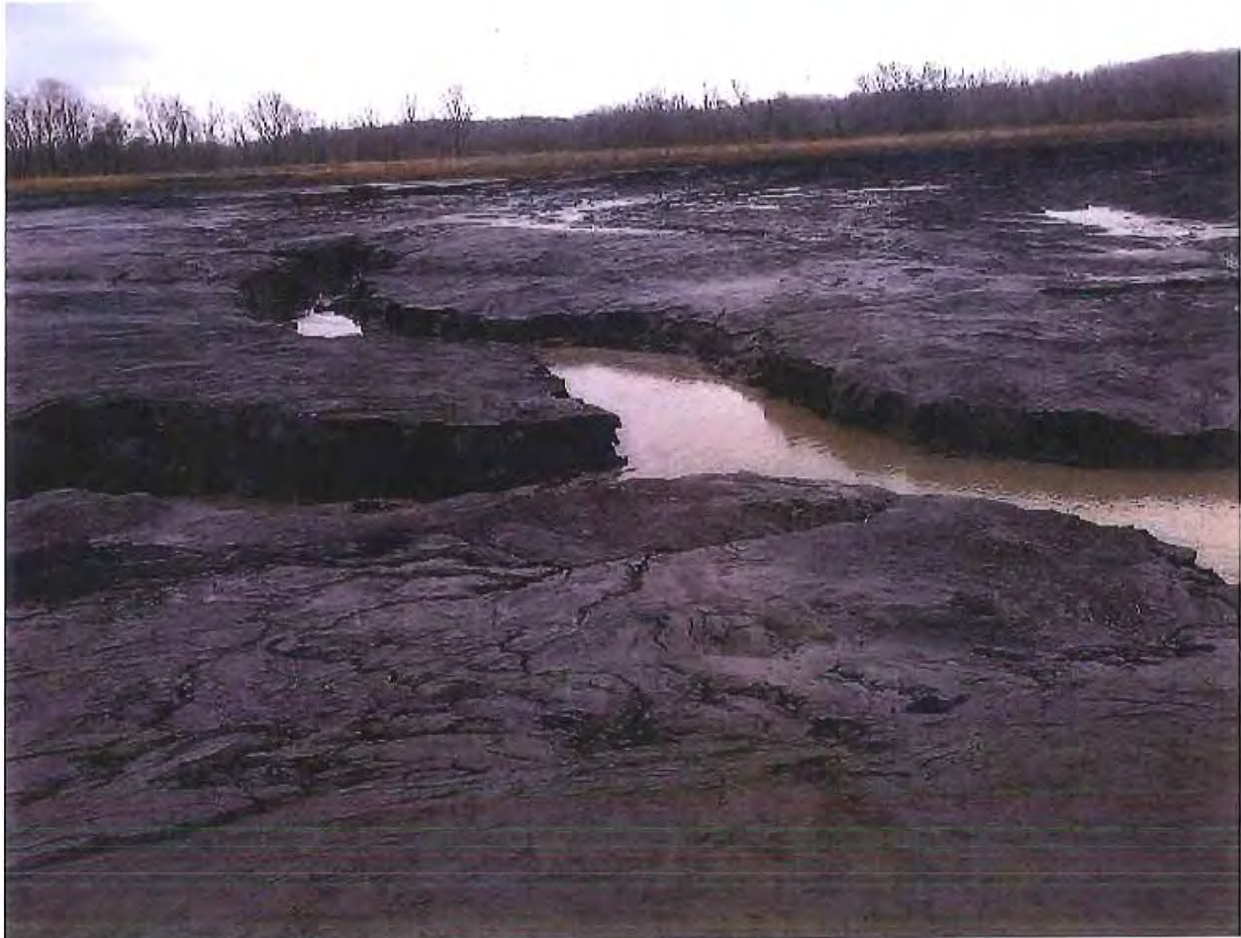
81. On February 2, 2014, a five-foot long elbow joint within the sixty-year-old corrugated metal section of the 48-inch pipe under the Primary Ash Basin at DAN RIVER failed, resulting in the release of coal ash wastewater and coal ash into the Dan River.

**Photograph 1.** Photograph of DAN RIVER coal ash basin during spill, attached to 2/2/2014, 3:49 p.m. e-mail from Duke Energy Business Services employee.

**Photograph 2.** Photograph of DAN RIVER coal ash basin during spill, attached to 2/2/2014, 3:49 p.m. e-mail from Duke Energy Business Services employee.

**Photograph 3.** Photograph of DAN RIVER coal ash basin during spill, attached to 2/2/2014, 3:49 p.m. e-mail from Duke Energy Business Services employee.

**Photograph 4.** Photograph of DAN RIVER coal ash basin during spill, attached to 2/2/2014, 3:49 p.m. e-mail from Duke Energy Business Services employee.

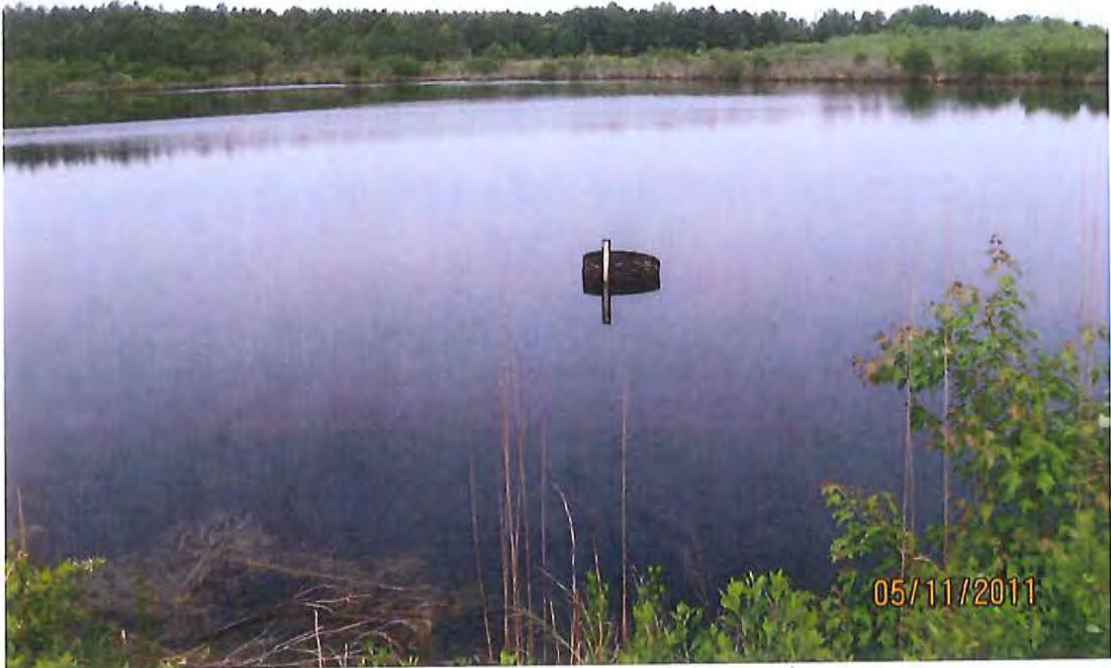
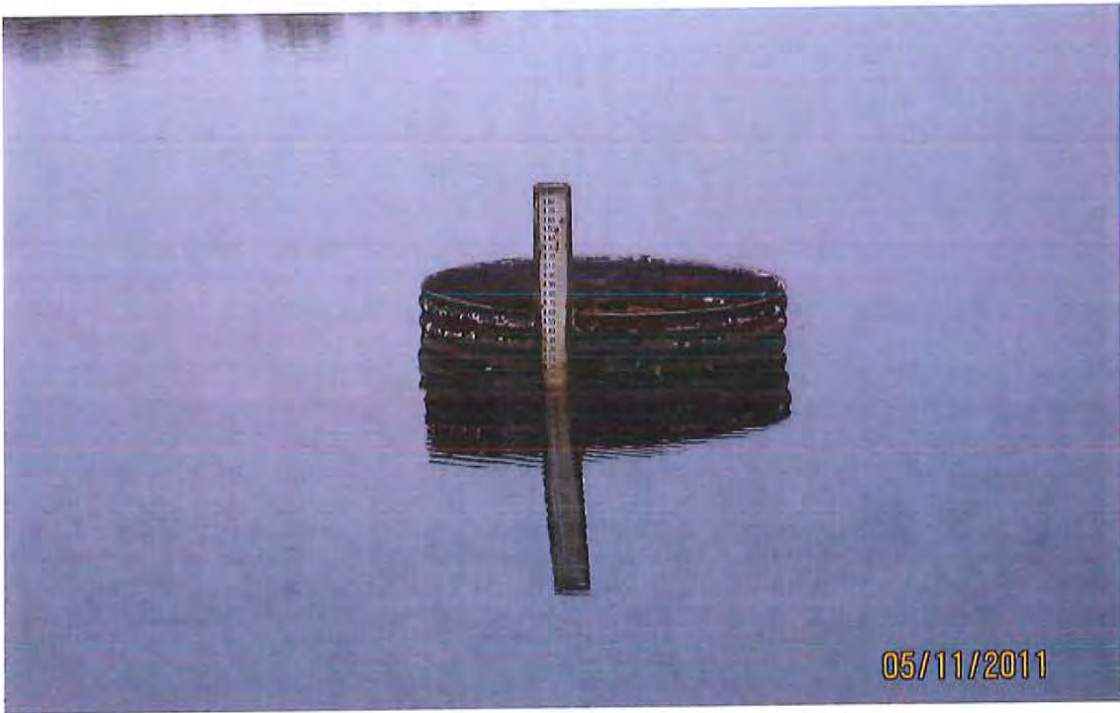
110. The 2012 Five-Year Independent Consultant Report, produced on January 26, 2012, by Engineering Firm #4, noted that the skimmer located at the top of the riser in the 1978 ash basin was corroded and tilted. The skimmer was designed to

113. Annual inspection reports for 2012 and 2013 also reported that the riser in the 1978 ash basin was damaged, deteriorated, and tilted. The annual reports recommended that DUKE ENERGY PROGRESS/Progress Energy Carolinas replace or repair the skimmer on the riser in the 1978 ash basin.

**Photograph 5.** Riser in CAPE FEAR 1978 coal ash basin from 2012 Five Year Independent Consultant Report.

**Photograph 6.** Riser in CAPE FEAR 1978 coal ash basin from 2012 Five Year Independent Consultant Report.

114. At no time from January 26, 2012, through March 2014 did DUKE ENERGY PROGRESS/Progress Energy Carolinas repair or replace the skimmer on the riser in the 1978 coal ash basin.

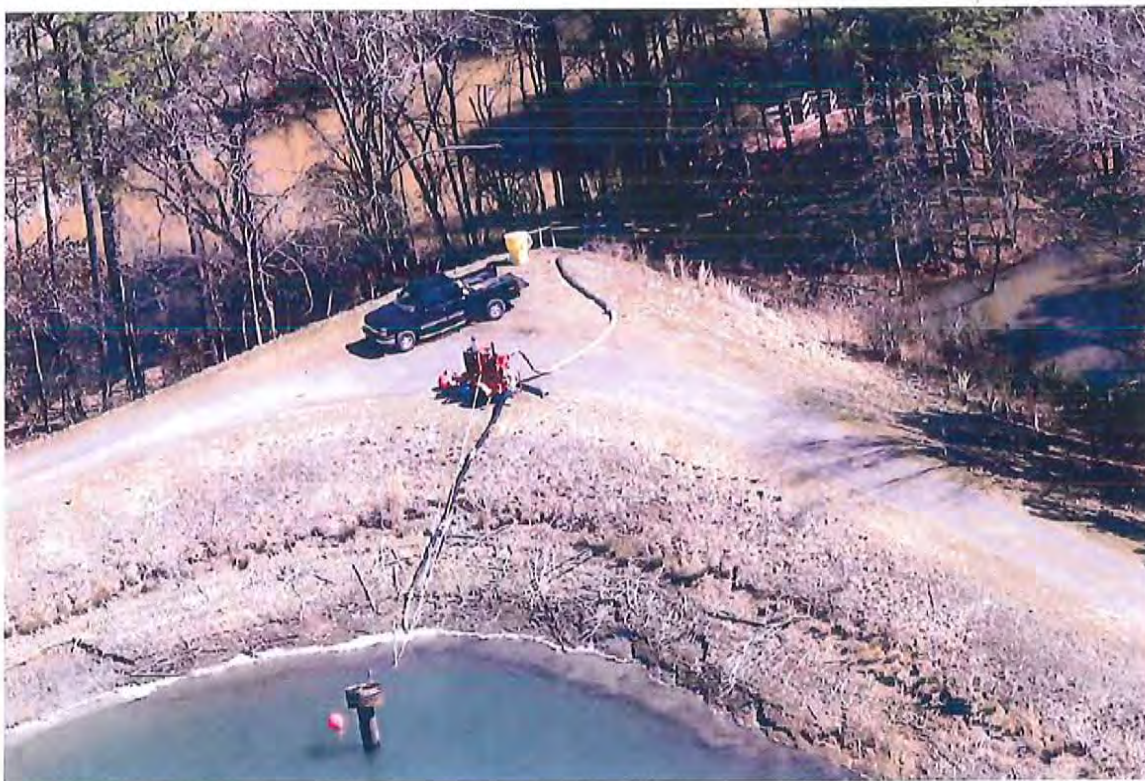
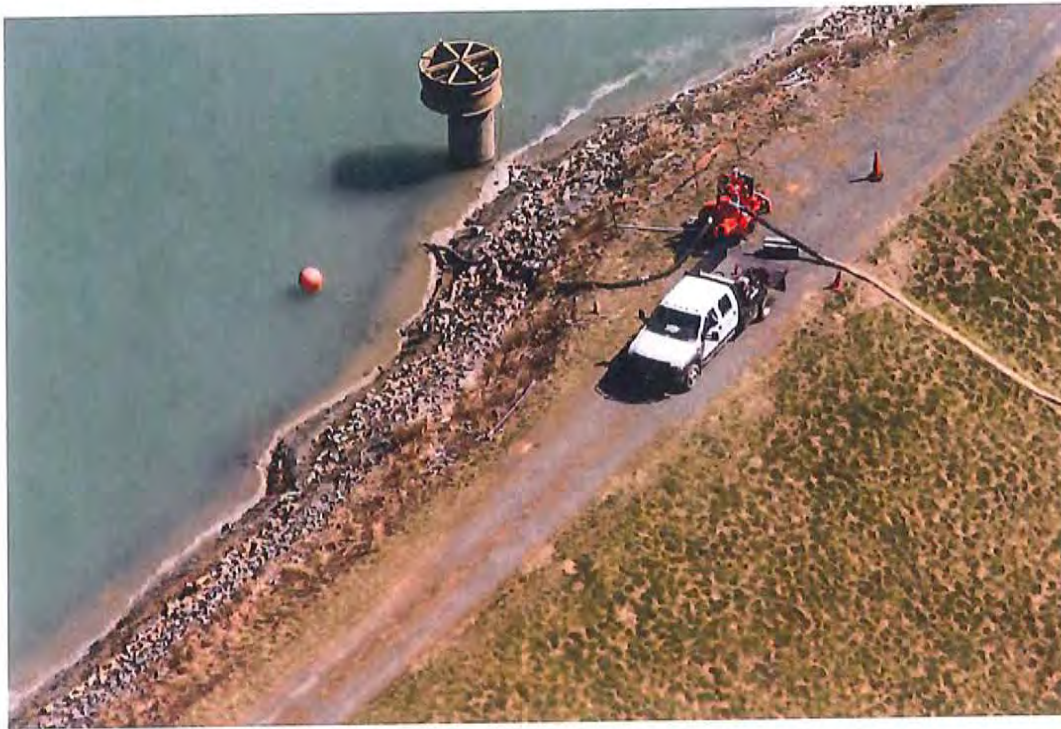
127. On or about March 11, 2014, DENR officials from both the DWR and the Division of Mineral and Land Resources visited CAPE FEAR to perform an inspection. The DENR officials were accompanied by several DUKE ENERGY PROGRESS and DUKE ENERGY BUSINESS SERVICES employees during their inspection. DENR observed the Godwin pumps at the 1985 and 1978 ash basins along with obvious signs of a significant drop in the water level in the coal ash basins and disturbances in the surface of the coal ash in the basins. **(See Appendix, Photographs 8 - 10).**

**Photograph 8.** 3/11/14 aerial photograph of CAPE FEAR 1978 coal ash basin with Godwin pump and truck.

Photograph 9. 3/11/14 aerial photograph of CAPE FEAR 1985 coal ash basin with Godwin pump and truck.

**Photograph 10.** 3/11/14 aerial photograph of CAPE FEAR 1985 coal ash basin with Godwin pump and truck.

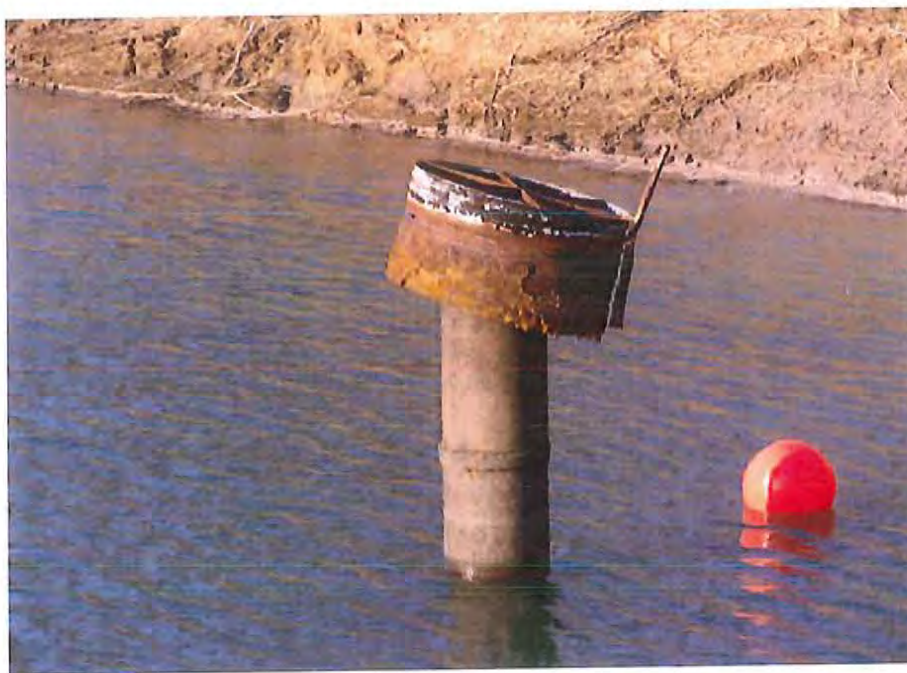
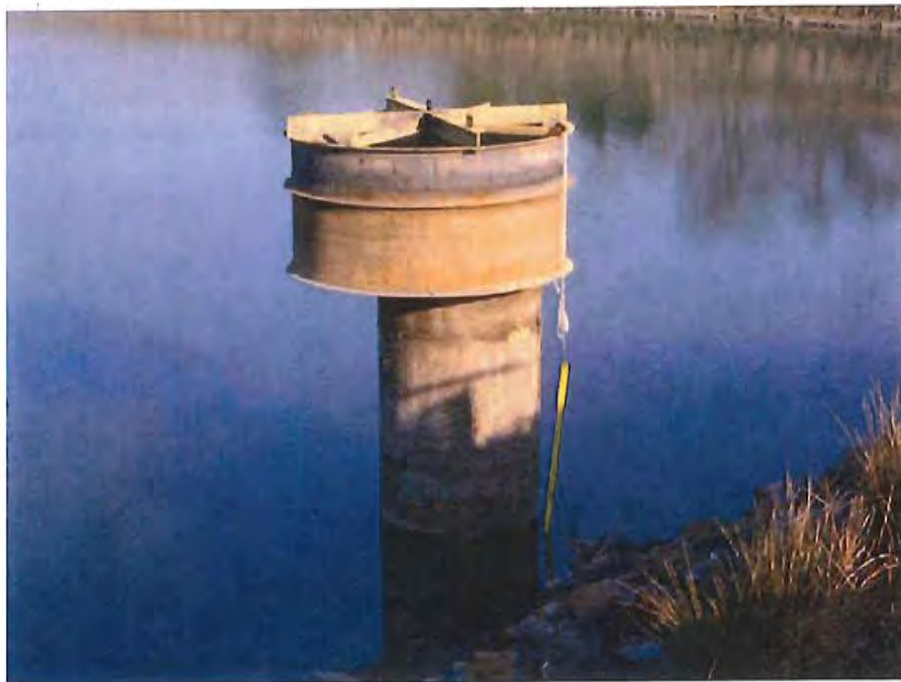
the 1985 coal ash basin, the visibility in one area was "next to nothing." The visibility was negatively impacted by turbidity and debris in the pipe. The contractor observed a "slow trickle" of water intruding into the riser in the 1978 coal ash basin. At the time of the camera inspections, the water level in both coal ash basins had already been lowered below the uppermost joints of the risers and, thus, below the level of some of the leaks.

**Photograph 11.** 3/19/14 photograph of CAPE FEAR 1978 coal ash basin riser, prior to repair work.

**Photograph 12.** 3/19/14 photograph of CAPE FEAR 1985 coal ash basin riser, prior to repair work.

131. On or about March 19 and 20, 2014, employees and agents of the underwater pipe repair contractor replaced and resealed the grout between the concrete pipe sections of the risers in the 1978 and 1985 coal ash basins. **(See Appendix, Photographs 11 through 14).**

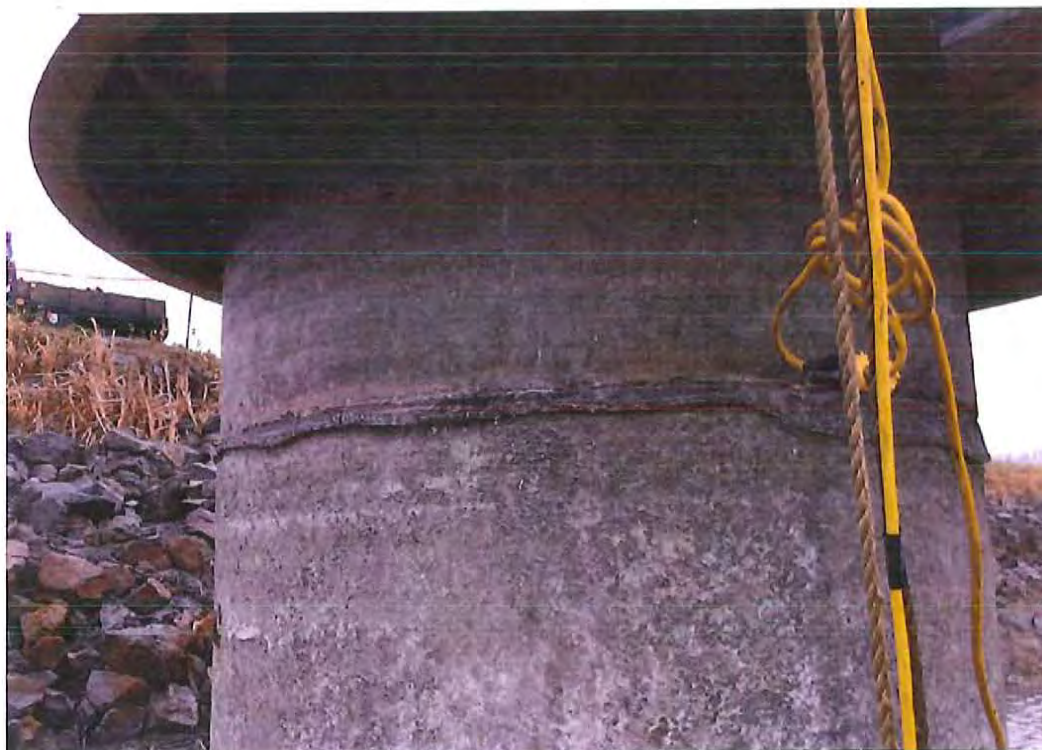
**Photograph 13.** 3/19/14 photograph of old grout on CAPE FEAR coal ash basin riser.

for contractors performing repair work. DUKE ENERGY PROGRESS and DUKE ENERGY BUSINESS SERVICES employees knew that the leaks in the risers were likely being caused by cracks or failures in the grout between the concrete pipe sections that were underwater. The employees did not know how far underwater the leaks or grout failures were or how many sections of the pipe would need repair. Because the risers were filled with air but surrounded by water, underwater repair of the risers could be hazardous to the divers due to a phenomenon known as "differential pressure." DUKE ENERGY PROGRESS and DUKE ENERGY BUSINESS SERVICES employees believed that removing the standing water from the 1978 and 1985 basins to at or below the level of the leaking portions of the risers would eliminate the risk from differential pressure.

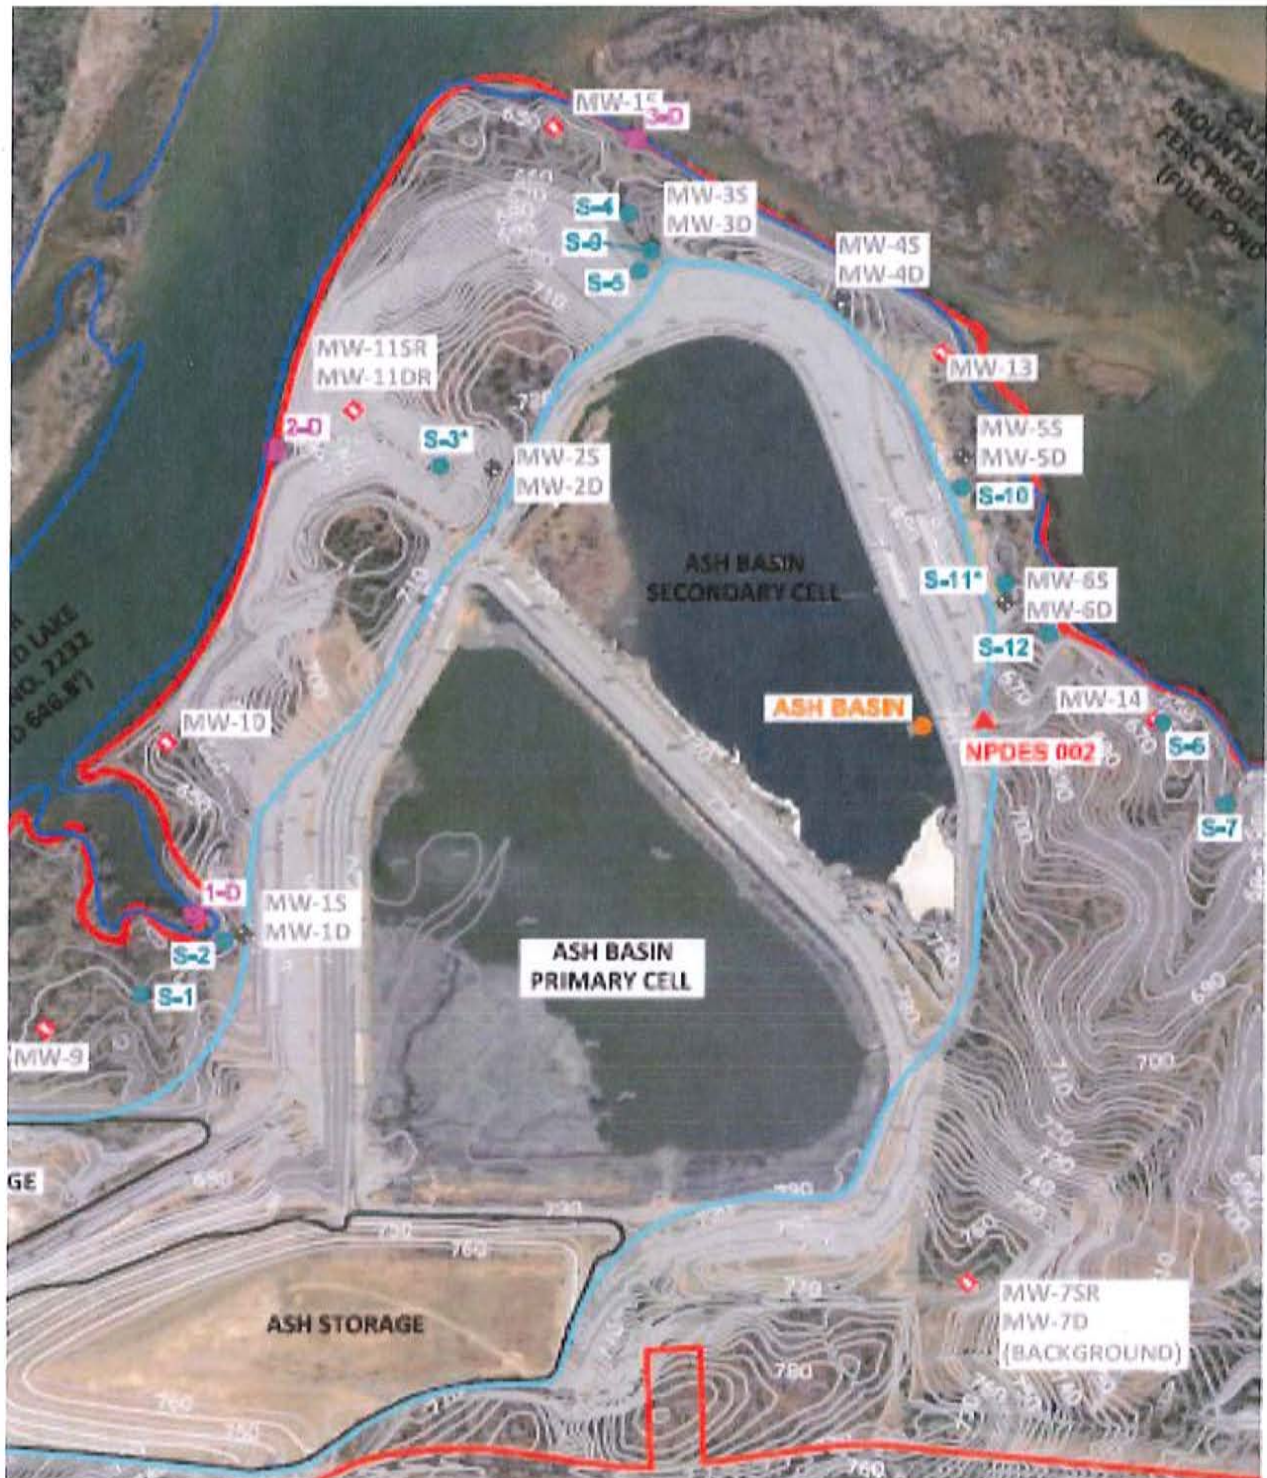
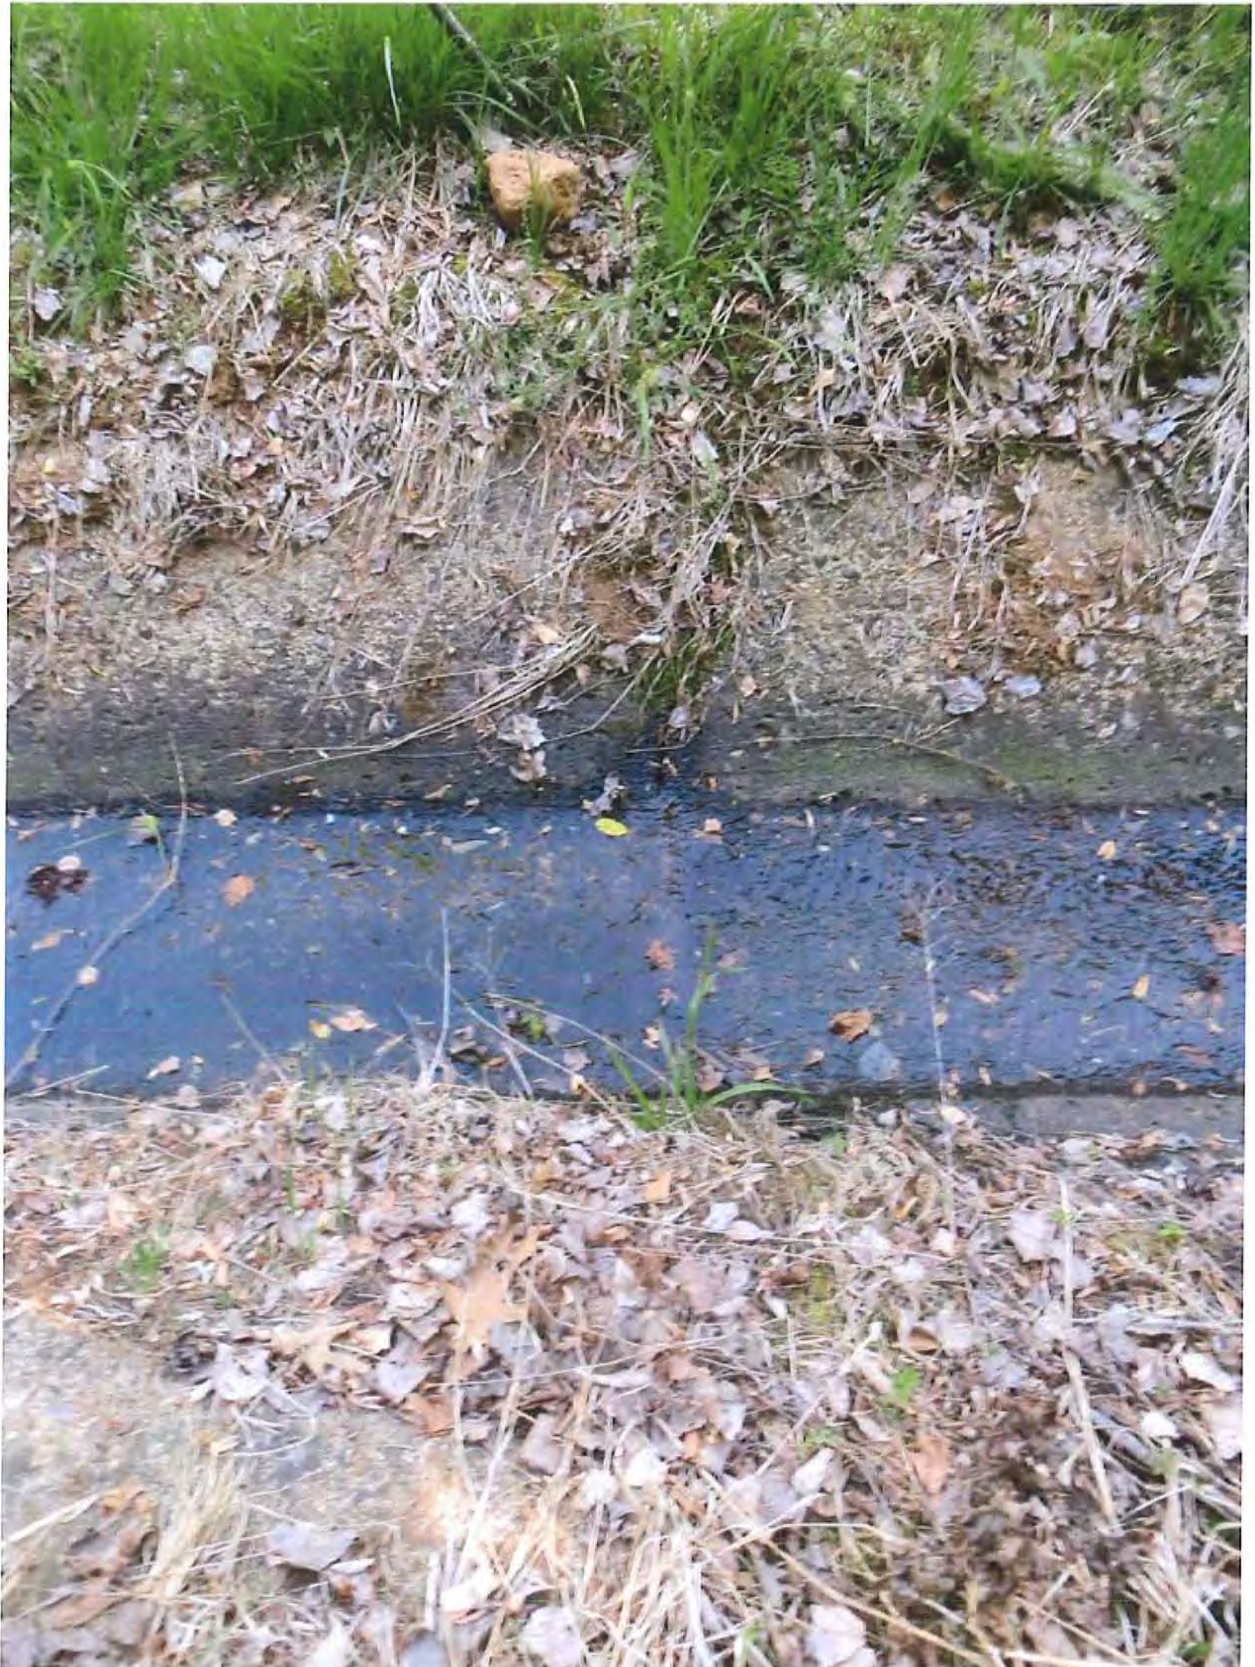
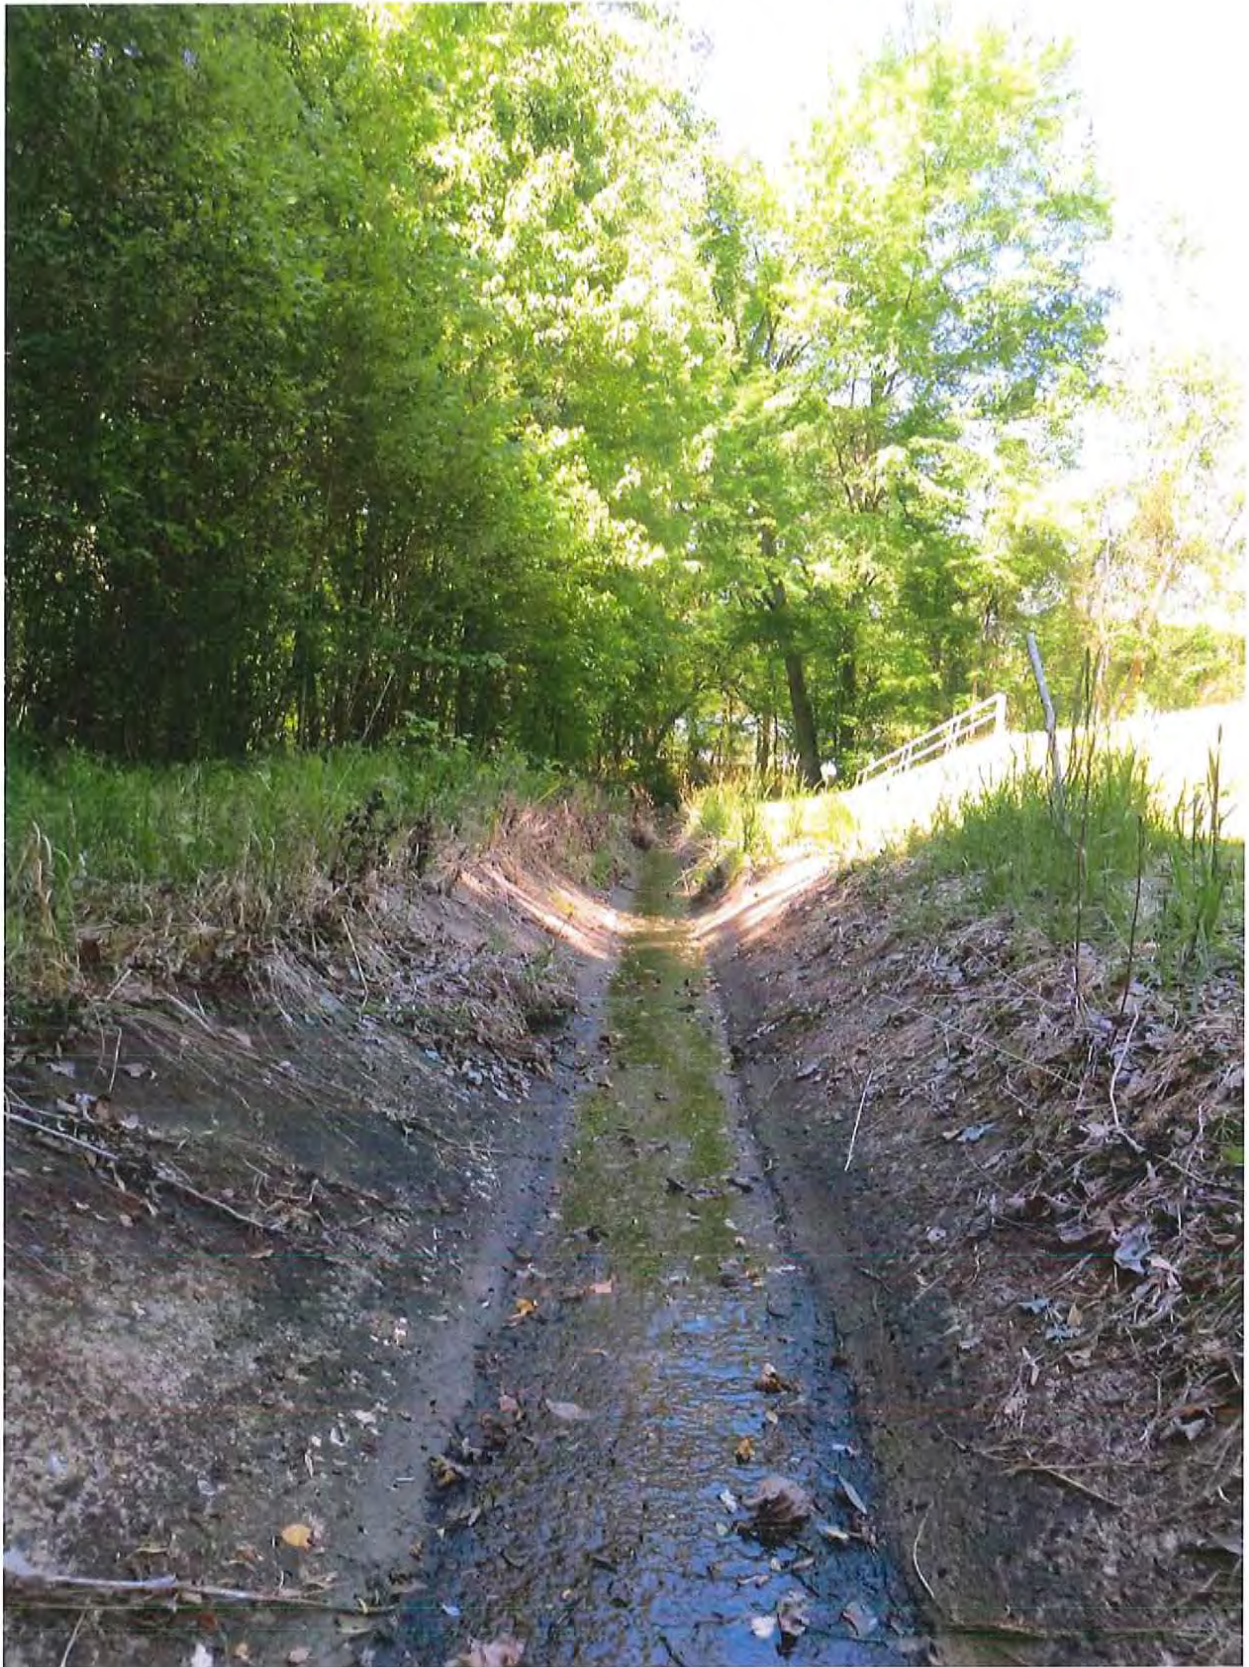
Photograph 16. Aerial photograph depicting location of RIVERBEND Seep 12.

Photograph 17. Photograph of RIVERBEND Seep 12.

Photograph 18. Photograph of RIVERBEND Seep 12.
